## Historic Bridge Foundation Facebook Archives

### Bad Repairs

December 2015

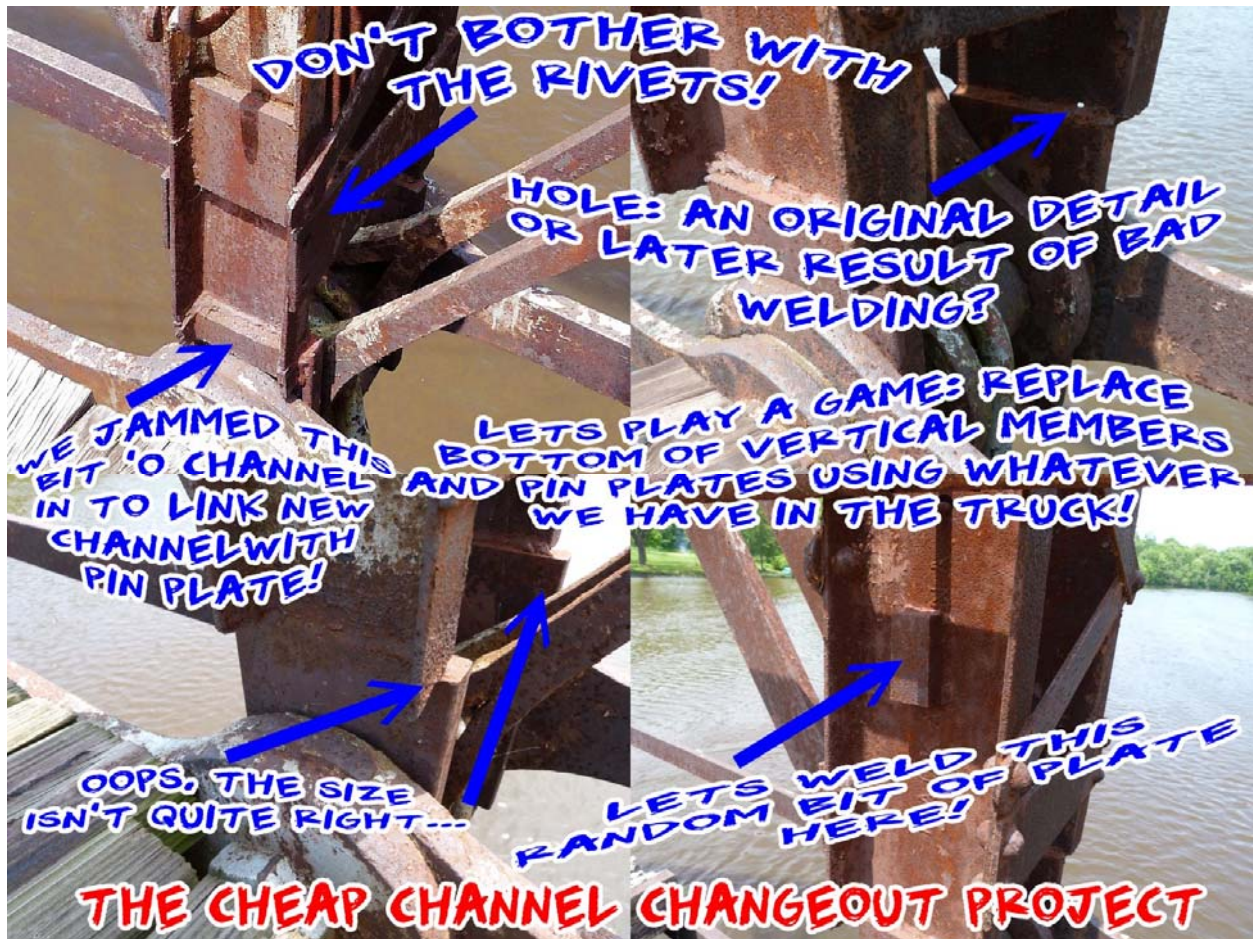
This repair was never a good one to begin with, but time and continued deterioration of this now-abandoned bridge have made the repair even less reliable. Here, pieces of channel were used to replace sections of some verticals. More noteworthy, all pin plates were replaced with new welded plates. Pin plates are structurally important since they link the vertical member to the connection. Here, the weld quality does not appear to have been very good, failing to offer much coverage between the two plates. As a result, section loss holes have developed in several areas along the welds, assuming they were not there to begin with when the repair was completed.

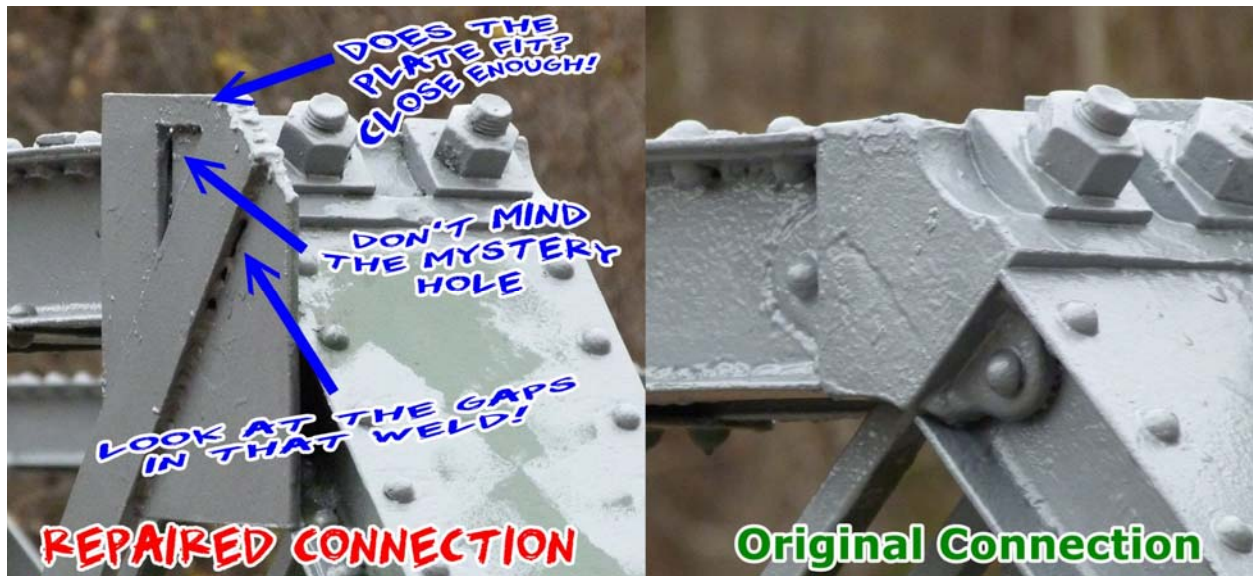
This repair sought to supplement an original cast iron connection plate and diagonal members at this truss pin connection location with welded bar and plate. The visual presentation of this repair as well as the actual workmanship is poor. The supplemental gusset plate that is welded on has messy cuts, uneven shape, and appears to be oversized. There is a big hole in the middle, which might have been the result of trying to make it fit, but regardless the visual presentation is that of a “mystery hole.” In terms of actual workmanship and quality the most striking aspect of this repair is the welding of the supplemental diagonal bar to the new gusset plate where at least three gaps (holes) in the weld are visible.

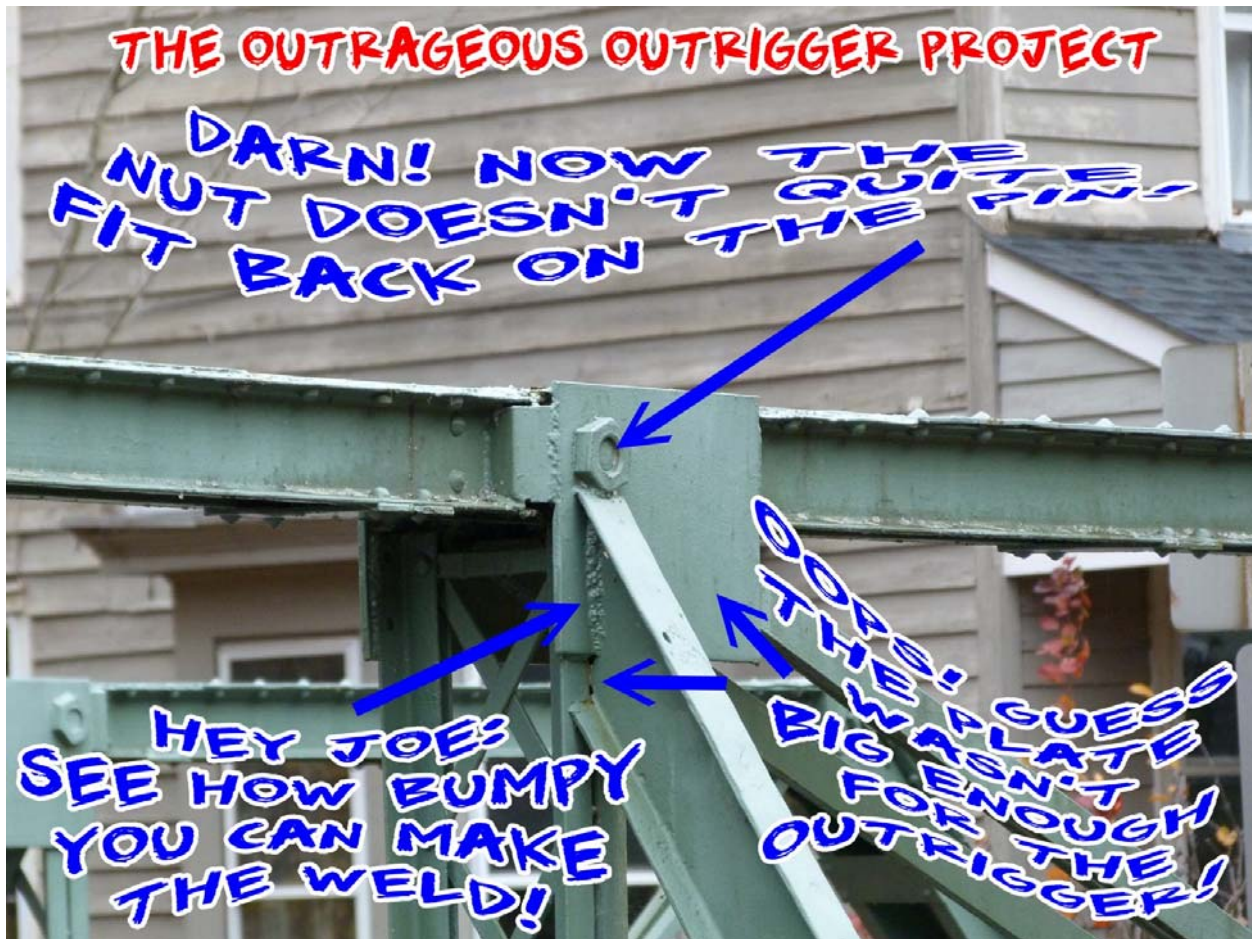
This repair does not appear to be thought out very well and also shows poor workmanship. The main features of the repair are that a gusset plate was added to an existing truss pin connection, and outrigger beams were added to this bridge. The intent appears to have been to weld the new outrigger to the new gusset plate. However, the gusset plate turned out not to be tall enough, so only the top two thirds of the outrigger are actually welded to the plate, with the remainder not welded to anything. Worse, the part that was welded shows very poor weld quality. The very random and bumpy looking weld does not display the even pattern of ridges that are characteristic of a good weld. Another problem with this repair occurred when it turned out adding the plate made it impossible to fully screw the nut back onto the pin, such that the nut is only about halfway on the pin.

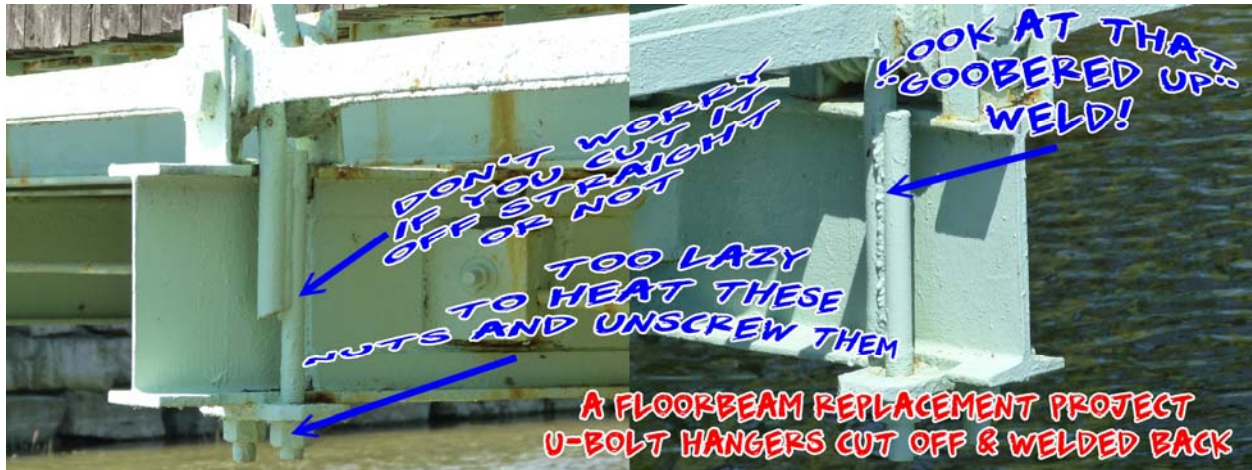
With this truss bridge, potentially as part of an effort to replace floor beams, the u-bolt hangers were cut, and rather than be replaced with new u-bolts, it appears some of the original u-bolts were welded onto new pieces of rod. The end result of this repair is that the u-bolts, which are tension members holding the floor beams onto the truss, rely on these welds for their function. Many engineers frown on repairs that require a tension member to rely on a weld for their function, even though a high quality weld may perform very well in tension. However, what about a bad weld? Certainly any engineer would frown at a tension member relying on a bad weld. Yet that is what is seen in this repair. The very random and bumpy looking weld does not display the even pattern of ridges that are characteristic of a good weld.

Its also worth noting that in some cases, u-bolts can be removed, and later reinstalled in a non-destructive manner by heating and unscrewing the nuts at the bottom. This approach would be a way to replace floor beams without requiring an unusual repair like this.

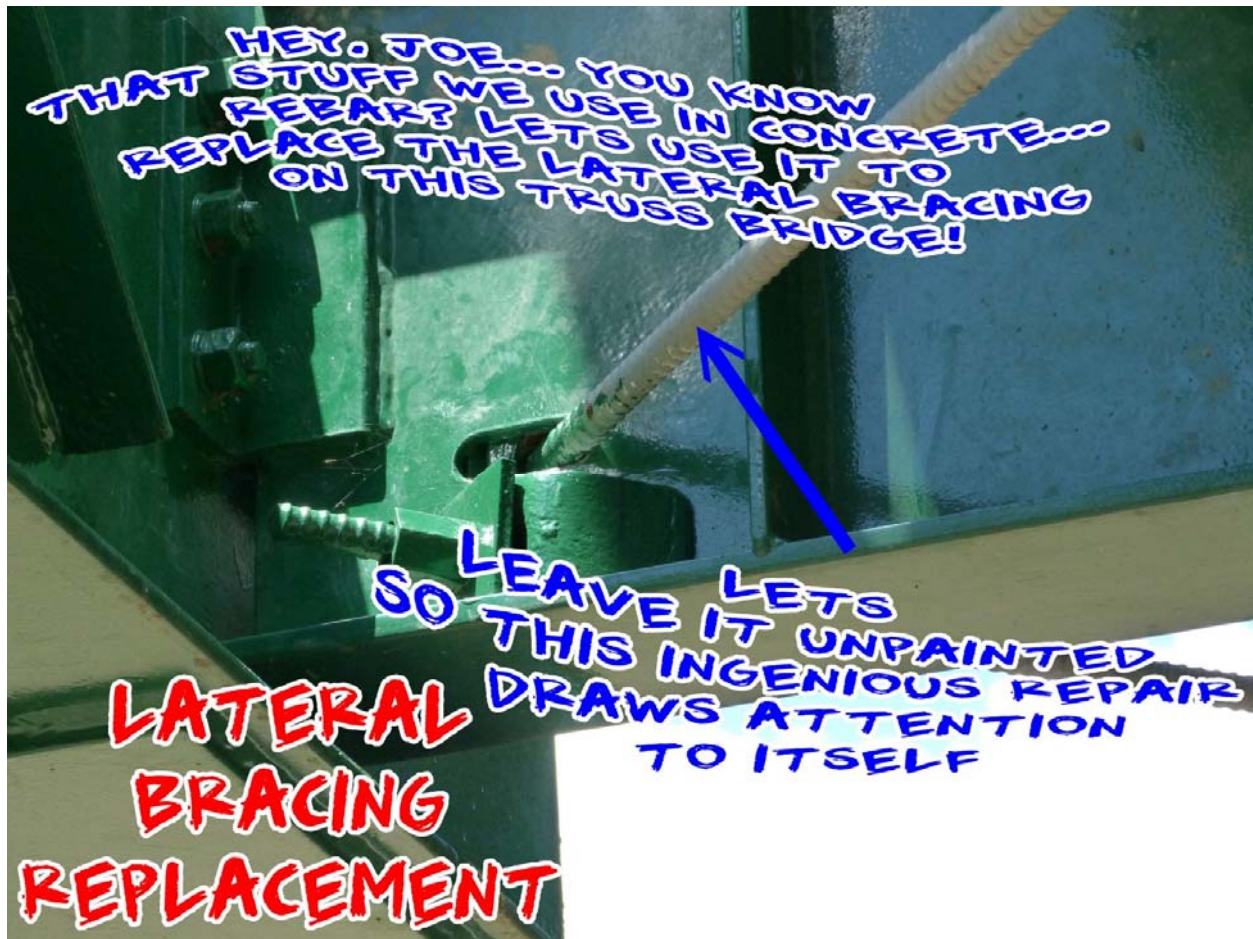
This is a good example of a repair of a metal truss bridge that from a structural standpoint probably performs just fine, but visually just doesn't look very nice or historically accurate. Here, the original lateral bracing under the deck was replaced with new rods. The rods used are the ribbed design found in concrete rebar. Seeing rebar on a historic truss bridge being used for lateral bracing just doesn't look very nice. Also these rods, which appear to be galvanized, were not painted green like the rest of the truss; therefore they stand out and call attention to themselves.

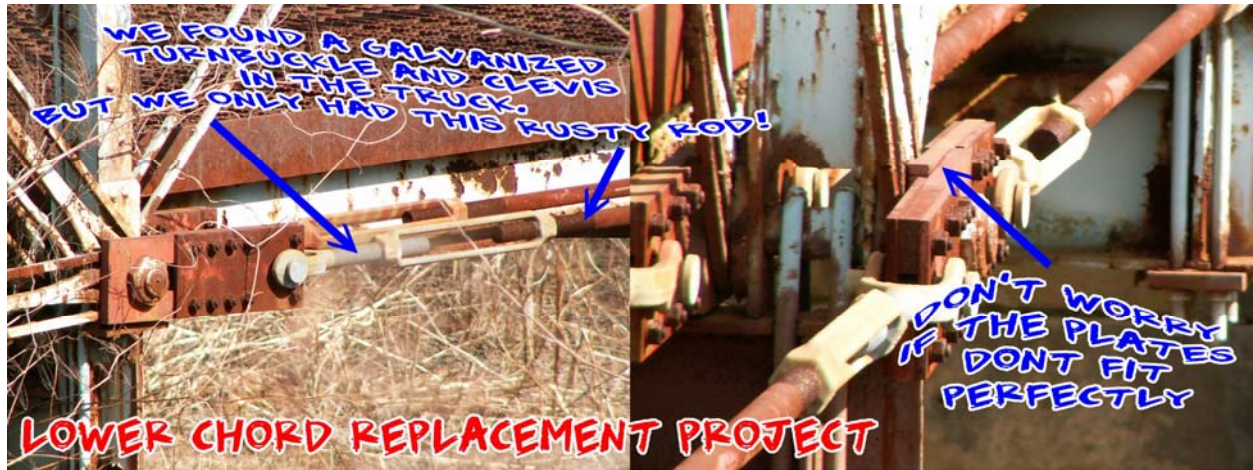
This is a repair for which its hard to tell how much structural value it provided. The intent appears to have been to replace one panel's worth of bottom chord in a pin-connected truss. It is a repair that has the appearance of being put together using spare parts. It includes galvanized turnbuckles, but these were the only things that were galvanized. The rest of the parts appear to have been painted steel, as they had rusted to varying degree in the years after the repair, unless rusty pieces were used to begin with. At the pin connection, a series of steel plates were stacked and bolted together. However, some of the plates were either not cut straight, or were not the right size, as they do not all line up.
