CASE STUDIES

STONE ARCH BRIDGES

Johns Burnt Mill Bridge (Adams County Bridge No. 56), Mount Pleasant and Oxford Townships, Pennsylvania

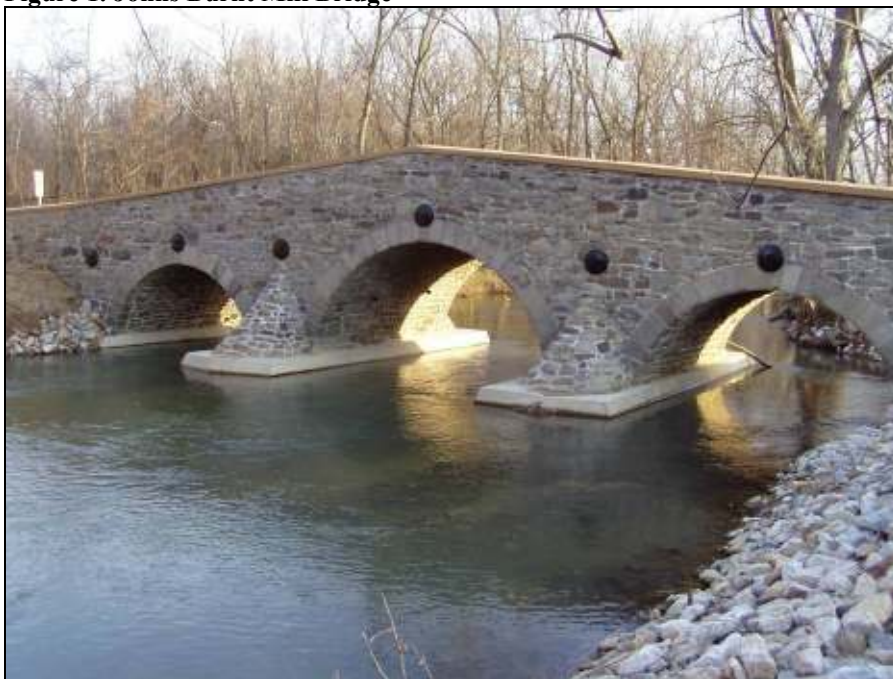
Figure 1. Johns Burnt Mill Bridge

In recent years, the bridge exhibited increased cracking in the arch barrels and spandrel walls, with a noticeable increase in cracking after a January 1996 flood. Inspection revealed that the fill above the arches had become saturated due to the flood waters. Freezing temperatures after the flood caused the saturated fill to expand, increasing the cracking in the arch barrels and spandrel walls. Scour of the stream bed at the piers also was observed during inspections.

The project began with a series of load tests, in addition to test borings into the bridge in order to determine the make-up and condition of the bridge's foundations. Based on these tests, the project team decided to use precast concrete backing blocks to strengthen the arches. A structural analysis

demonstrated that installing the backing blocks would strengthen the bridge, eliminating the need for the existing 15 ton weight limit.

- installing concrete aprons around the abutments, wingwalls, and piers;
- installing temporary centering to support the arches, and bracing to support the walls;
- removing the existing fill above the arches;
- installing the precast concrete backing blocks;
- installing a drainage system with weepholes;
- installing well-draining backfill;
- installing a heavy duty membrane;
- placing new bituminous pavement;
- repointing stone masonry;
- replacing the concrete parapet caps;
- installing new approach guide rail; and
- installing a standard one lane bridge signing.
