## **Historic Bridge Foundation Facebook Archives**

### **Did You Know... That Florida has a cast and wrought iron swing bridge?**

**December 2014**

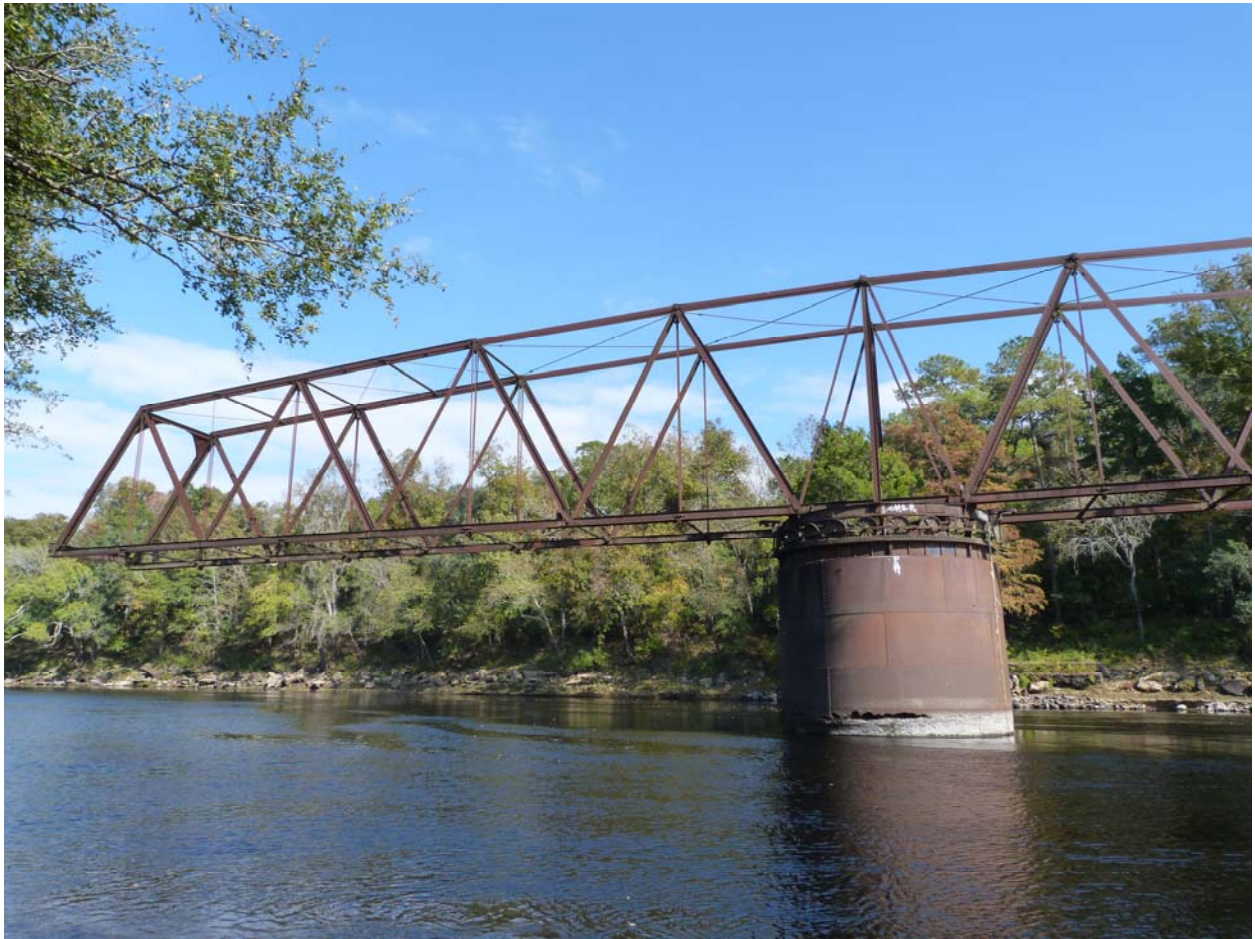
The bridge is a pin-connected Warren through truss, with a symmetrical rim-bearing swing design. It rests on a riveted steel caisson that appears to be filled with concrete and is deteriorating near the water level. While the truss webs of this bridge are composed of wrought iron members only, transverse struts that run between the upper chords and lower chords of the bridge are cast iron beams. Cast iron blocks are found between the upper lower chord channels. On the lower chord, these blocks also act as guides for the vertical members, which at each panel point consist of three rods. Lateral bracing

Elevation showing Warren truss configuration and the caisson pier.

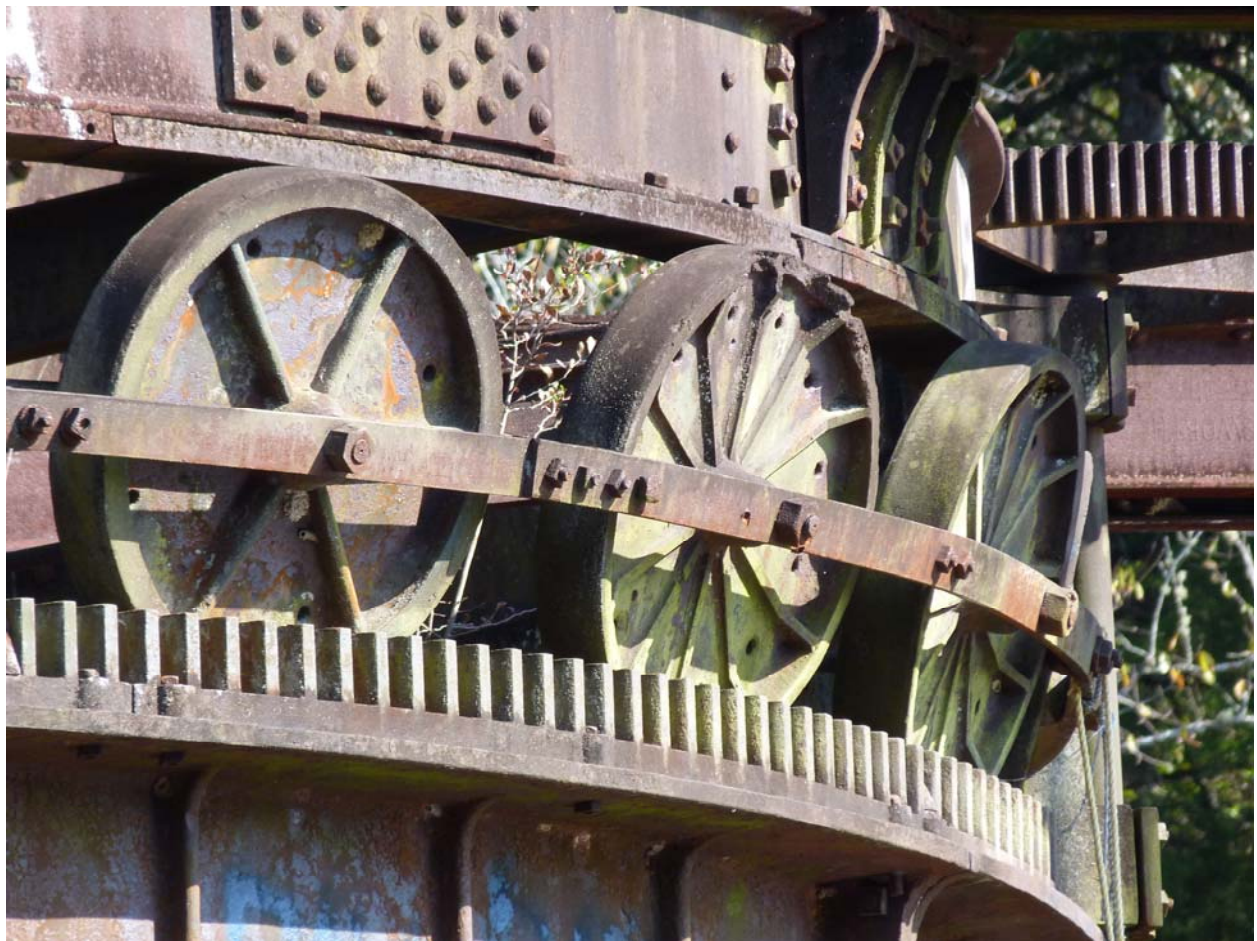
between the lower chord are held in place by way of nuts and castings attached to the channel. Overhead lateral bracing is an unusual clevis rod design, with the two eyes at each end fitting around the cast iron strut. The hand-turned swing truss rests on cast iron rollers, some of which appear to slowly tipping outward, presenting a possible risk to the future of the bridge. The toothed swing rack rests on an unusual cast iron circular rim. No evidence of approach spans or abutments remain, only the main through truss span is in place today. It appears to be largely unaltered and despite the potential issues with the rollers and the pier, the truss itself shows very little deterioration, likely a testimony to the corrosion-resistant properties of iron.

Detail of the rollers which appear to be tipping outward. The top of the cast iron rim can be seen at the bottom of the photo.

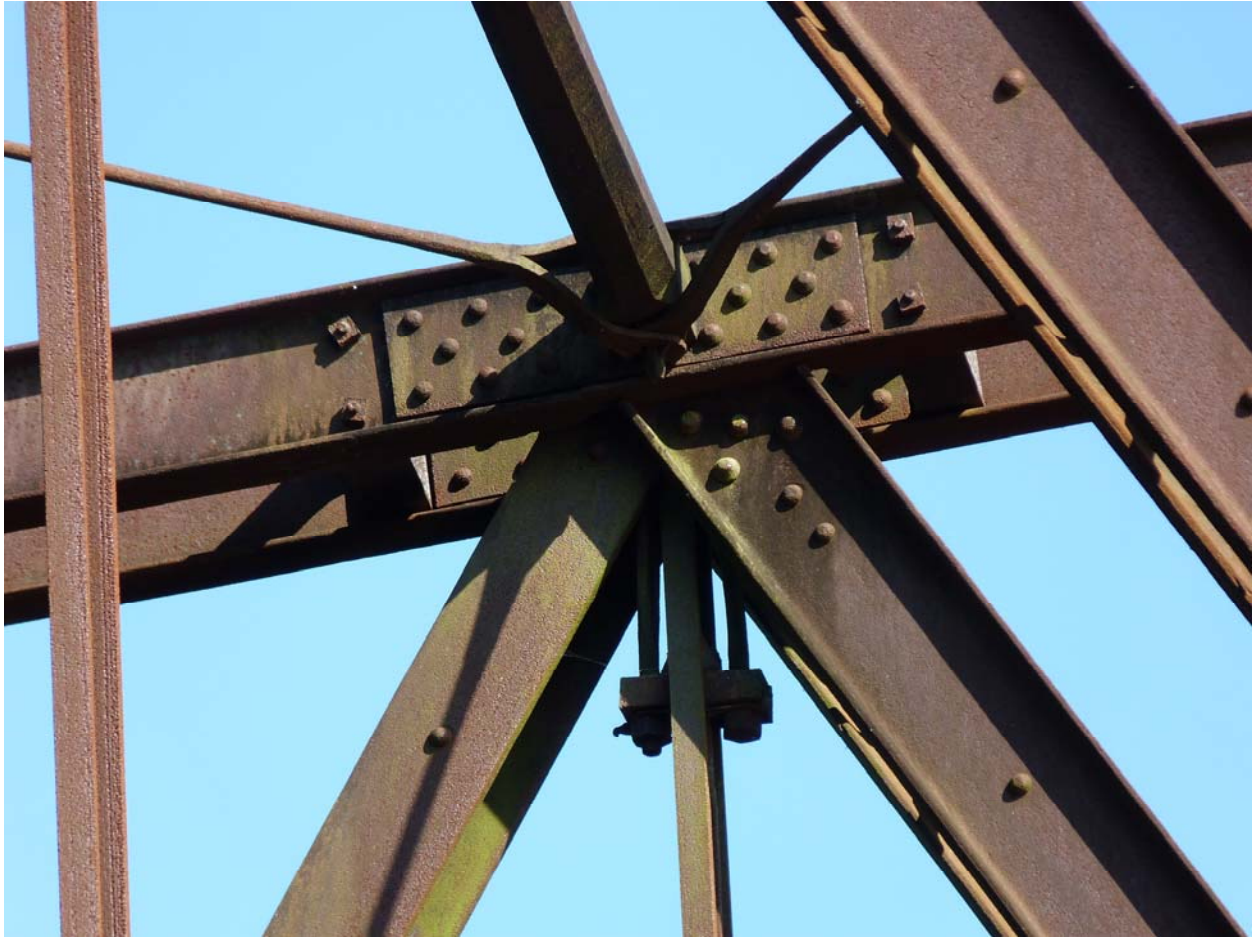
Upper chord connection detail. A cast iron strut is visible at the top of the photo, and to the left and right of the strut, a clevis rod functioning as lateral bracing is visible.

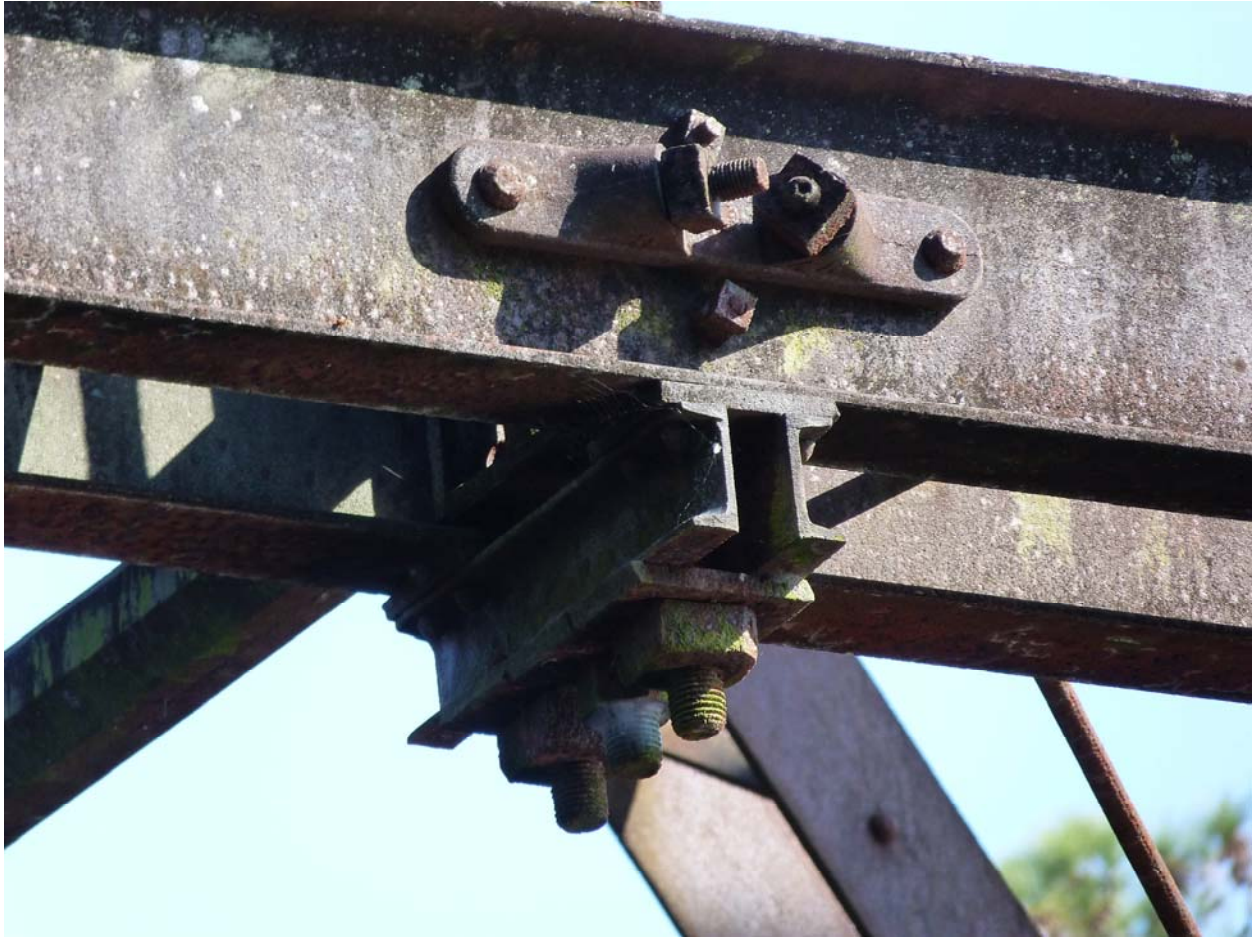
Lower chord connection detail, showing the nuts and casting which hold the lateral bracing in place, as well as the paired channels and nuts which hold the verticals in place.

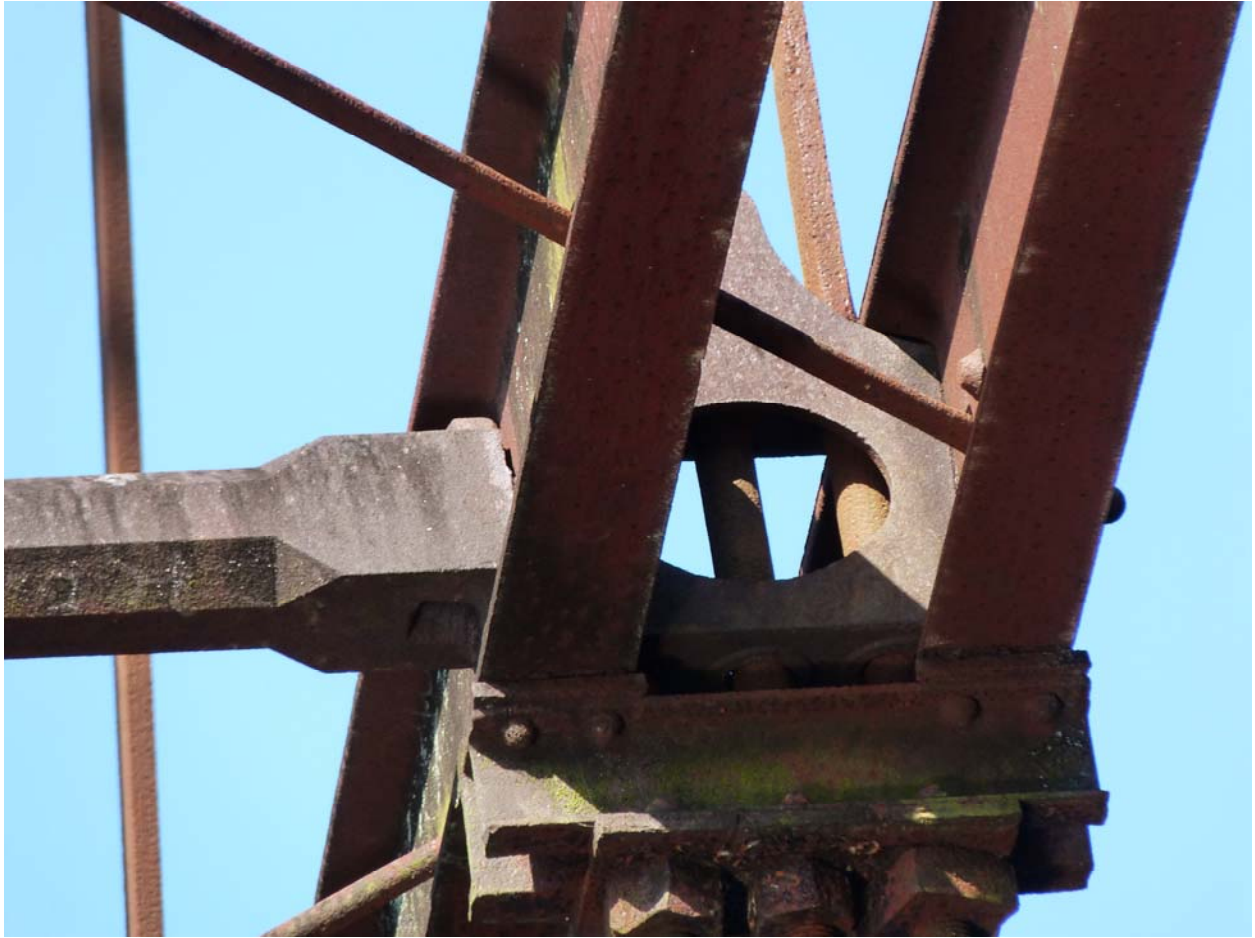
Lower chord connection detail. A cast iron spacer and vertical member guide can be seen between the channels, and a cast iron strut is visible to the left.
