Historic Bridge Foundation Facebook Archives

Did You Know... In the past, metal truss bridges were reconfigured and reused in some bizarre ways?

August 2016

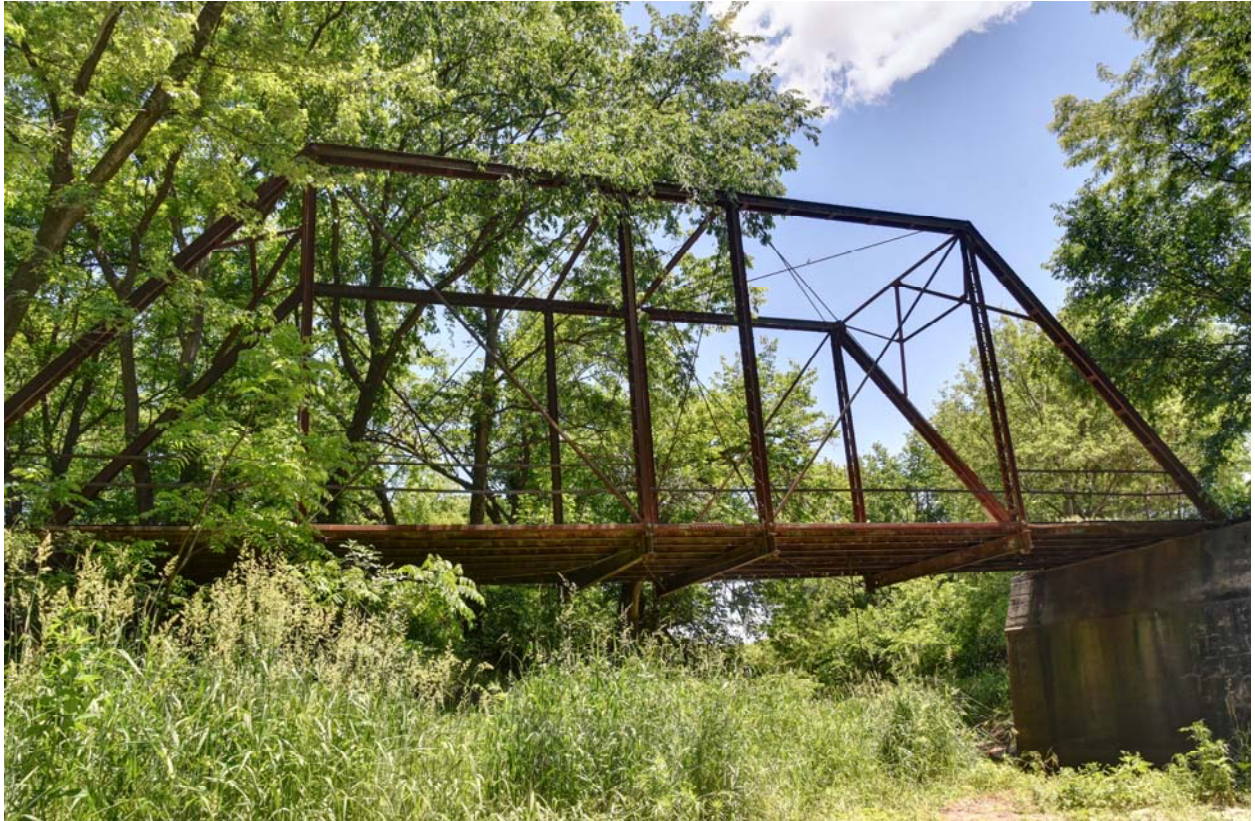
The bridge carrying Larkinburg Road Cottonwood Creek is a relocated truss bridge with an unusual, but relatively minor alteration: the bridge was shortened to some extent, presumably to fit the different dimensions of its new crossing. The bridge is an otherwise traditionally composed example of a pin-connected Pratt through truss. One hint that this bridge might not be in its original location is its abutments. The concrete design looks perhaps a bit out of place with a pin-connected truss bridge, and the abutments also have an unusual sloped design. There is a possibility that they encase stone abutments from a previous bridge, although this is pure speculation. Stronger evidence of the truss being shortened is found in the center panel which is far shorter than the other truss panels. Panels are normally all approximately the same length on a truss, and having a panel as short as this bridge's center panel is unheard of. Closer inspection of this panel offers more detailed evidence. The lower chord eyebar shows evidence of being shortened. A riveted splice in the center of each bar shows that what was originally a single bar was cut and riveted back together. A similar riveted splice appears at the center of the upper chord at the same location. The overhead lateral bracing was simply removed for this panel. The diagonal members do not show obvious alteration, however being center panel "counters" they have turnbuckles, and so the rod might have been simply cut shorter and re-threaded.

larkinburg_1600_1_2f - Larkinburg Road Bridge with the narrow center panel clearly visible.

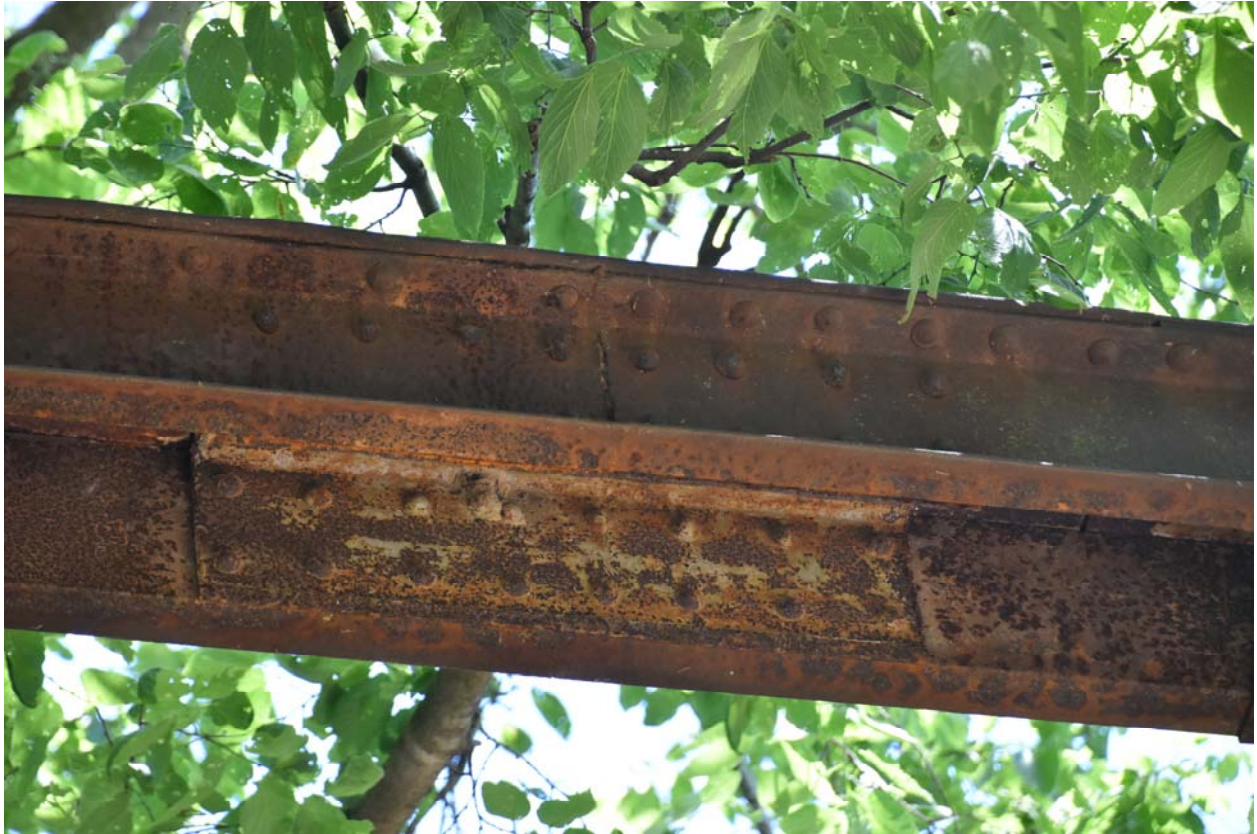
larkinburg_1741 – Larkinburg Road Bridge: Upper chord at center panel showing riveted splice.

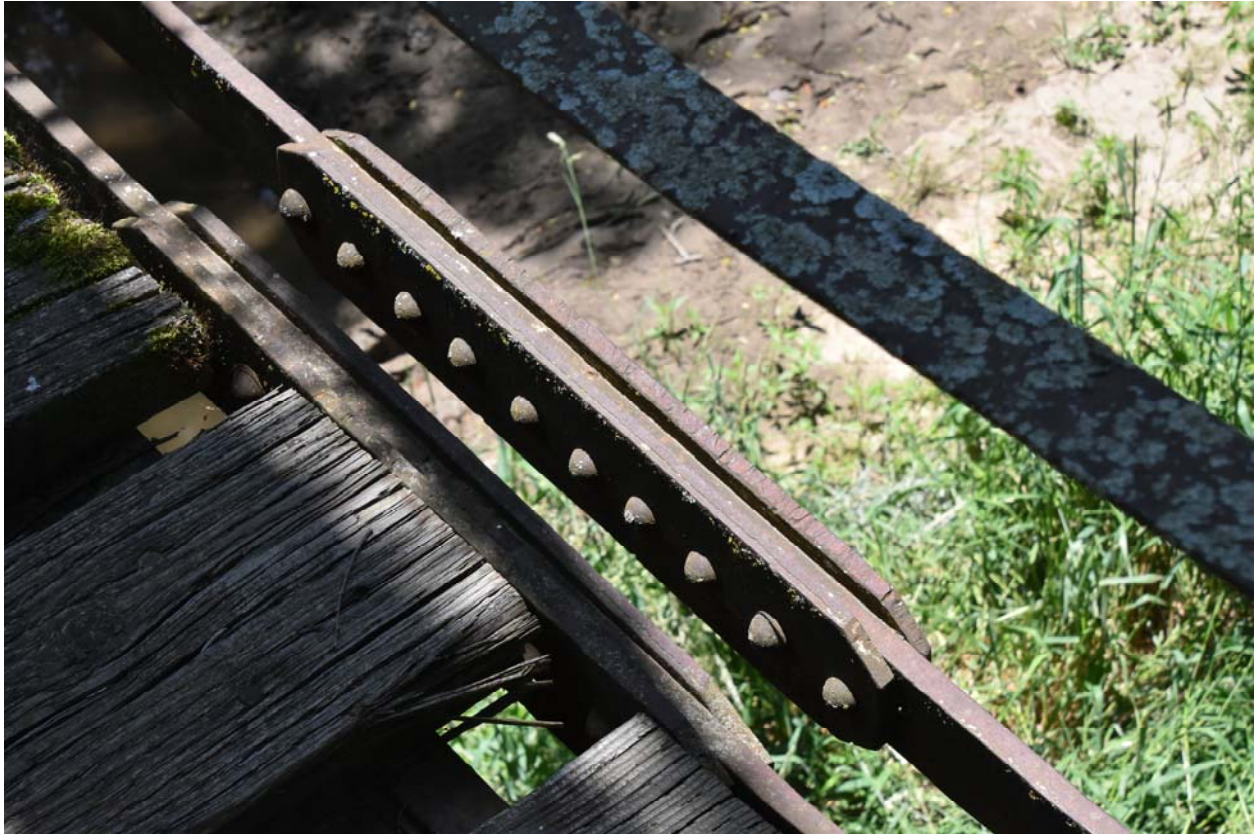
larkinburg_1732 - Larkinburg Road Bridge: Lower chord at center panel showing riveted splice.

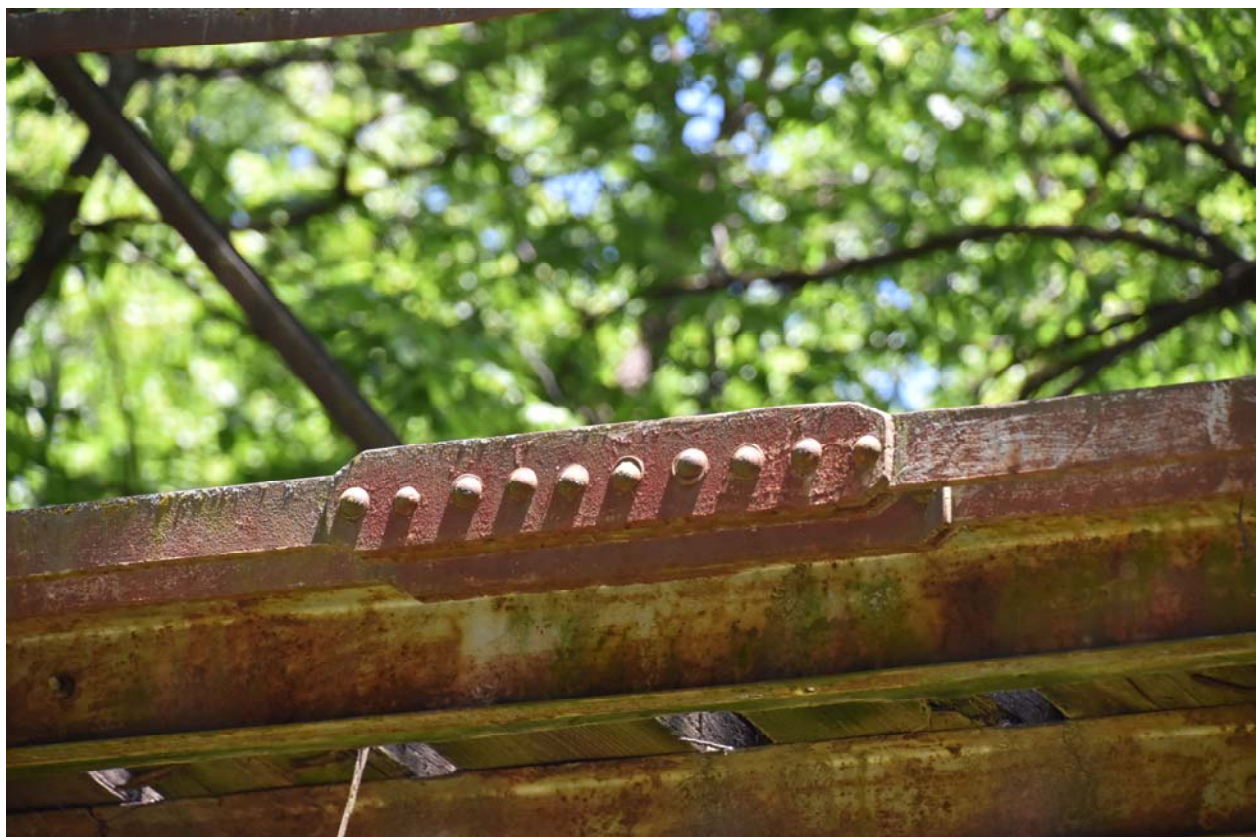
larkinburg_1645 - Larkinburg Road Bridge: Lower chord at center panel showing riveted splice.

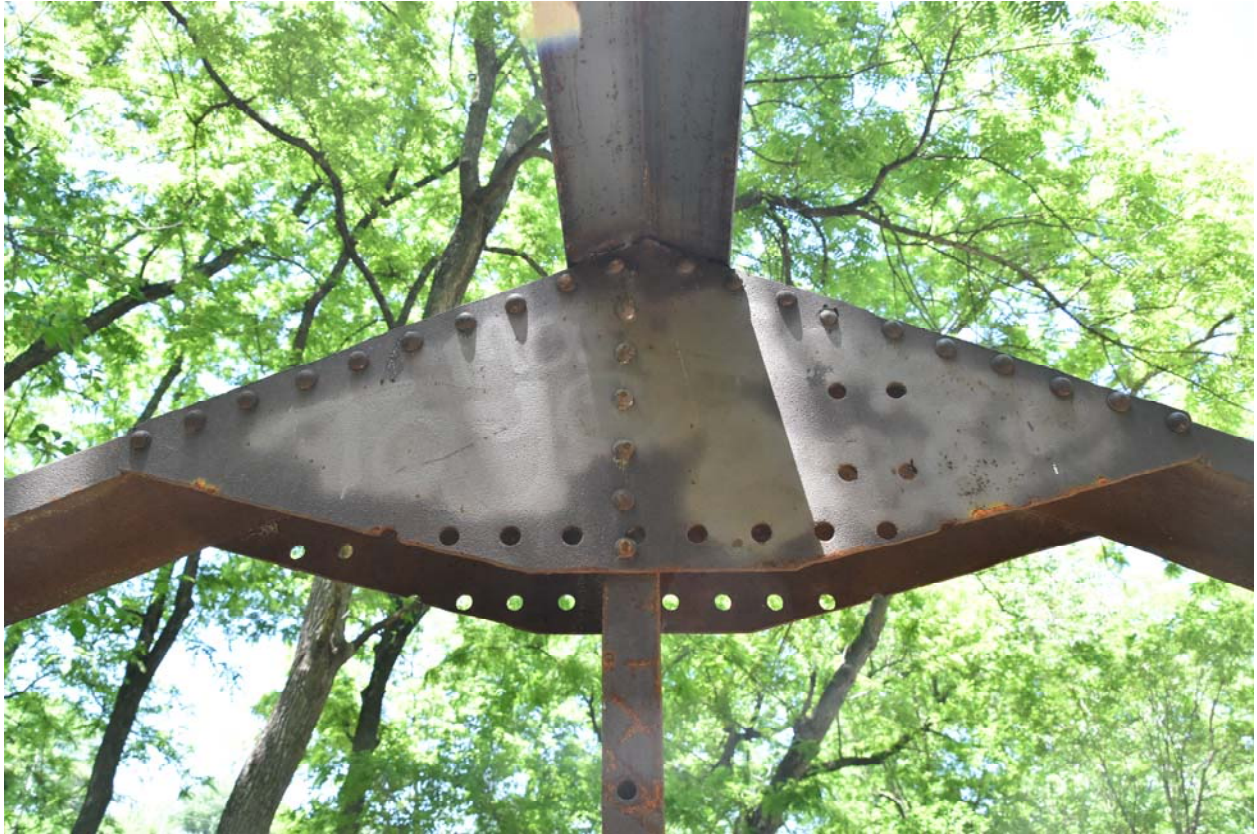
monumentroad_1564 – Monument Road Bridge: Upper chord connection gusset plate with numerous empty rivet holes, including some right on the edge. Also note the torch-cut edge of the plate, and the unequal length of the horizontal portion of the plate to the left and right of the vertical member.

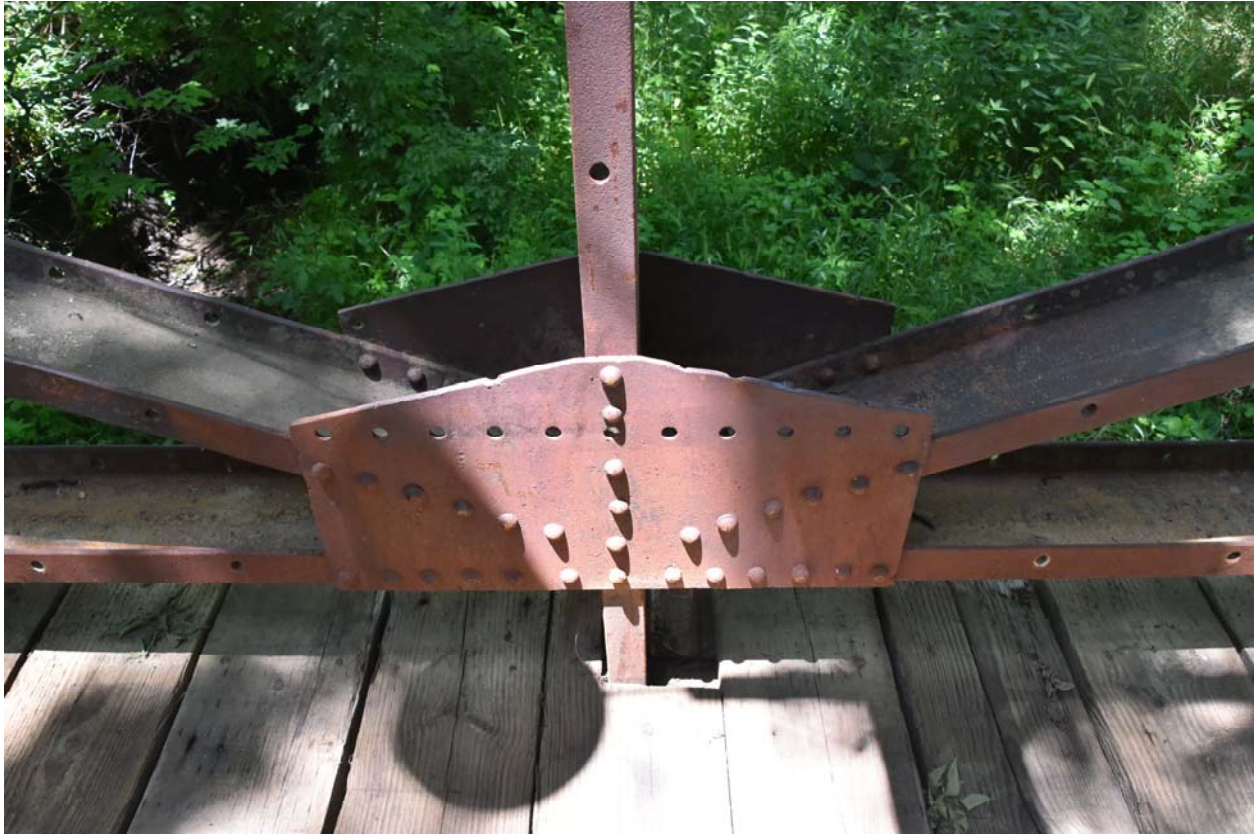
monumentroad_1561 – Monument Road Bridge: Lower chord connection gusset plate with numerous empty rivet holes, including some right on the edge.

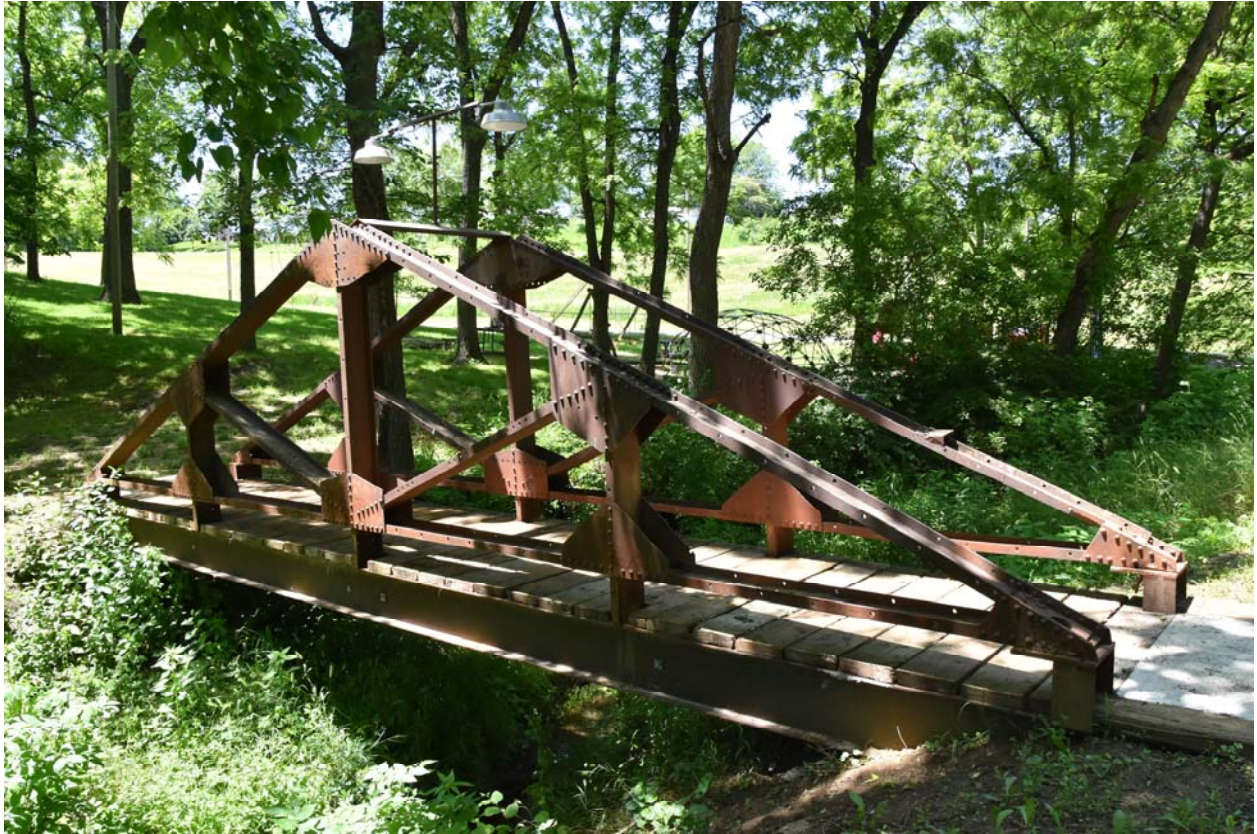
This bridge has more recently been relocated to nearby Troy in the community park. Here, the trusses were used as non-functional decorations on a small load-bearing stringer structure. The outriggers that were on the trusses were removed, and an angle was added between the topmost connection turning what was originally a pony truss into a very small through truss.

monumentroad_1507 – Monument Road Bridge: View showing the bridge in its current location. Note the load-bearing stringers under the trusses.

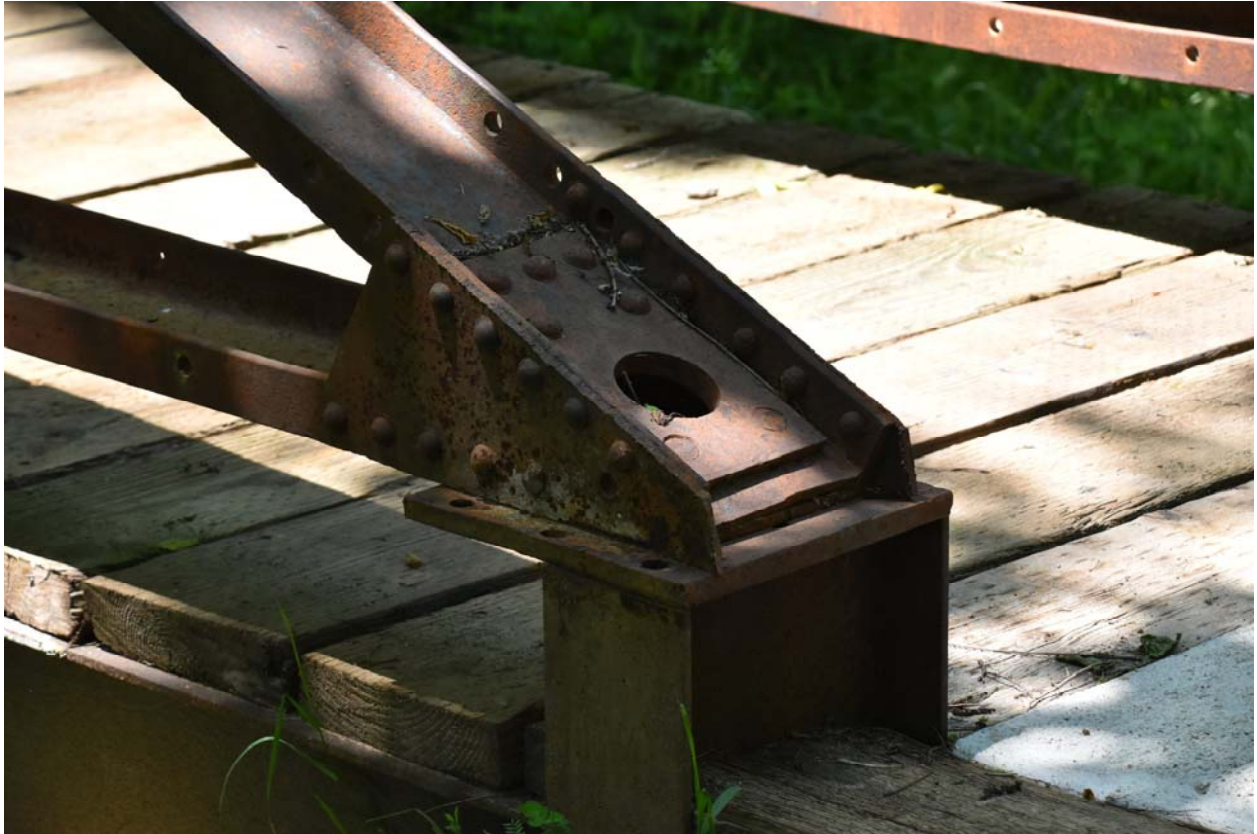
Lastly, there is a bridge that was located on Monument Road and, much like the Randolph Road Bridge, also appears to have been reused from a variety of truss bridge parts. The bridge features a very unusual truss design that resembles a Waddell A-Frame truss. Unlike the Randolph Road Bridge however, the Monument Road Bridge's parts may have come from a highway truss, as they are not as massive. The Monument Road Bridge has end posts, vertical members, and diagonal members that all have numerous empty rivet holes and serve no purpose on the bridge. The members with these holes are rolled channels and the numerous rivet holes suggest these channels may have previously been part of a built-up beam, such as back-to-back channels with lacing bars or battens. Even the gusset plates have some empty rivet holes, including some partial holes right on the edges of the plates. The plates are flame cut (cutting torch), further evidence that they are reused. At least some of the bridge parts may have come from a pin-connected truss bridge: A large pin hole is visible at the base of one of the current bridge's end posts.

monumentroad_1480 – Monument Road Bridge: View showing the bottom of the end post. Note the large unused hole, which undoubtedly was the pin plate for the connection of the previous bridge.

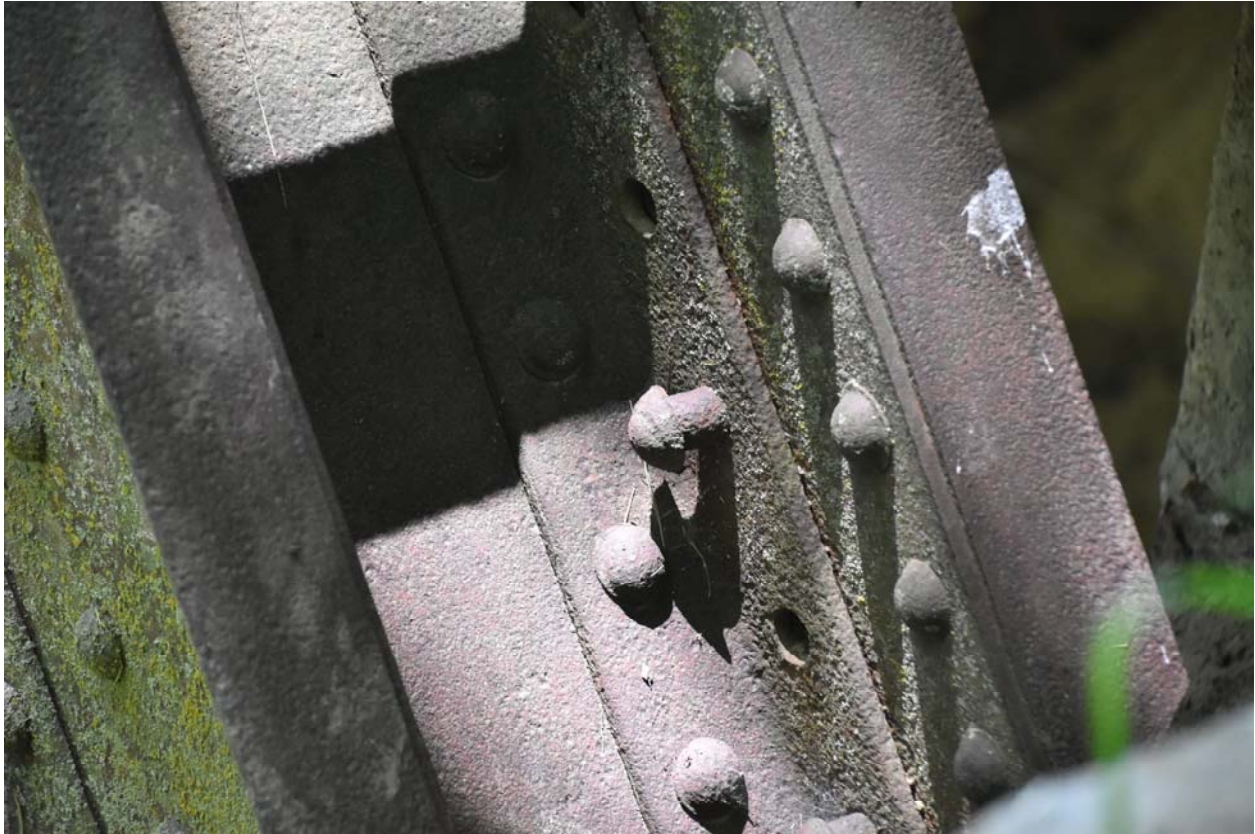
The Randolph Road Bridge over Duncan Creek is a very unusual bridge. The bridge is a Parker through truss, albeit with only four slopes and with a span length of only 86 feet: very short for a through truss. The unusually massive members, particularly the hip verticals, of this bridge are very much like those seen on railroad truss bridges. The short length, unusual four slope Parker truss design, and presence of many empty rivet holes and other alterations are strong evidence that this is not merely a relocated truss bridge, but more likely a bridge built from scratch using parts salvaged from one or more railroad truss spans. Several items stand out as noteworthy. The struts (sway bracing) of the bridge have large holes at the end where lateral bracing might be expected to have been placed, yet instead the lateral bracing on this bridge is tied right into the main upper chord connection pins. The ends of the upper chord appear to be flame cut to match the end post slope. Nearly all bridge members have varying quantities of empty rivet holes on them, and these holes are in locations that serve no purpose on the bridge seen today. There are various areas where steel has been flame cut to allow the members to fit together, or in some areas to perhaps shorten the dimension of the reused member. There are vertical members that end prematurely and have extensions riveted onto them at the top. Lastly, on one of the end posts, a section of angle has empty rivet holes. However, with one hole, someone must have grown weary of trying to drive the rivet out: a rivet that is only partially driven out remains in place.

randolphroad_1429 – Randolph Road Bridge: End post detail showing empty rivet holes as well as one unused rivet hole where the rivet was not fully removed and remains partially sticking out.

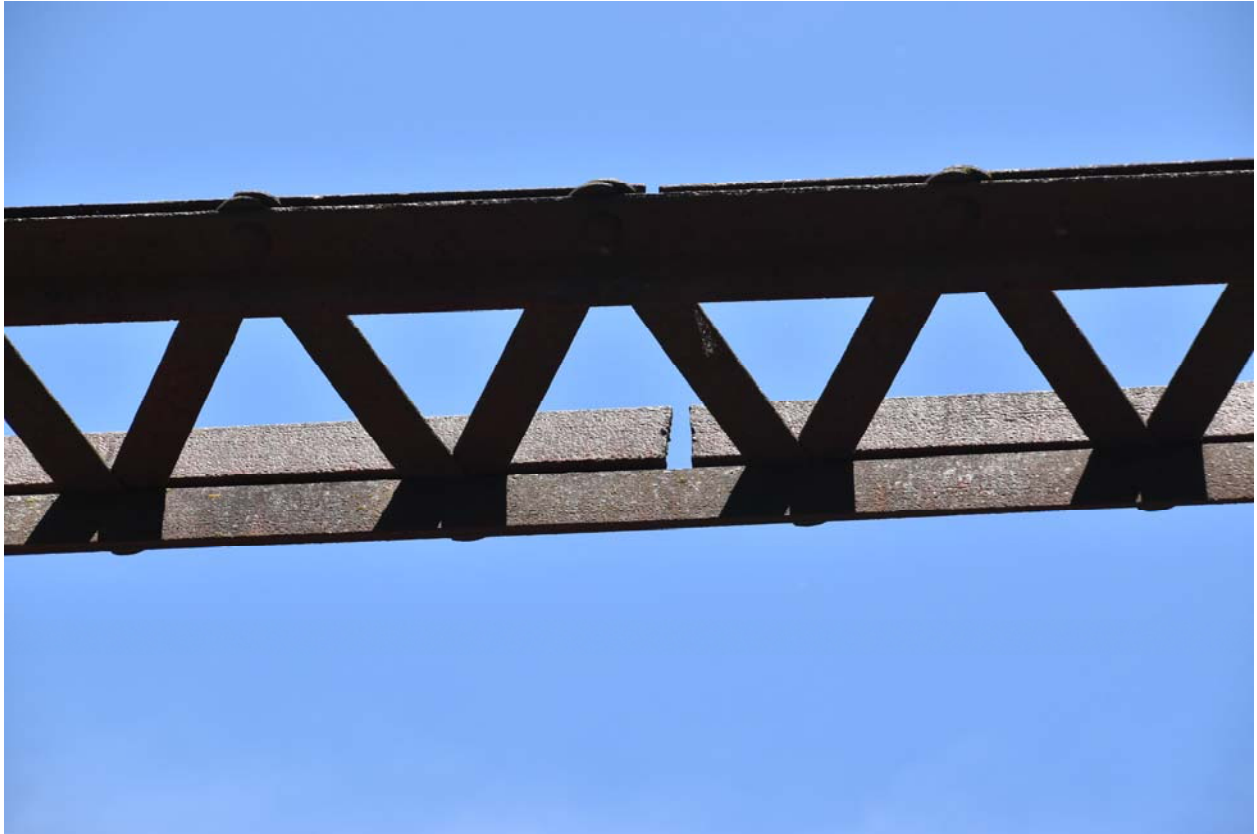
randolphroad_1384 – Randolph Road Bridge: Sway bracing. Note the torch cut angle located top and back in this photo.

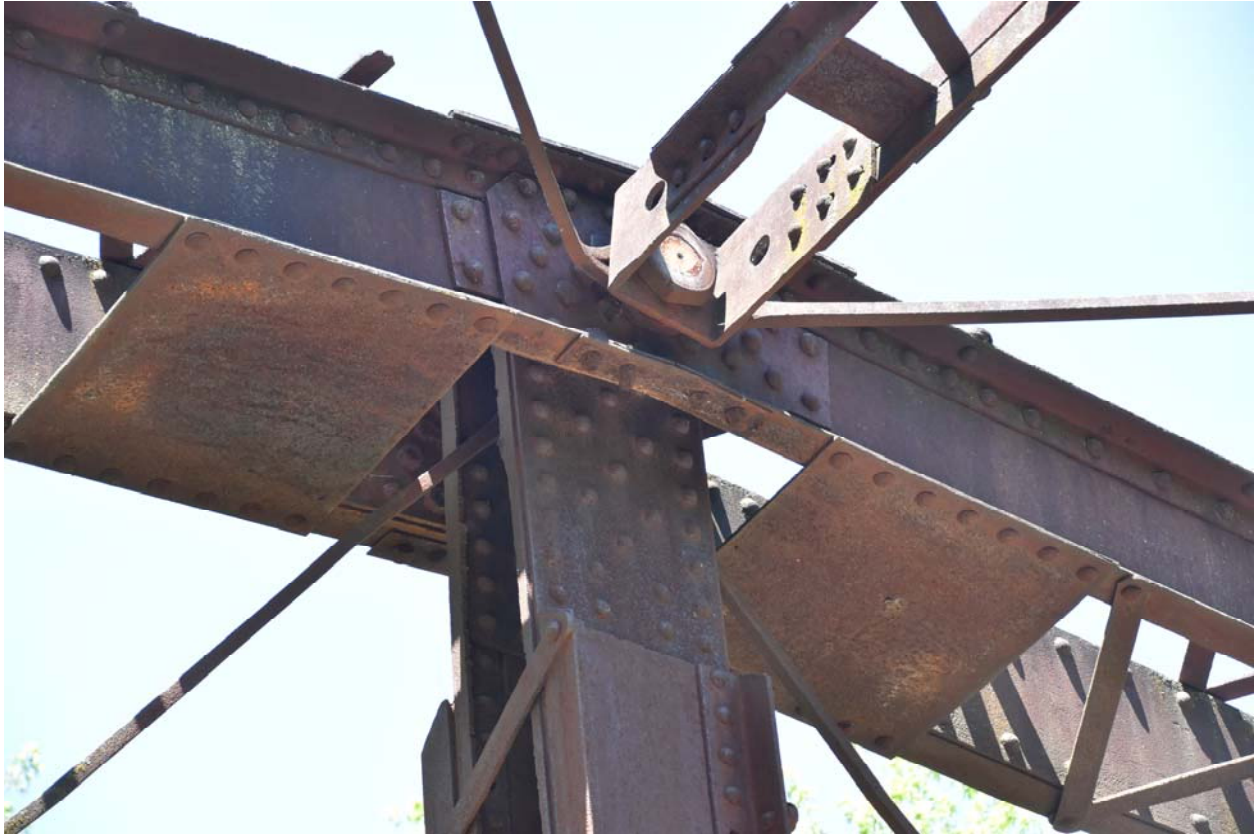
randolphroad_1381 – Randolph Road Bridge: Sway bracing connection to upper chord. Note the large unused holes, likely for a different style of lateral bracing connection for the previous bridge. On this bridge today, lateral bracing can be seen in this photo tied into the main connection pin.

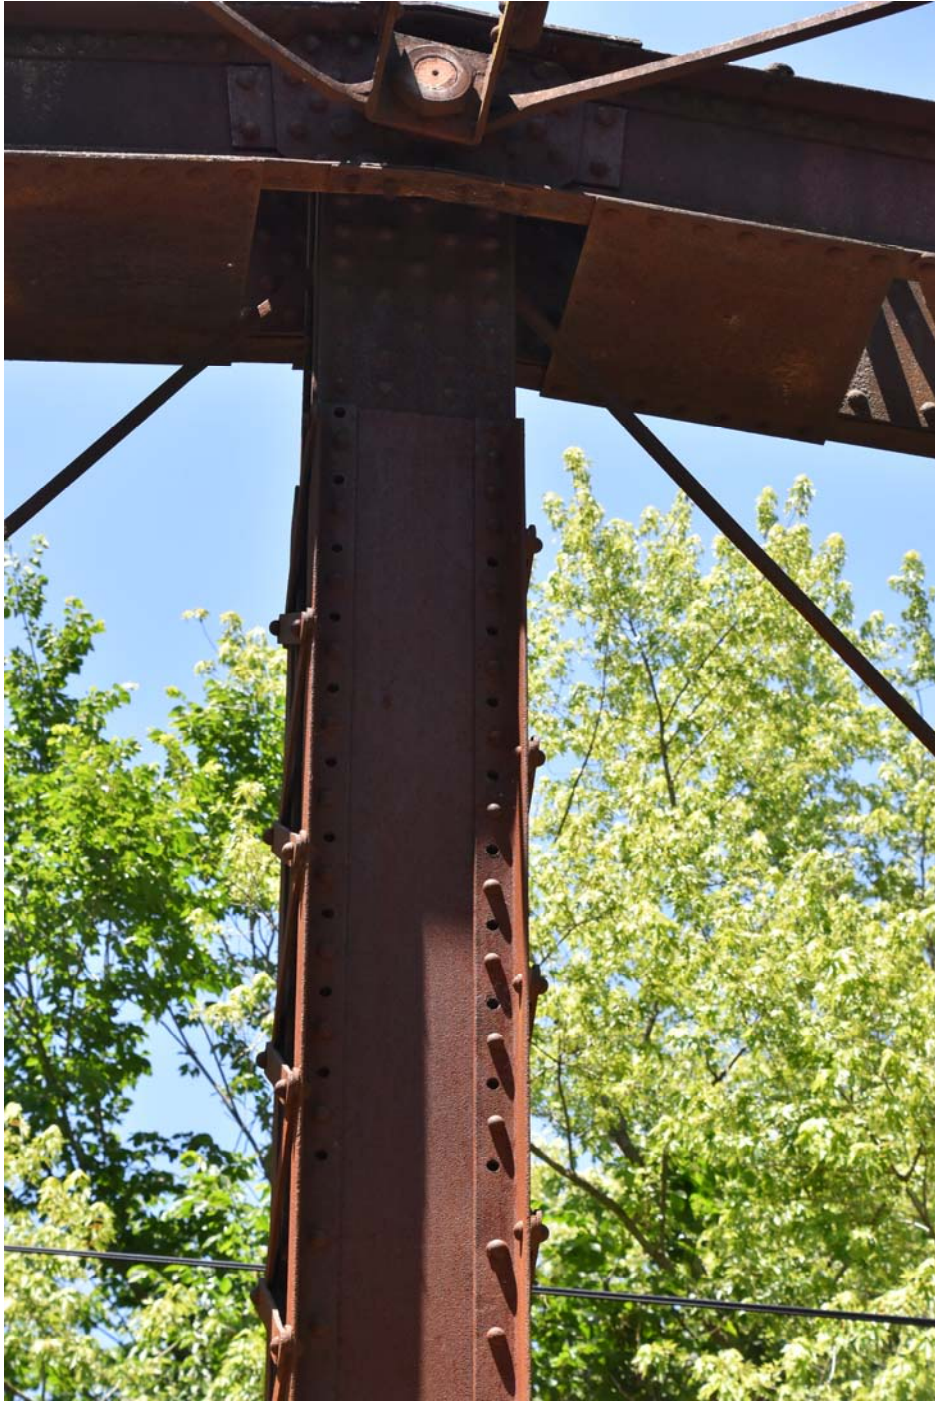
randolphroad_1372 – Randolph Road Bridge: Vertical member. Note numerous empty rivet holes. Also note at the top there is a riveted extension of the original vertical member.

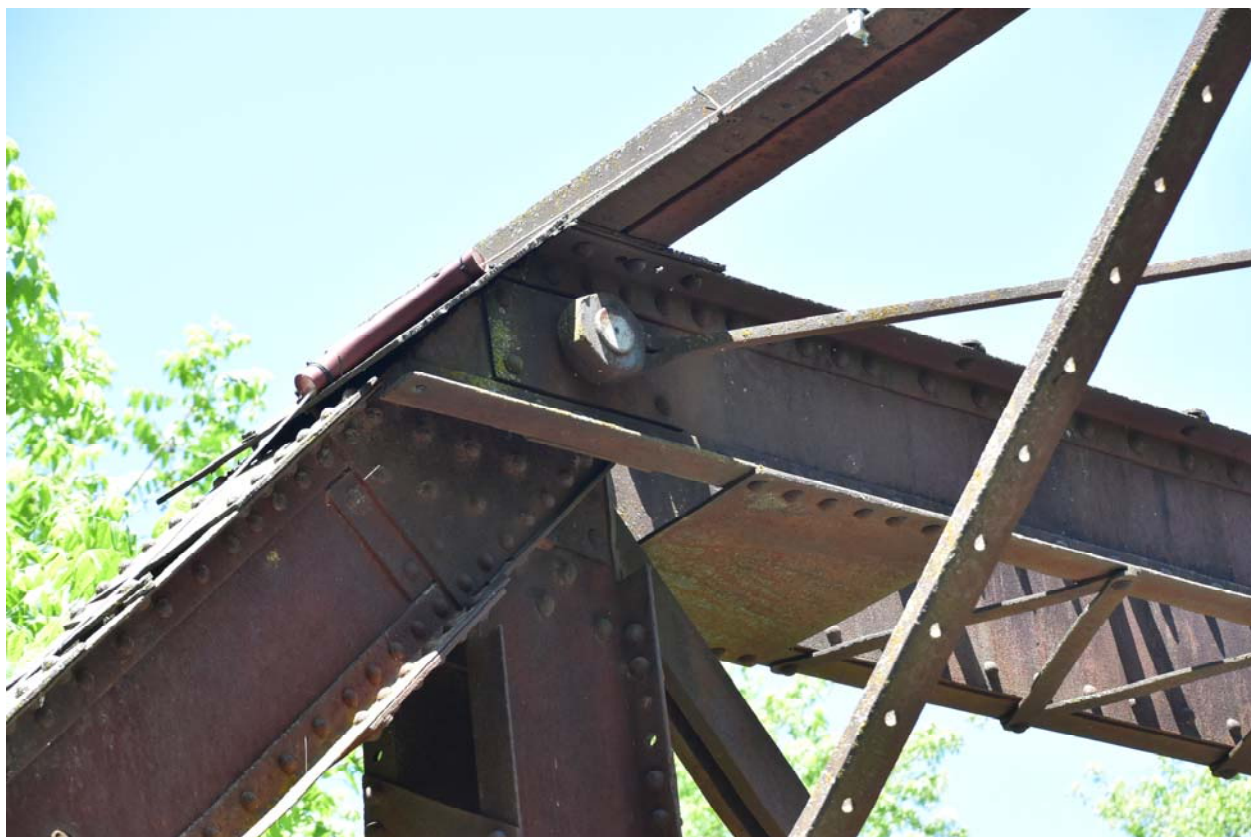
randolphroad_1318 – Randolph Road Bridge: Detail at the end of the upper chord which appears to be torch cut to match the slope of the inclined end post, which in turn was covered up with a flame cut plate. In the foreground of this photo to the right the portal knee brace can be seen as well, with numerous empty rivet holes.
