## ***Walnut Street Bridge, Mazeppa, Minnesota***

### **Description of Bridge:**

## **Rehabilitation Project Information**

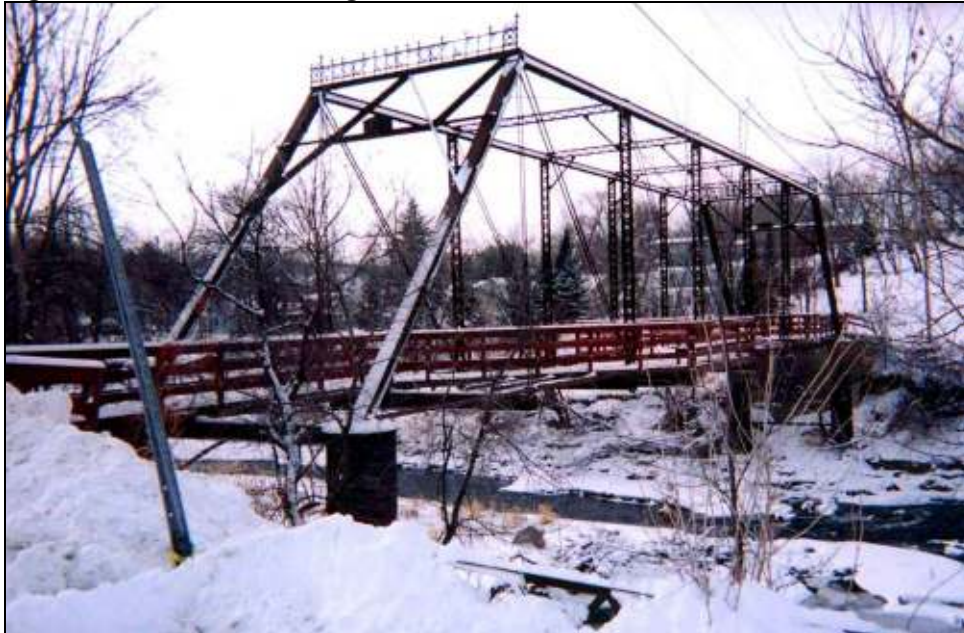
**Figure 14. Walnut Street Bridge**

The Walnut Street Bridge, constructed in 1904, is a Pratt truss with riveted connections. The main span of the bridge is 118 feet.

A detailed inspection was performed to assess current deficiencies and needed repairs. Deteriorated bridge bearings, truss members, stringers, piers, and abutments were replaced to address that safety concerns that had closed the bridge. Repairs to the bottom chord were field connected with hex head bolts. Button head bolts were used for the upper chord repair in areas visible to pedestrians. Temporary bracing was used to support the truss during the chord repairs. The timber deck and railing were also replaced. New abutments and lengthened approach spans were designed to alleviate erosion problems that resulted from the area's steeply sloped banks. Formliners with architectural surface treatment and color staining were used on the new piers and abutments.
