MOVABLE SPAN BRIDGES

Bridge of Lions, St. Augustine, Florida

HISTORIC BRIDGE REHABILITATION CASE STUDY

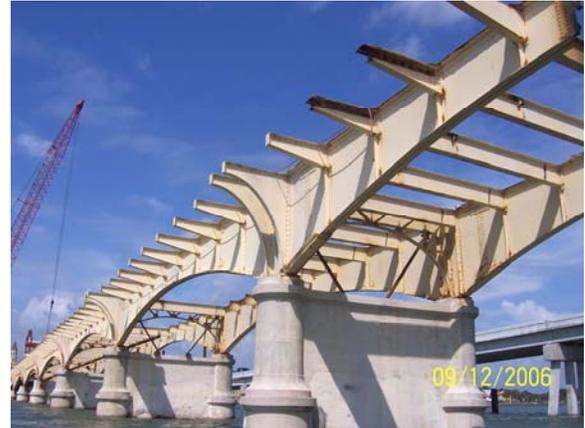
Description of Bridge: Constructed in 1927 with a total length of 1,545 ft. Main span is a 95 ft. double-leaf rolling lift bascule. Approach spans are steel arched girder-floorbeam spans with cantilevered overhanging sections.

The two fascia girders were retained for visual appearance but relieved of most of the loads by installing new steel stringers inside the girders that carry the majority of the dead load and the traffic loads. The stringers are hidden from view and will not distract from the architecturally significant arched girders. The approach spans are being widened in order to improve the roadway geometry. The fascia girders are being removed and repaired, then reset in place to provide the wider roadway section while retaining the same visual profile once completed. The approach substructure units are being replaced. The bascule piers and associated towers are being left in place and repaired, including cover replacement of the concrete within the splash zone to remove the existing concrete that contains high levels of chlorides. The bascule piers are being strengthened by the addition of drilled shafts and a new footing below the existing waterline footing to provide sufficient strength for a modern design scour event.
