Historic Bridge Bulletin

**Lessons From Dr. Waddell:
Case Study 1 (Heat Straightening)
And Case Study 2 (Laser Scanning)**

**Guidance for the Treatment of
Historic Bridges**

**Railroad Heritage on Virginia
Highways**

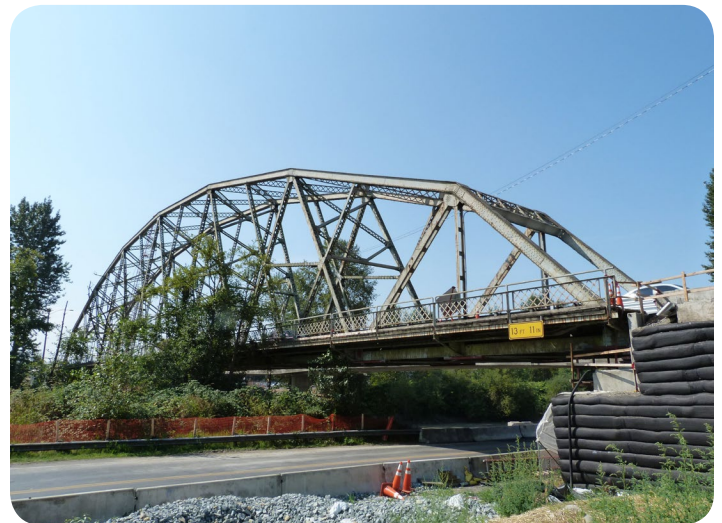
Meridian Street Bridge over Puyallup River in Washington State. Photo by Nathan Holth.

A notable bridge up for reuse is the Puyallup River Bridge (Meridian Street Bridge) in Washington State. The 1925 bridge is a riveted modified Warren through truss displaying some visual characteristics of the Turner truss configuration. After successful relocation to nearby WSDOT property, the goal is to offer the bridge to a new owner for use as a pedestrian or bicycle facility. Check out the time-lapse video of moving the 379-ton bridge away from the Puyallup River and onto WSDOT right of way:
<https://www.youtube.com/watch?v=bmzmtlwbDA4>
Moving a bridge is not something you see every day!

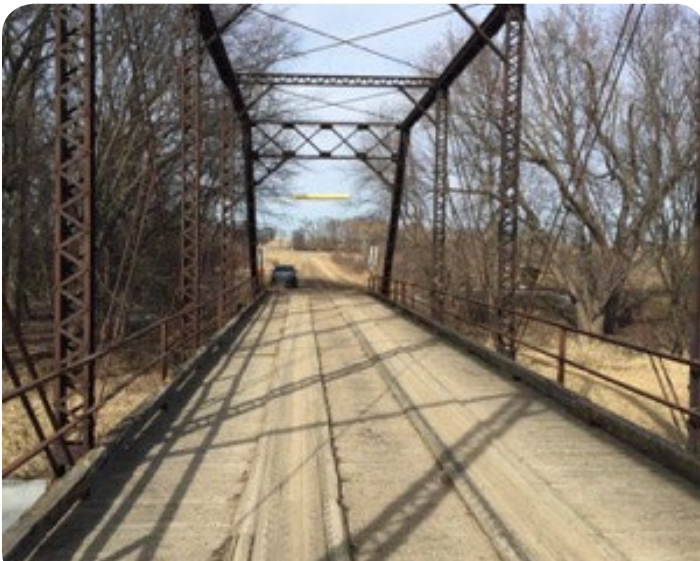
Salisbury Bridge deck.

The Salisbury Bridge is narrow single lane bridge with a timber deck. It has light truss members and only a three-ton load capacity. An errant vehicle on a snowy, icy road impacted the end post of this 1899 through truss over the North Fork of the Crow River near Kingston, Minnesota. The vehicle damage nearly collapsed the pin-connected truss.

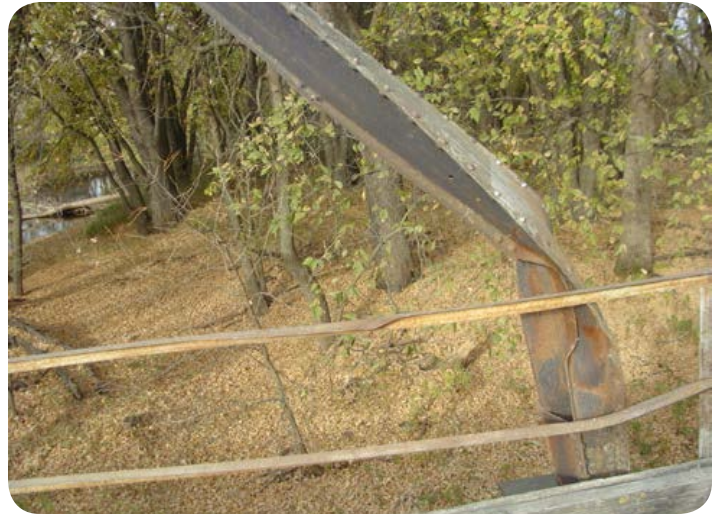
Damaged end post.

Originally, after we reviewed the bridge in the field, we felt that the lower portion of the end post would need to be replaced to put the bridge back in service. However, the contractor we were working with suggested using heat straightening to return the end post to its original geometry. We agreed to see how the heat straightening worked out. After shoring the hip joint and a week of field work, the heat straighteners were somewhat amazingly able to return the end post to its original alignment. However, longitudinal cracks were observed in the web of the primary channels after heat straightening operations. Due to the cracking and because we were

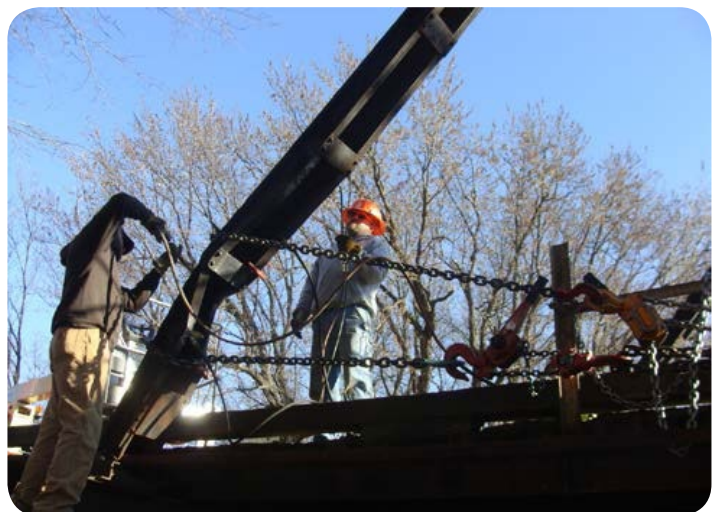
Heat straightening operations underway.

uncertain of the impacts of heat straightening on the chemistry of the 19th century steel, supplementary plates were bolted to the web of the channels to carry the entire end post load. As a result of this decision, the heat straightened portion of the end post just needed to brace the new supplementary web plates. Construction was simplified because we did not need to develop an end post splice near the lower chord. Consequently, it was a simpler solution to plate the web compared to replacing portions of the channels and splicing new material to the original.

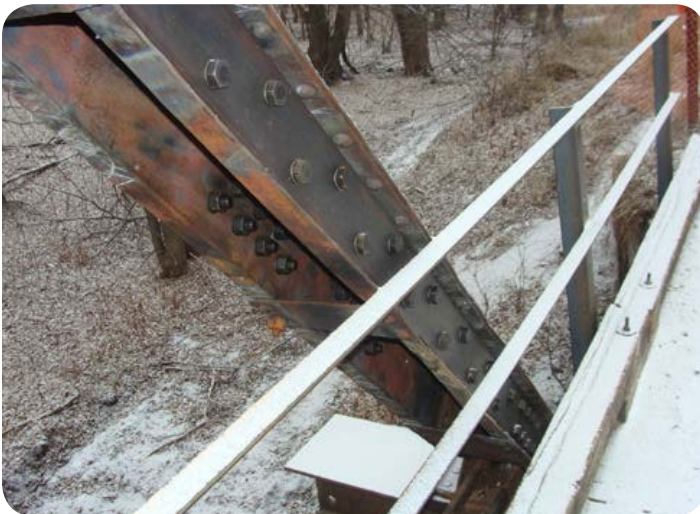
Repaired end post.

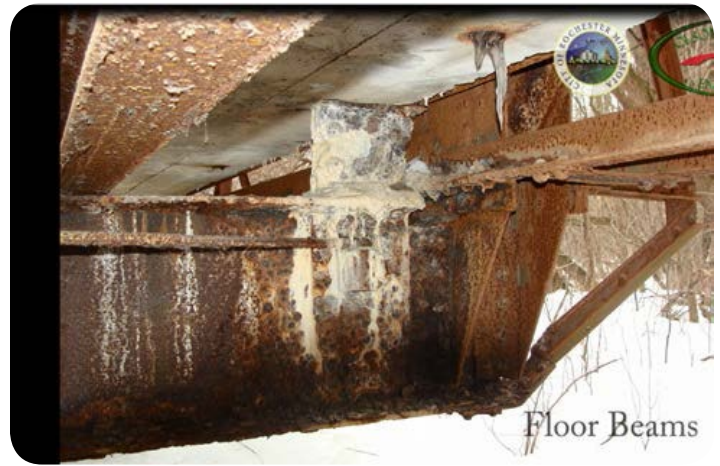
Deteriorated components on the north truss.

However, by 2011, the structure was showing its age with extensive deterioration of the floor system, the lateral bracing, and the knee bracing.

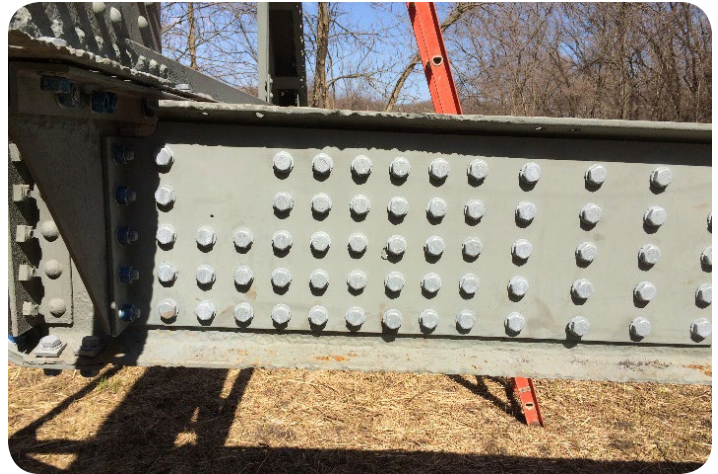
Supplemental floor beam web plate prior to final paint coats.

The floor beam deterioration at the ends of the beams was addressed by sandwiching supplemental web plates on both sides. The new plates arrived at the site with a shop applied zinc primer and were placed against the original web after it was blast cleaned and primed in the field.

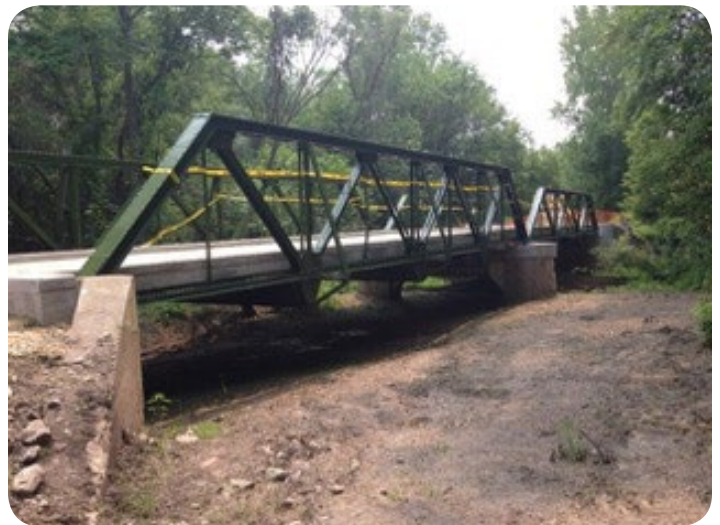
Rehabilitated pony truss spans.

span had racked a small amount and turned into a parallelogram. By recognizing this early in the design, we were able to detail the railing to be supported by the curb instead of the distorted trusses.

By adding a small profile to the bridge deck we reduced the amount of drainage washing over the steel bridge components and which will slow the rate of future deterioration. The bridge should be an asset for the City of Rochester for decades to come.

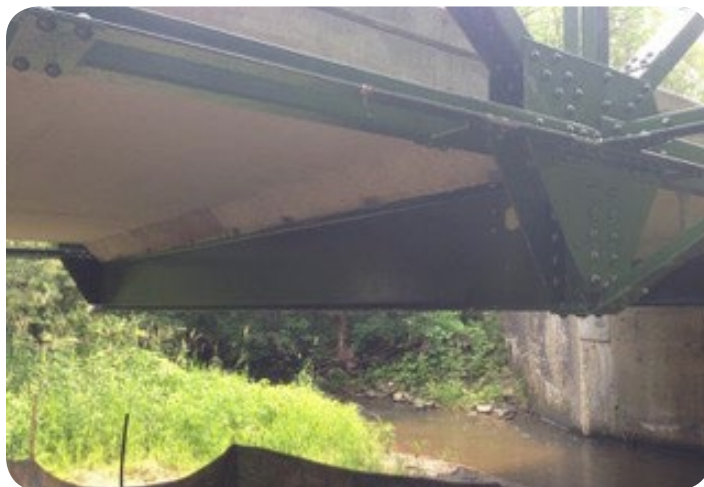
New slab floor system.

The floor system for the Quarry Hill Nature Center Bridge was rehabilitated by removing the old deck, stringers, and lateral bracing. The new floor system included a cast-in-place slab spanning from floor beam to floor beam.

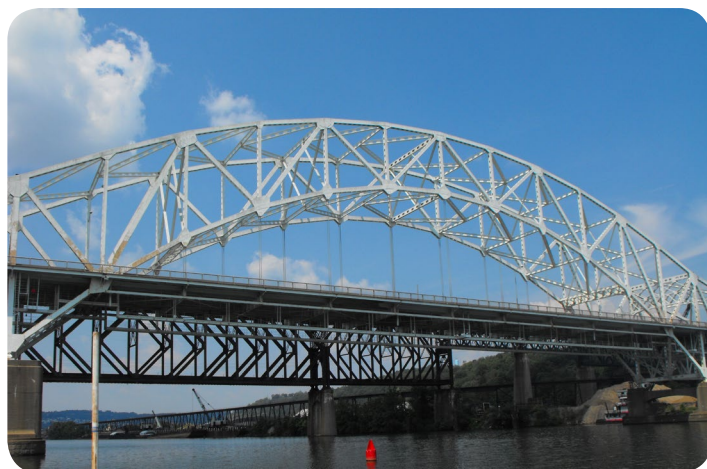
The Belle Vernon bridge carries I-70 over the Monongahela River, railroads, and roads in Washington County. At least three different bridges can be seen in this photo and illustrates the diversity of bridge types in Pennsylvania. Photo by Nathan Holth, August 2010.

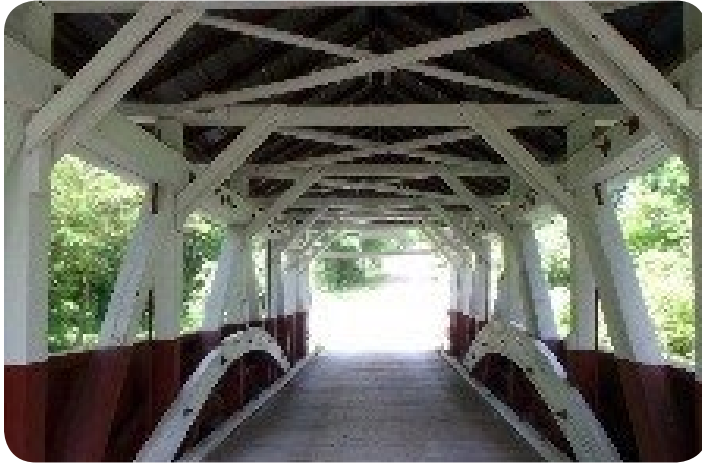
These heavy timber trusses are among the character defining features of the Burkholder Covered Bridge over Buffalo Creek in Somerset County. Photo from PennDOT BMS2 Inspection Files, June 2016.

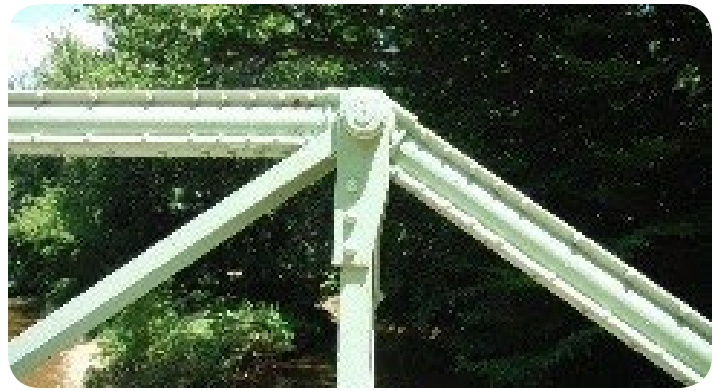
The upper chords of the Ross Fording metal truss bridge in Chester County are Phoenix columns. These columns reflect an important engineering technology. Photo from PennDOT BMS2 Inspection Files, July 2014.

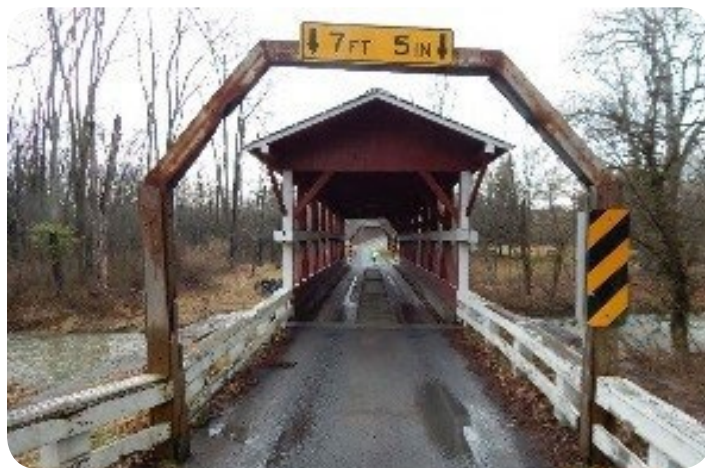
This clearance device protects the Mill Road Covered Bridge in Bedford County from being crossed by vehicles that are taller than the portal opening. Photo from PennDOT BMS2 Inspection Files, February 2017.

- **Identify, Retain and Preserve:** To begin, all character-defining features of the historic bridge should be identified and measures should be taken to retain these features in the process of rehabilitation. If after rehabilitation the bridge still has load and height restrictions, the bridge may be protected by posting a roadway weight restriction or using a headache bar to stop traffic that is taller than the allowable clearance.

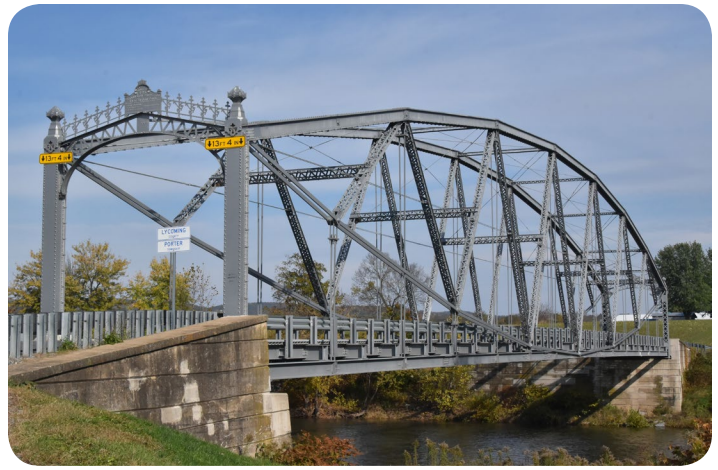
The Pine Creek bridge in Lycoming County is a rare lenticular truss. An early inappropriate repair led to the bearings being encased in concrete which caused the bottom chord to buckle over time. In a later rehab, the damaged bottom chord was replaced with high-strength steel, an example of the use of substitute material. Photo by Nathan Holth, 2016.

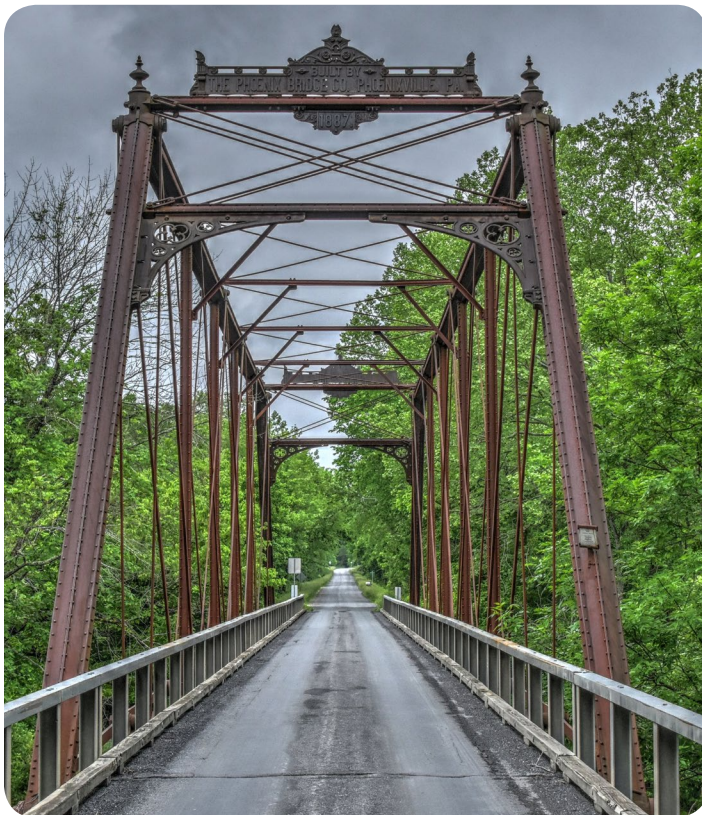
Phoenix Bridge portal. Photo by Nathan Holth.

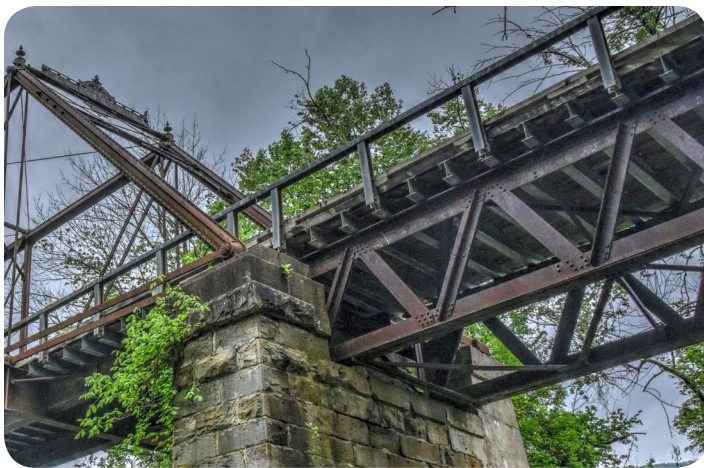
Looking up at the Phoenix Bridge, with the deck truss approach span shown to the right. *Photo by Nathan Holth.*

Located in Botetourt County, the Phoenix Bridge crosses Craig Creek on Ball Park Road (Route 685). The Phoenix Bridge as seen today was a replacement for a previous bridge built ca. 1891 to serve the Craig Valley Line of the Chesapeake and Ohio (C&O) Railroad. In 1903, this bridge was replaced with two truss spans that were reused from an unknown location. One span is a pin-connected Whipple through truss with Phoenix columns and built by the Phoenix Bridge Company in 1887. The other span is a rivet-connected Warren deck truss built in 1888. The Phoenix Bridge Company had supplied the C&O Railroad with a number of 150-foot truss spans. Therefore, it is not certain where this span originally came from. The original location of the Warren truss span is also unknown, as is the builder for that span.

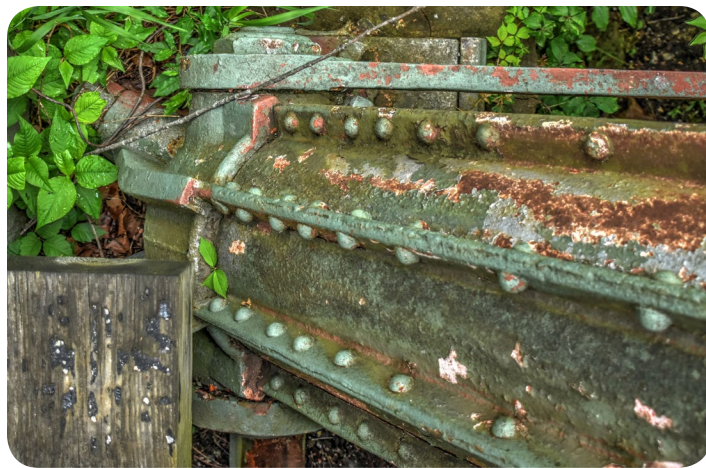
End post, cast iron shoe, and bearing for Rocky Gap Bridge. This detail photo shows the rounded Phoenix sections making up the end post. *Photo by Nathan Holth.*

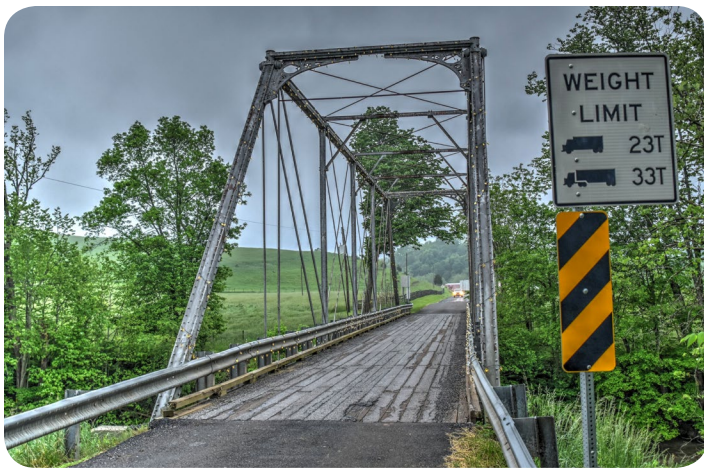
The Gleaves Road Bridge. Photo by Nathan Holth.

The Gleaves Road (Route 619) Bridge over Cripple Creek in Wythe County is a 128-foot Pratt through truss with Phoenix columns. This bridge continues to carry vehicular traffic on a highway that was originally part of the Speedwell Extension of Norfolk and Western Railway. This railroad line was built ca. 1903, and this bridge was erected to serve the railroad line. Like the bridge at Rocky Gap, this bridge's design suggests the truss span is a relocated and reused bridge originally dating to the ca. 1880-1890 period. The Speedwell Extension was abandoned in 1938 and later converted into a highway ca. 1948. This bridge has changed little from its original design.

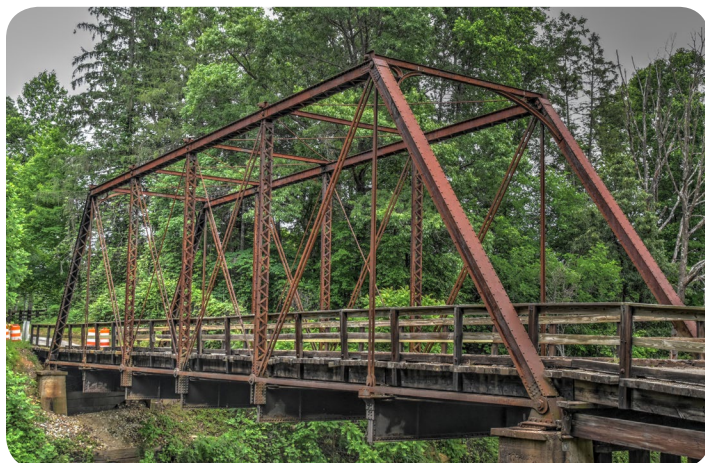
Oak Ridge Bridge. Photo by Nathan Holth.

What is today the Norfolk Southern Railway has two similar highway overpass bridges in Virginia that bear mention. One carries Aden Road in Prince William County, while the other carries Wilson Road in Nelson County. Constructed in 1882, both are early surviving pin-connected Pratt through truss bridges,

The exact history of the bridges is not known, but it is assumed that they share a similar history. The bridges were originally built to carry railroad traffic on unknown parts of the Virginia Midland Railroad. Likely in 1904-1905, when this railroad line was converted into a double-track line, the bridges were relocated to their present locations where they were converted for use as vehicular bridges.

Both the Oak Ridge and Aden Road Bridges are noteworthy for their association with the Keystone Bridge Company, which was a business associated with Andrew Carnegie. Further, because these bridges were originally railroad bridges, they are early surviving examples of iron railroad bridges.

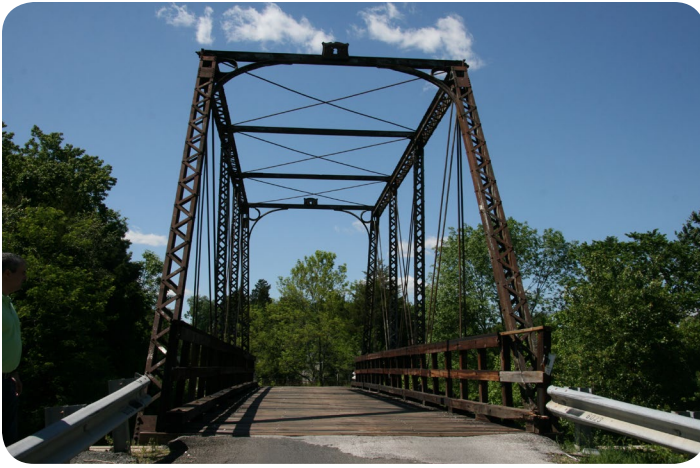
The Aden Road Bridge before the 2017 project began.

Railroad bridges of this vintage are uncommon today because their lightweight construction rapidly became insufficient in the early 20th Century and most bridges from this era were replaced. These two bridges survived because of their conversion to highway use, where load and width requirements were not as high. However, after over 100 years of service, the Aden Road Bridge nevertheless became insufficient for the needs of the highway. As of 2017, a project to

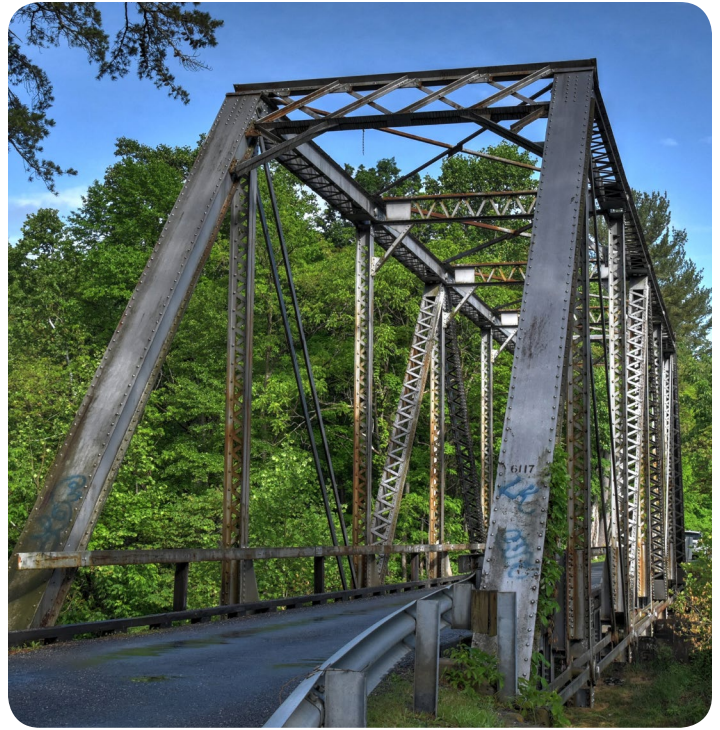
The Stokesville Bridge as seen in 2017. *Photo by Nathan Holth.*

The Stokesville Bridge in Augusta County is another pin-connected Warren through truss that is better documented and more clearly indicates its railroad origins. A rather late example of the uncommon pin-connected Warren truss design, this bridge was built ca. 1901. It displays design and fabrication details typical for this period with the exception of its truss configuration. The bridge today carries Stokesville Road (Route 730) over North River, but the bridge and the road it carries was originally the Chesapeake

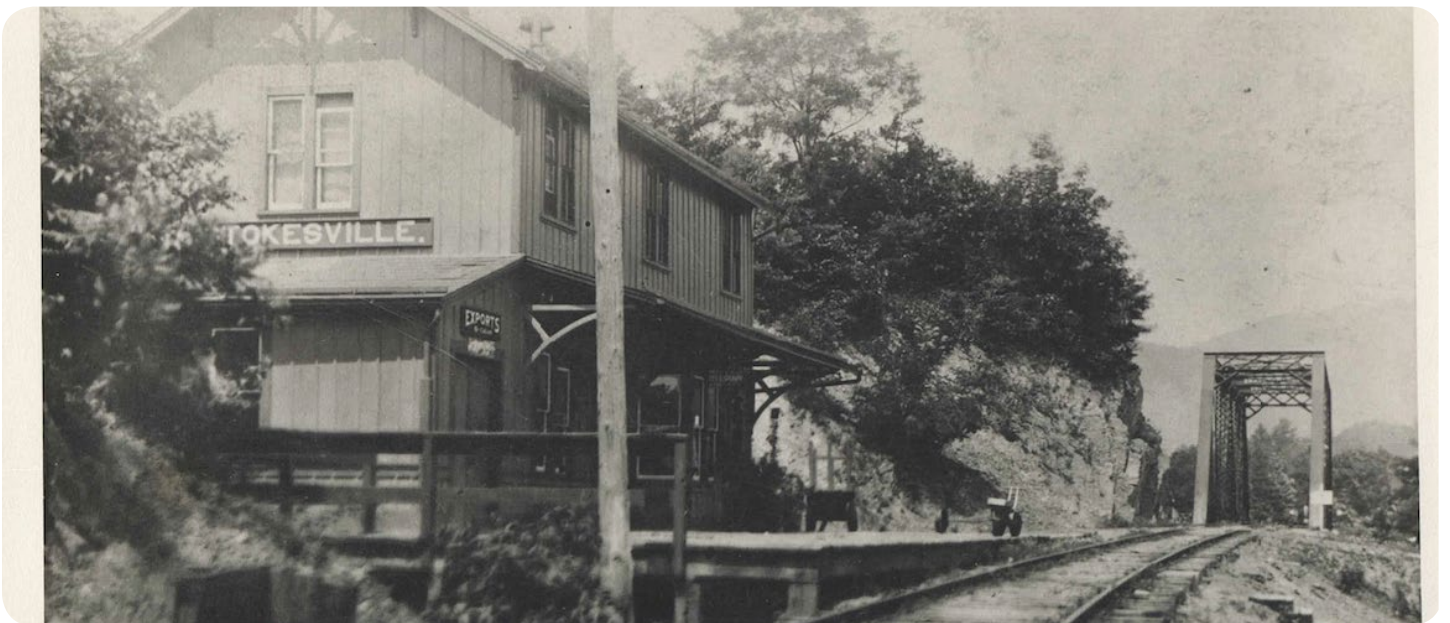
This historical photo of the Stokesville Bridge shows it as a railroad bridge with tracks and train station clearly visible.

and Western Railway. Immediately southeast of this bridge, the Stokesville Railroad Depot remains standing. Historical photos provide further proof of this bridge's railroad past.

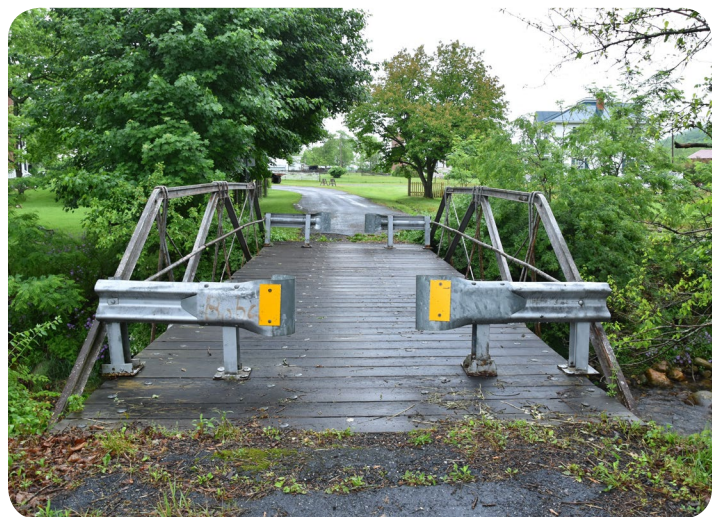
The Crab Run Bridge trusses. Photo by Nathan Holth.

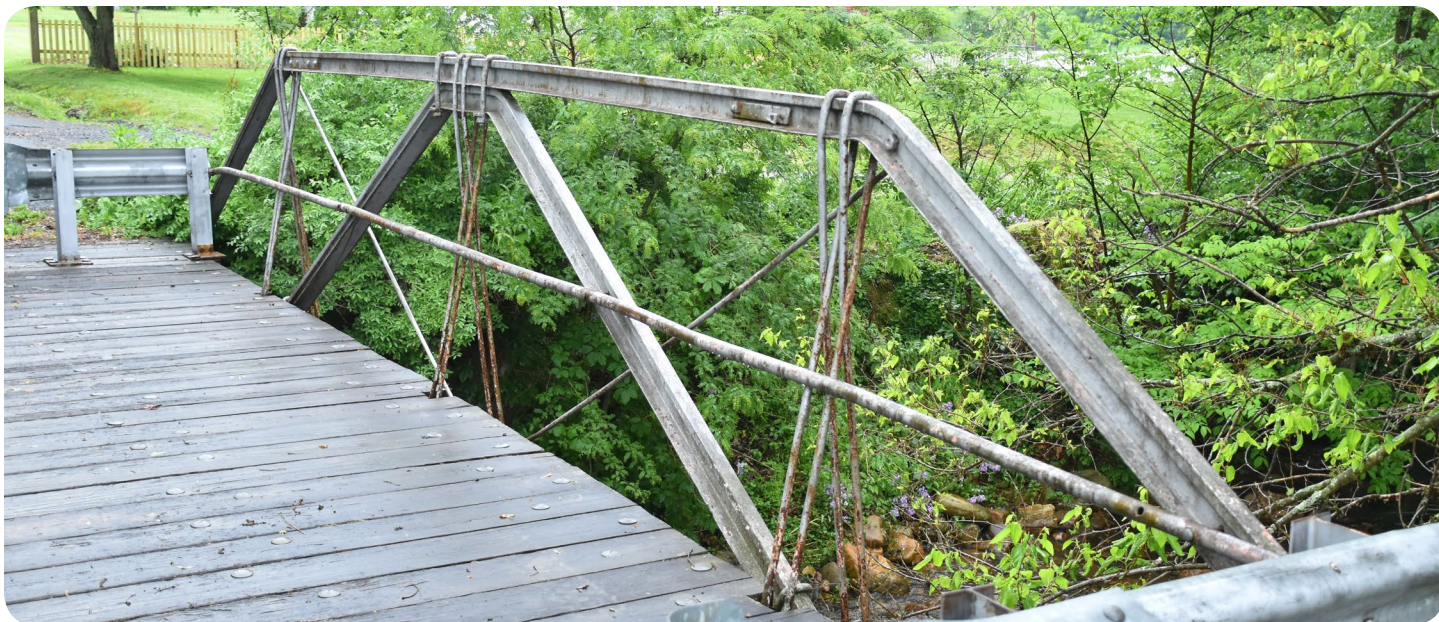
The Crab Run Bridge trusses. *Photo by Nathan Holth.*
