Historic Bridge Bulletin

Volume 6, Number 2
July 2019

Seeking A New Home: Kern Bridge, America's Largest Bowstring Span
By Historic Bridge Foundation

The Preservation of Historic Bridges
By Patrick Sparks, PE

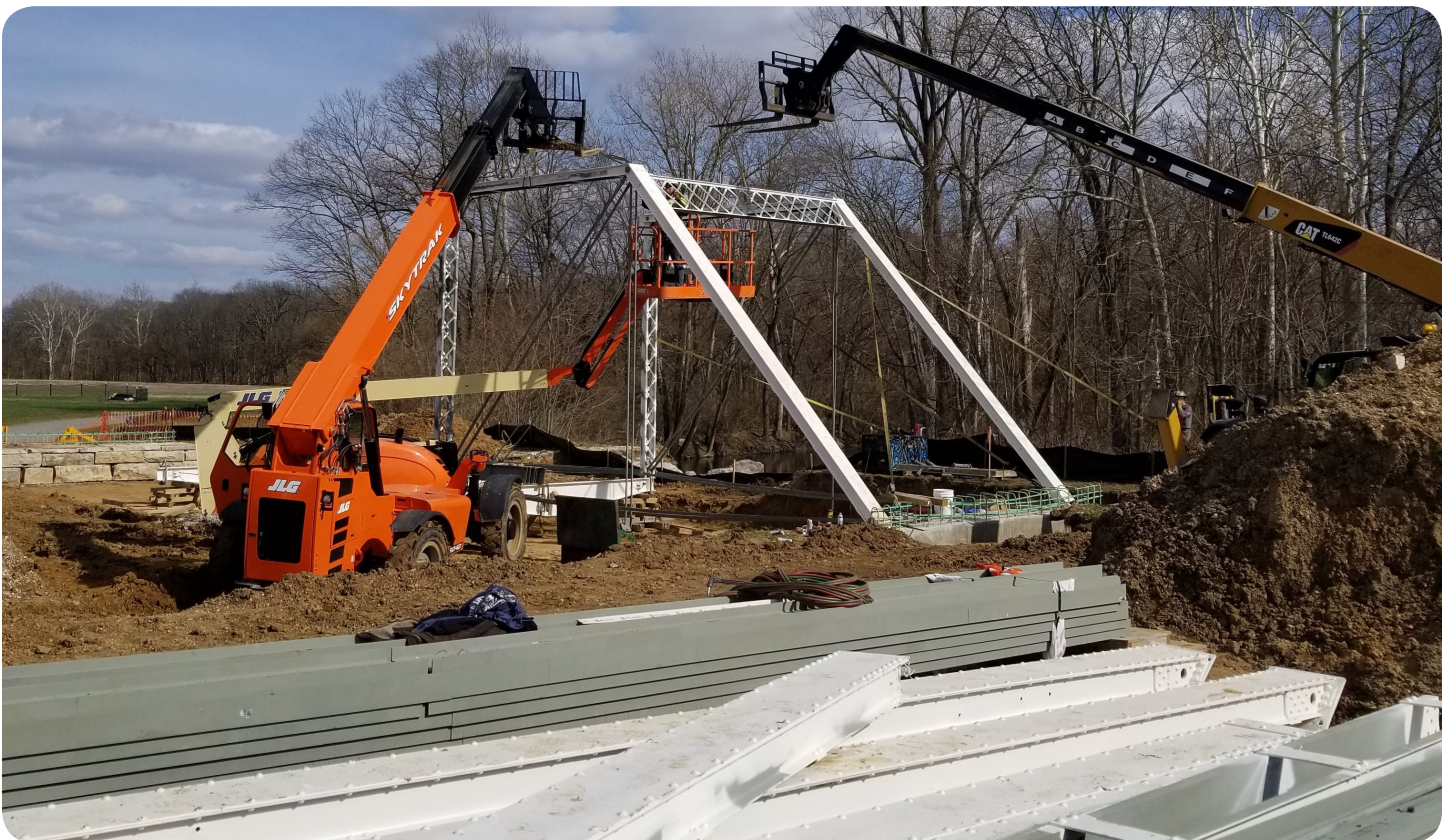
Workers from Bach Steel assemble the Clover Ford Bridge in its new home at Blue River Park in Shelbyville, Indiana, in April, 2019. The Pratt truss bridge was built in 1889 by the King Bridge Company of Cleveland, Ohio, and was previously located over Buck Creek on CR-875 West in Shelby County. *Photo by Nels Raynor.*

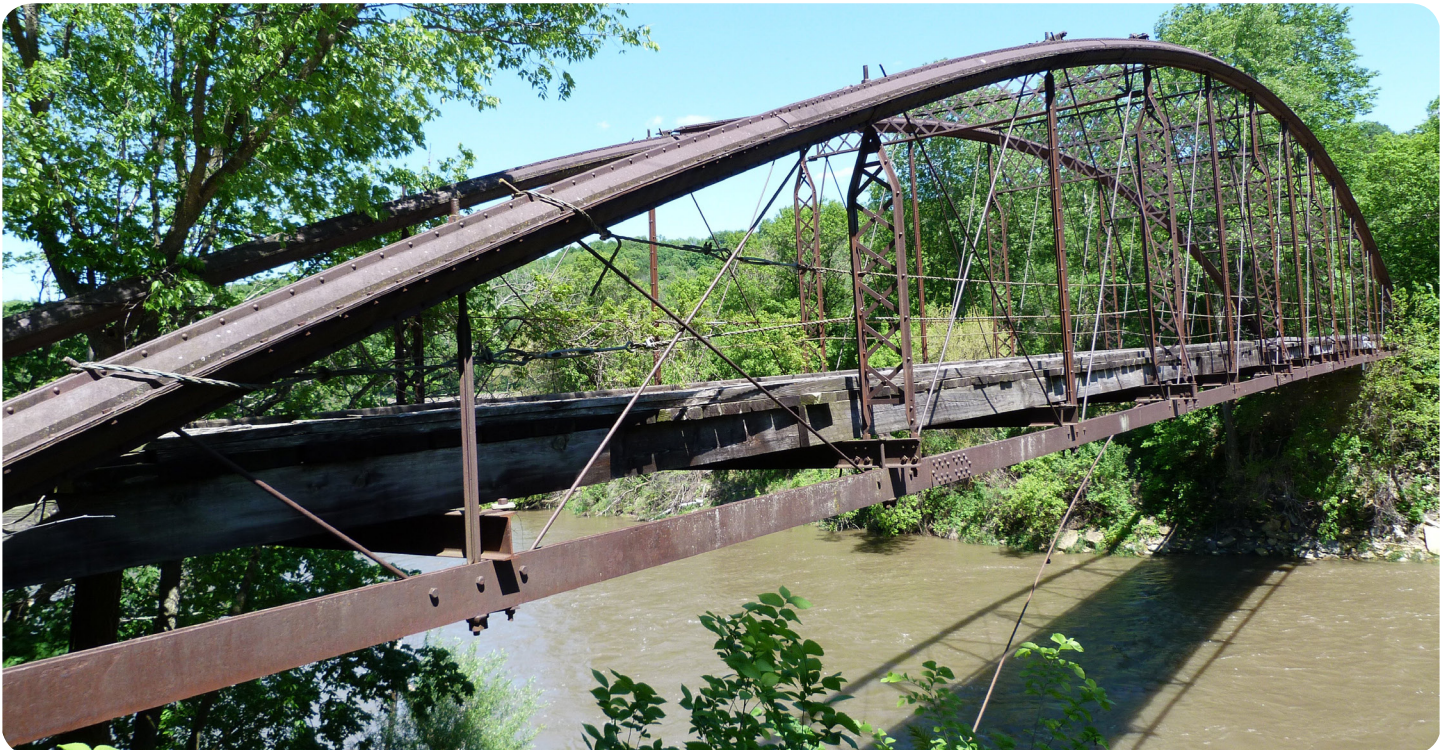
A view standing beside the Kern Bridge. Photo by Nathan Holth.

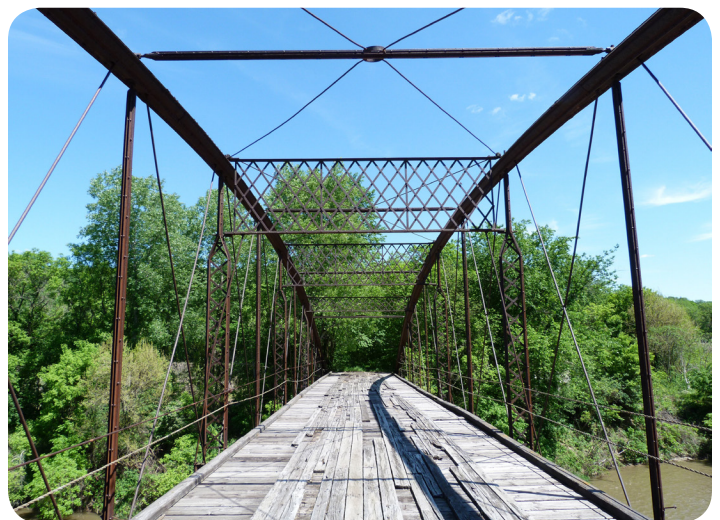
A view on the deck of the Kern Bridge. Photo by Nathan Holth.

The superior rust-resistant chemistry of cast and wrought iron (in contrast to steel), combined with the fact that it avoided the winter deicing salts found on modern paved roads, has allowed this bridge's trusses to remain in outstanding condition despite a lack of paint. Indeed, much of the iron on the bridge looks like it did the day it was erected. Tiny notches on the top chord placed by fabricators to mark the position of rivet holes remain clearly visible. Tiny

punch marks associated with fabrication can be found in other areas of the bridge as well. The iron on the bridge remains smooth with no pitting and the edges of the metal remain sharp. Pack rust and section loss are practically nonexistent. A few minor parts have damage that would be easy to repair. One portal bracing beam is bent, and some of the castings which connect the truss members have cracked.

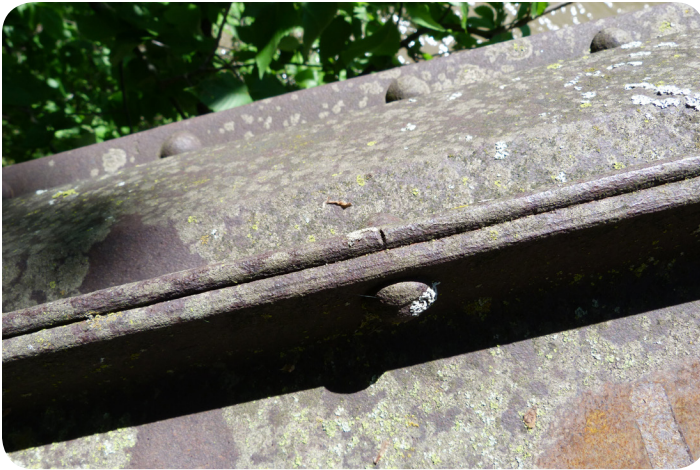
Typical view of a rivet along the top chord column of the Kern Bridge. Note the small notch in the rolled column channel, which was used by the fabricator to locate the holes for the rivets. Photo by Nathan Holth.

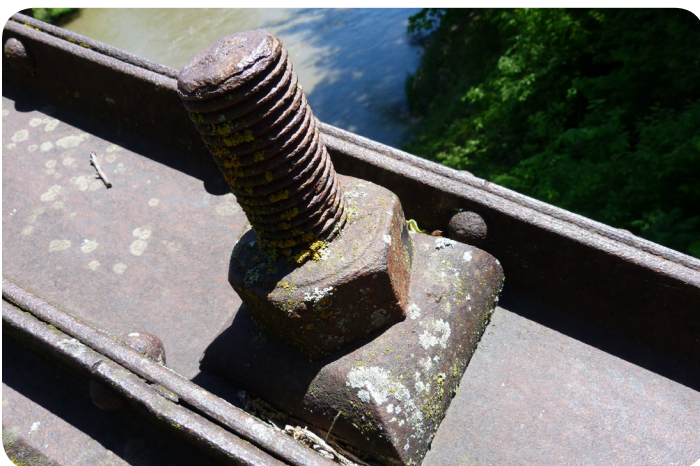
Detail of vertical member threaded rod and nut connection, with cast iron washer, along the top chord. Photo by Nathan Holth.

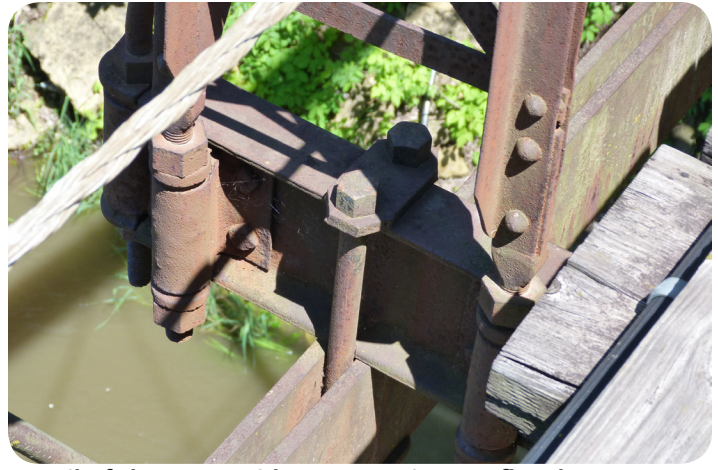
Detail of the Kern Bridge connections at floorbeam, bottom chord, and vertical member. Photo by Nathan Holth.

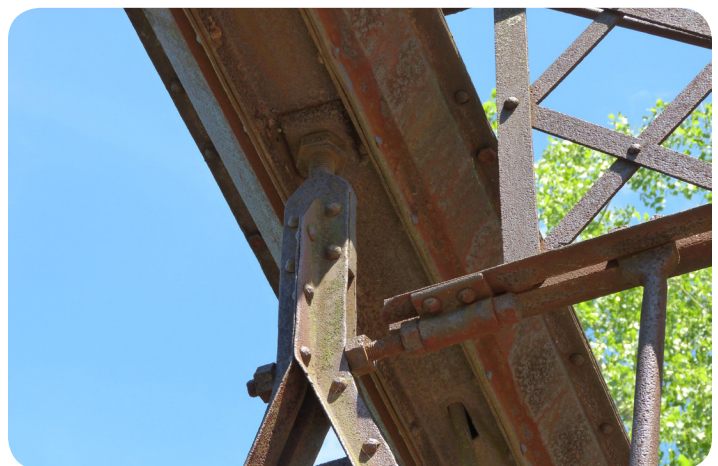
Detail of Kern Bridge's vertical member connection to top chord, and sway bracing connection to vertical member. Photo by Nathan Holth.

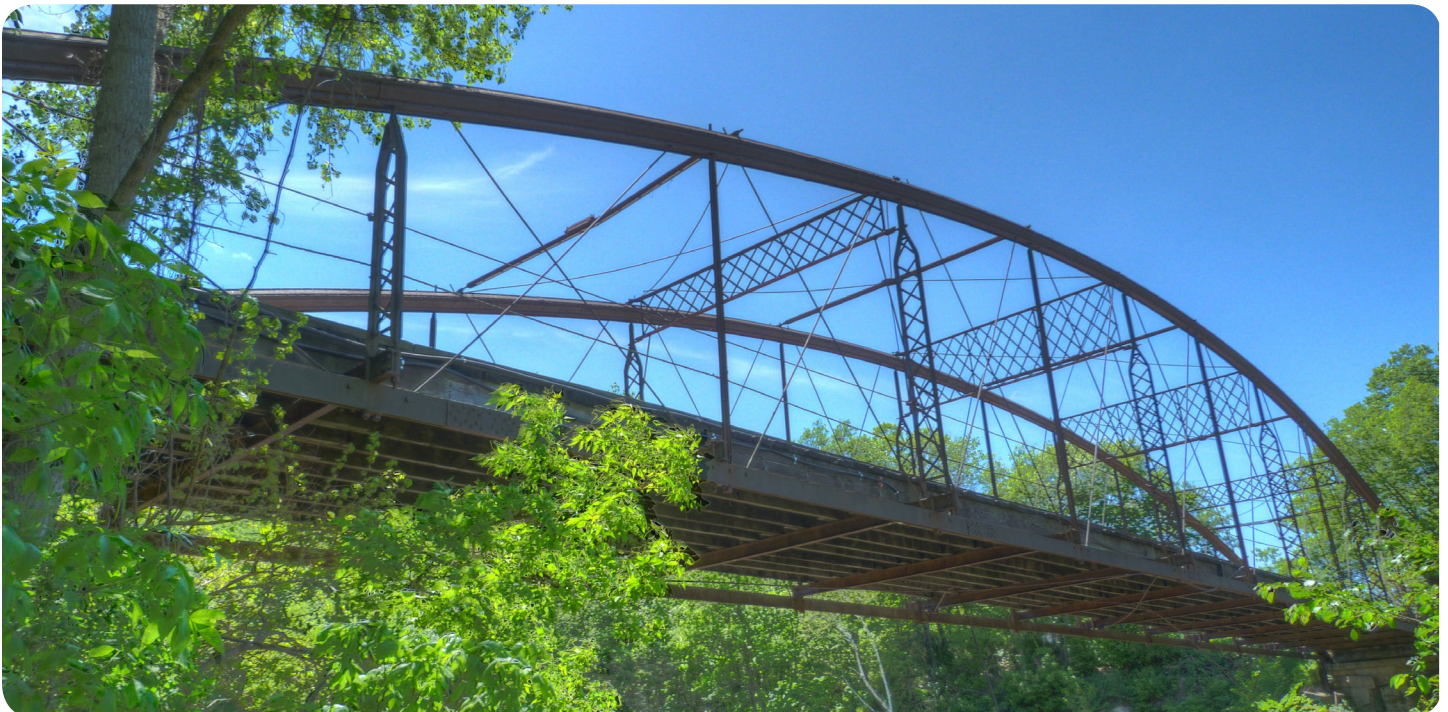
An elevation view of the Kern Bridge, showing the shallow arch of the bridge. *Photo by Nathan Holth.*

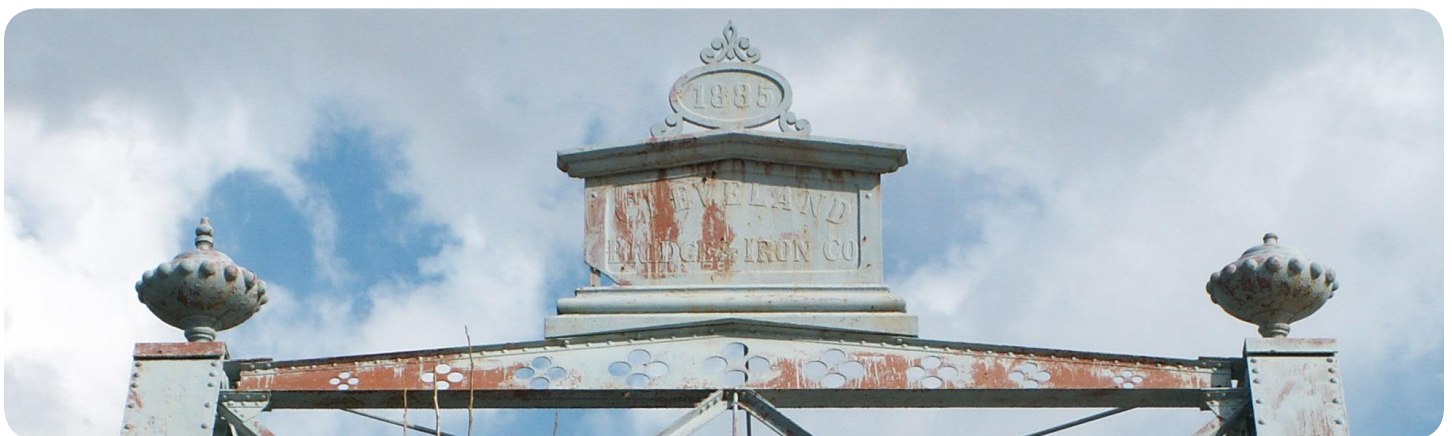
Ornamentation and plaque on the Orient Bridge's portal bracing. Photo by Nathan Holth.

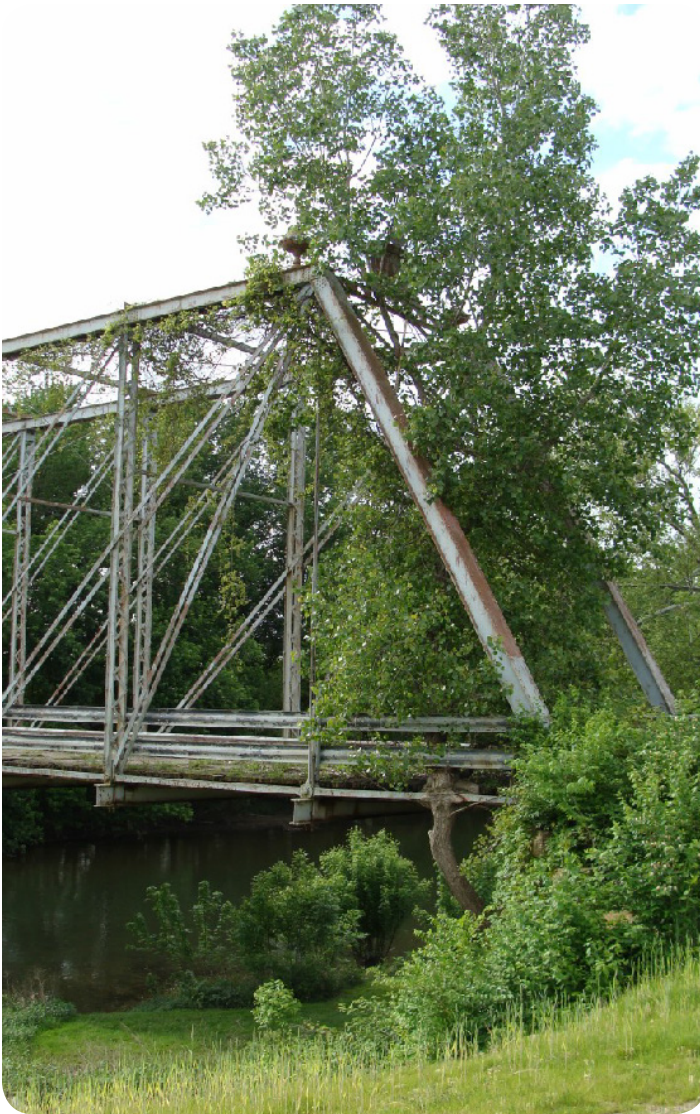
The cottonwood had actually grown around the lower chord of the Orient Bridge and when in full leaf totally obscured the end of the bridge. *Photo by David Simmons.*

bridge was part of the spring tour in 2014. Since being closed, trees had grown up around the bridge. In fact, a cottonwood tree had germinated at the base of the western abutment, grown around the lower chord, and was towering over the portal of the bridge. It was a pretty ludicrous sight, and several local residents told me that they regularly complained to both ODOT and county officials. In fact, ODOT had explored removing the tree in 2012, but it obviously remained a low priority. In early April this year when traveling to and from Washington Court House, I decided to stop and inspect the bridge a little closer. The tree had continued to grow, convincing me that OHBA needed to get involved. I sent some photographs to the Cultural Resources Section in ODOT's Columbus office. My query was forwarded to the District 6

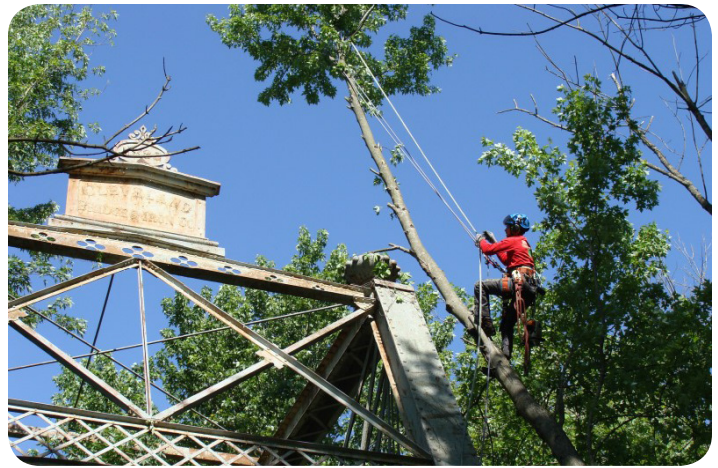
While removing trees from the east end of the bridge, the trimmer discovered a honeybee hive and comb attached to an onion finial. *Photo by David Simmons.*

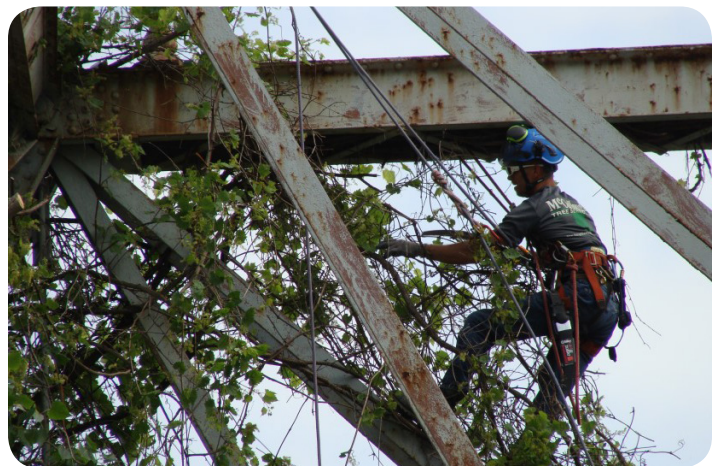
Grapevines had crawled up the Orient Bridge end post and grown into the top chord of the bridge. The trimmer had to suspend himself between the top of the cottonwood and the lacing of the top chord to remove them. *Photo by David Simmons.*

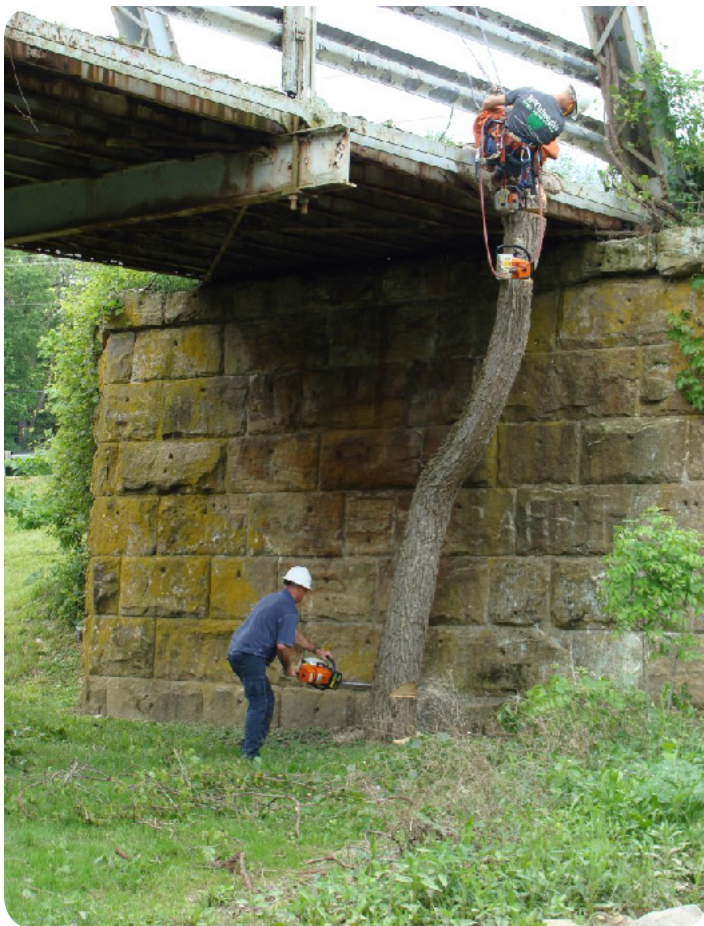
While cutting the tree from around the Orient Bridge's lower chord, the trimmer got his chain saw caught. It was only released when a colleague sawed through the trunk closer to the abutment. . Photo by David Simmons.

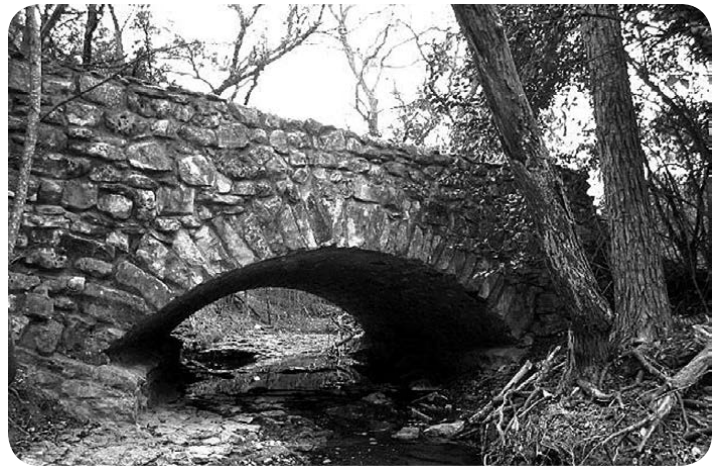
A 1930s WPA stone arch bridge, Austin, Texas. Photo by Patrick Sparks.

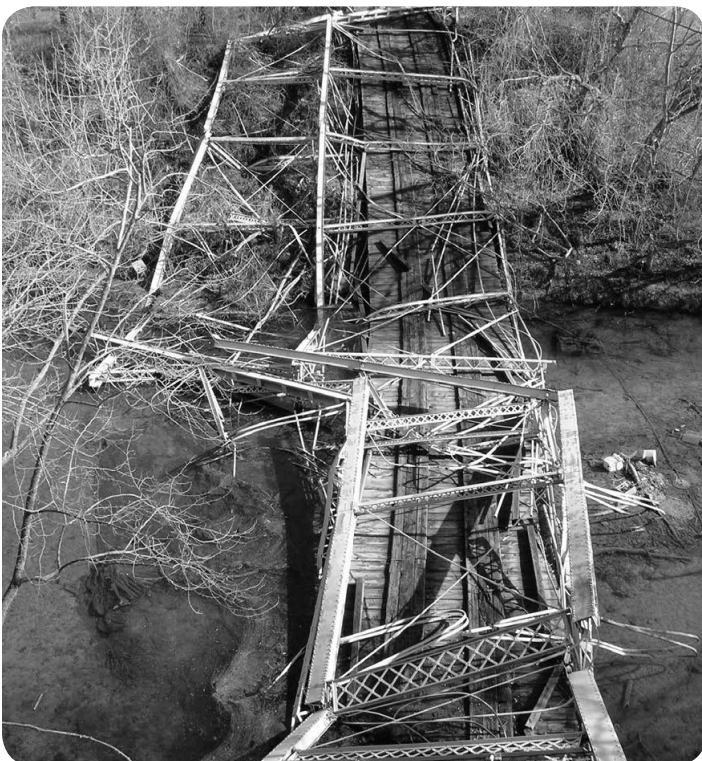
The c. 1889 Lampasas River Bridge in Bell County collapsed on February 4, 2006, when a vehicle struck the northwest end-post during a police chase. It was one of a handful of wrought-iron Whipple through-trusses remaining in Texas. Photo by Trent Jacobs. Photo by Trent Jacobs.

flood, and overload. Sometimes these conditions lead to collapse, as in the example of the Lampasas River Bridge in Bell County, Texas. Fortunately, the risk of collapse can usually be minimized with a modest investment in proper maintenance and repairs.

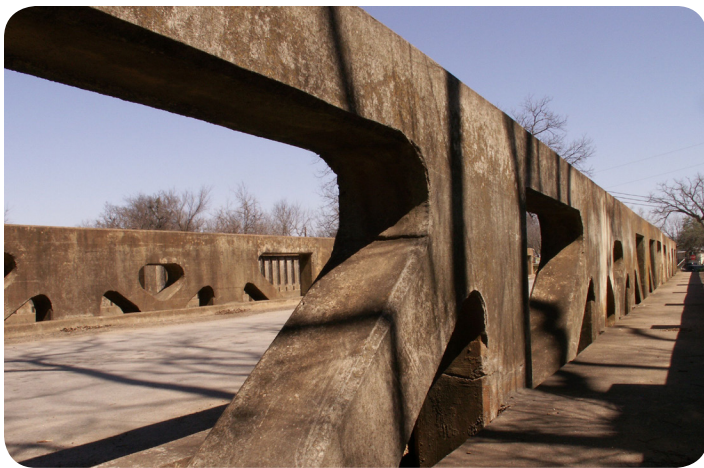
The Broad Street Bridge in Mason, Texas, is an example of a rare concrete truss bridge. Photo by Nathan Holth.

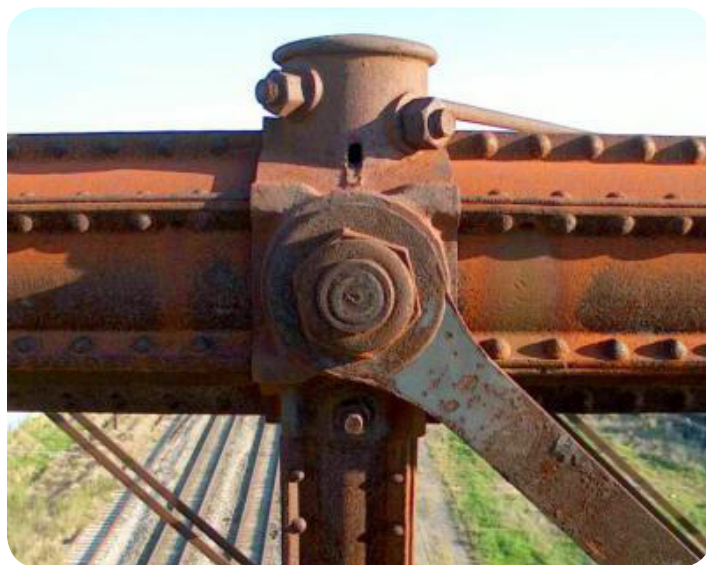
A top-chord pin connection from the 1881 Phoenix Whipple truss on the Hays Street Bridge in San Antonio. The bridge contains three distinct materials: wrought-iron, cast-iron, and early steel. Photo by Patrick Sparks.

For example, in early concrete bridges, much of the engineering significance may be in the steel reinforcement system, which is not visible, and for which documentation is rare. In metal truss bridges, the kind of metal becomes a consideration due to rapid technological change. Whether a bridge is made of wrought iron, of which few remain, may determine if it is more or less significant than a similar bridge of steel. Another example is the combining of multiple types of metal in one structure, such as the Hays Street Bridge in San Antonio, an 1881 Whipple through-truss that has cast iron joint blocks, wrought-iron chord members, and steel pins.

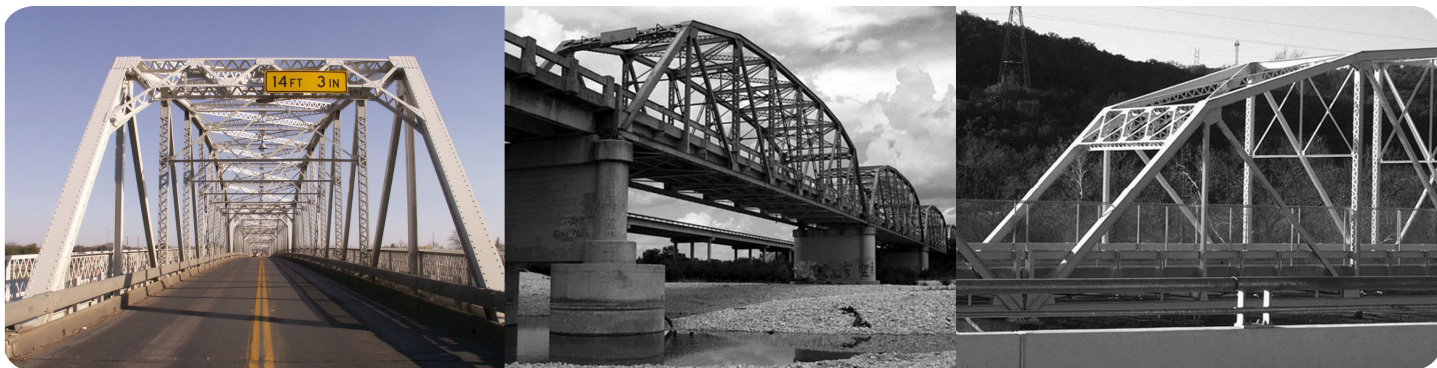
From left to right, three similar Parker through trusses with different outcomes: The Llano River Bridge was once slated for removal but was rehabilitated and kept in vehicular service. *Photo by Nathan Holth.* The US 90 Bridge over the Nueces River was successfully kept in service as part of a one-way pair. *Photo by Patrick Sparks.* The Colorado River bridge on SH 29 was bypassed and converted to pedestrian use, albeit with an inappropriate chain link fence. *Photo by Patrick Sparks.*

As an example of alternatives, consider the case of similar Parker trusses. Bridges of this type from the 1920s and 1930s tend to be well-constructed robust structures. They often have less width and vertical clearance than is now required in new construction, but rarely do they have major structural deficiencies. The Llano River Bridge in Texas remained in service because citizens rallied to save it and engineering studies validated its structural capacity. The U.S. 90 Bridge over the Nueces River in west Texas was continued in service as part of a one-way pair. Similar bridges on U.S. 377 and on SH 29, both over the Colorado River, were bypassed with new bridges. The U.S. 377 Bridge was cut-off entirely from vehicular and pedestrian access. The SH 29 Bridge is accessible to pedestrians, but is enclosed in a historically inappropriate chain-link fence.

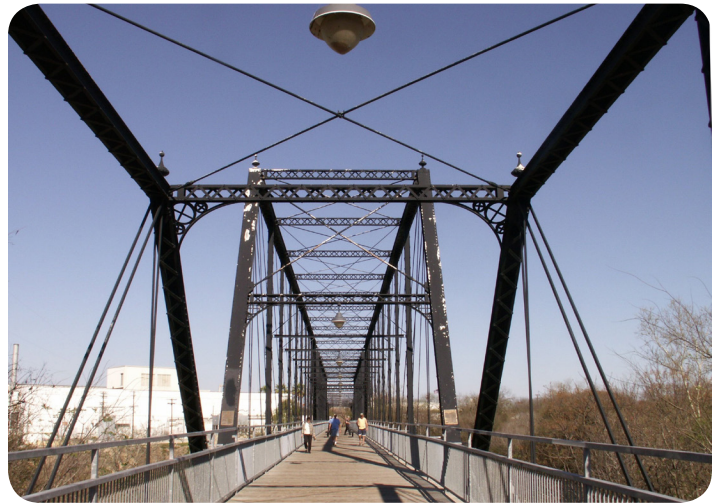
1887 Faust Street Bridge, New Braunfels, Texas, rehabilitated to pedestrian and bicycle use in 1998, using Transportation Enhancement funds. Photo by Nathan Holth.

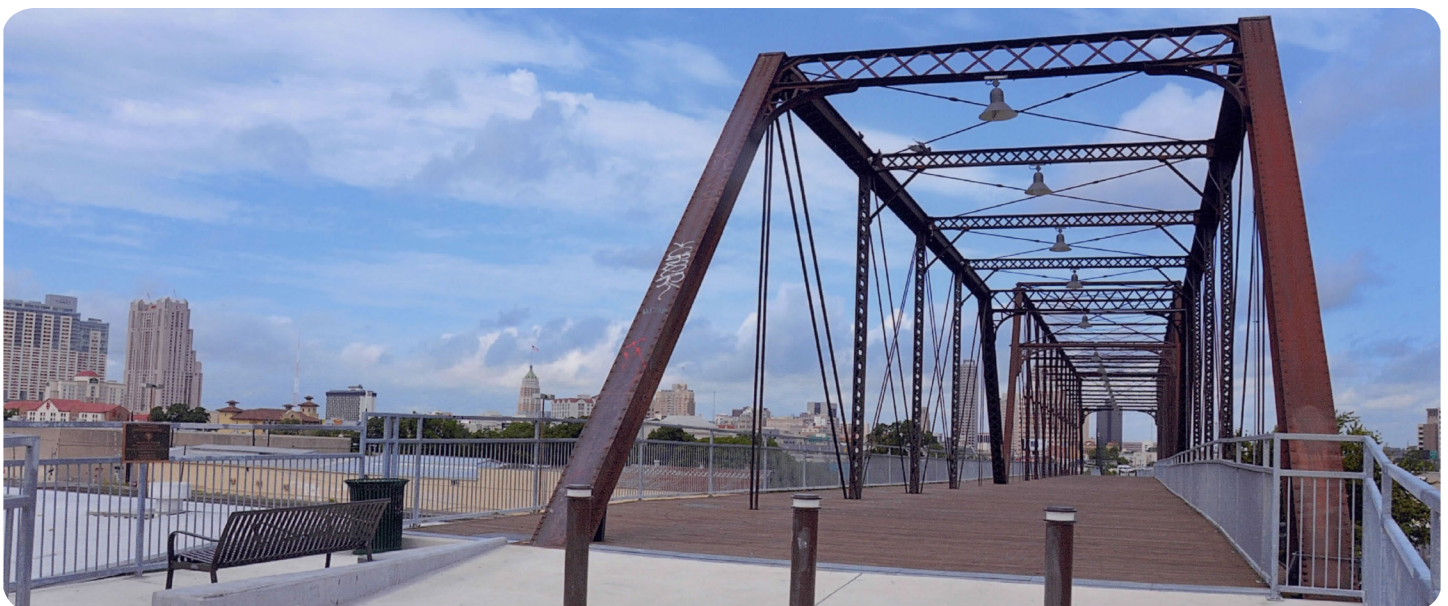
1881/1910 Hays Street Bridge in San Antonio, rehabilitation as a pedestrian and bicycle bridge using Transportation Enhancement funds, completed by 2010. Photo by Patrick Sparks.

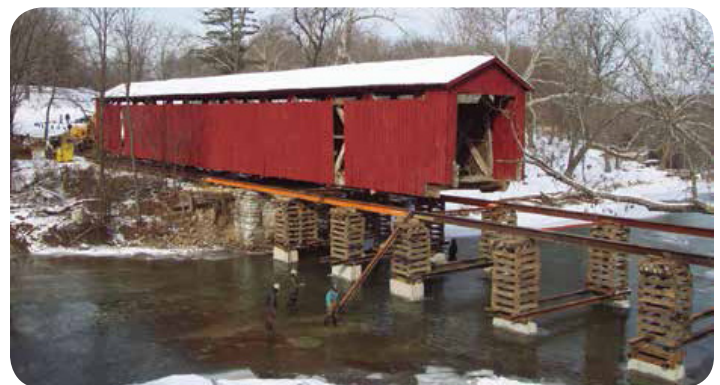
Cataract Falls Covered Bridge, located in Owen County, Indiana. This Smith truss, built by the Smith Bridge Company of Toledo, Ohio, in 1876, is shown here being moved off the river for restoration. Photo by J. A. Barker Engineering, January 2003.

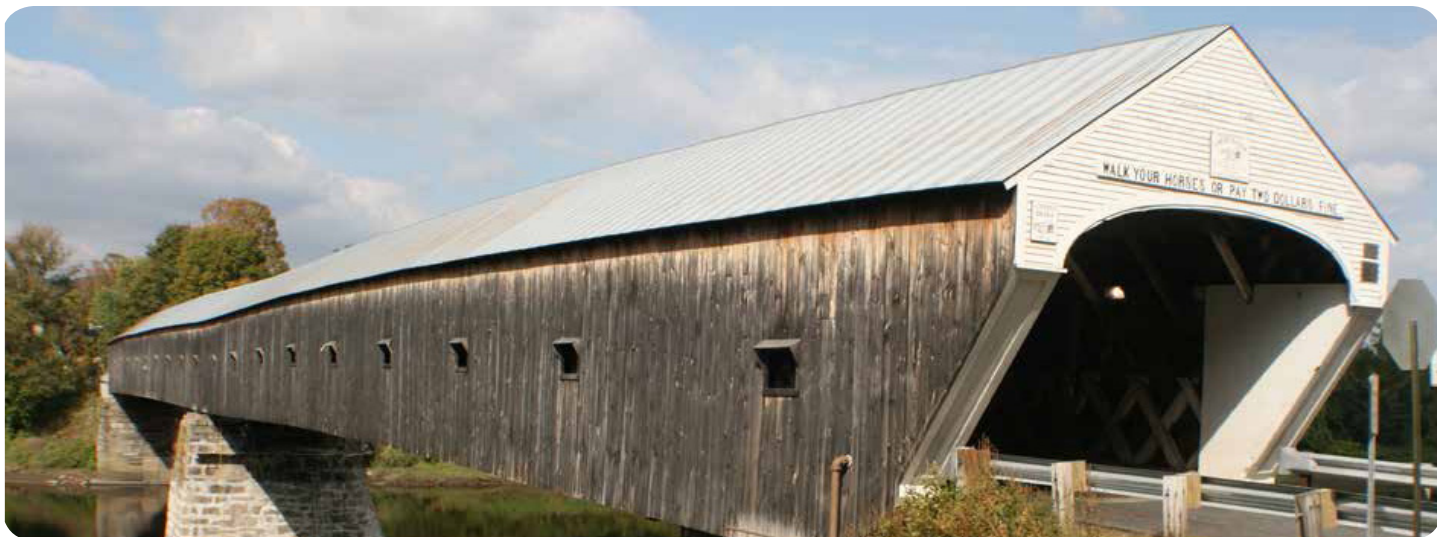
Cornish-Windsor Covered Bridge, located on the state line between Sullivan County, New Hampshire and Windsor County, Vermont. This two-span modified continuous Town lattice truss was built in 1866. Photo by Scott Wagner, 2013.
