Historic Bridge Foundation Facebook Archives

Focus Bridges: The Great 1913 Flood

September 2016

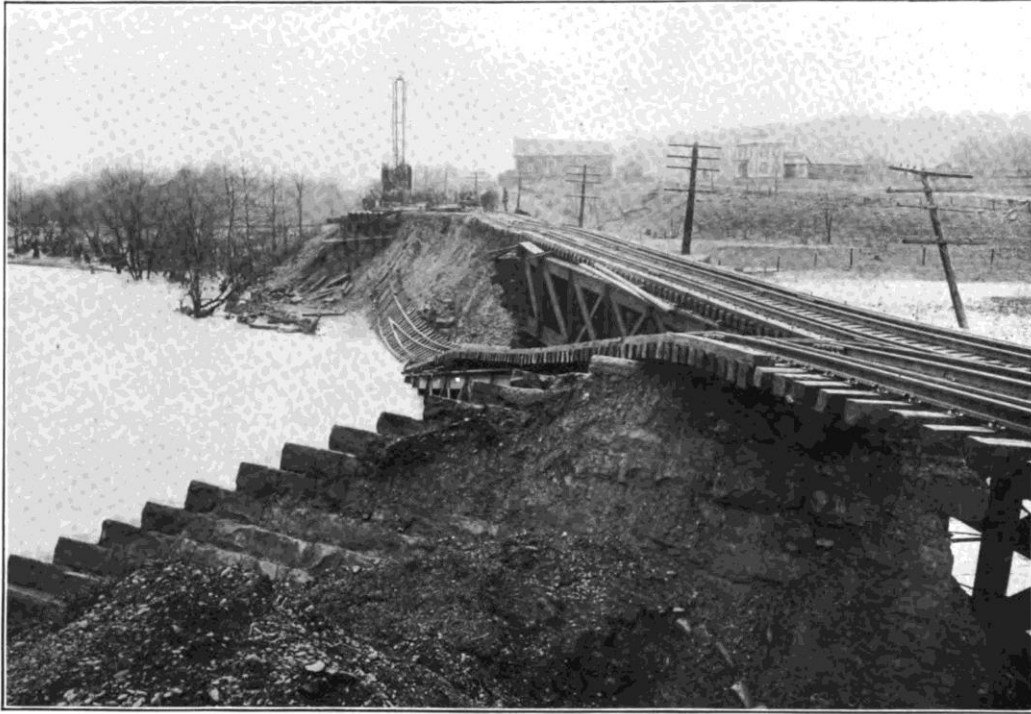
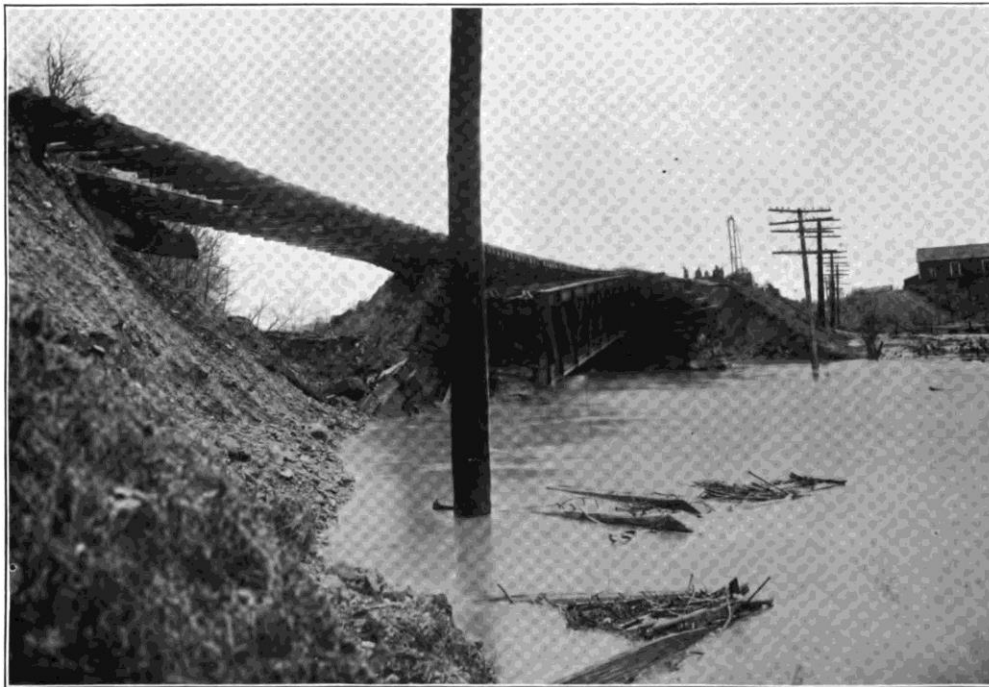
47 and 122 – Lucas, Ohio. Bridge over Rocky Fork.

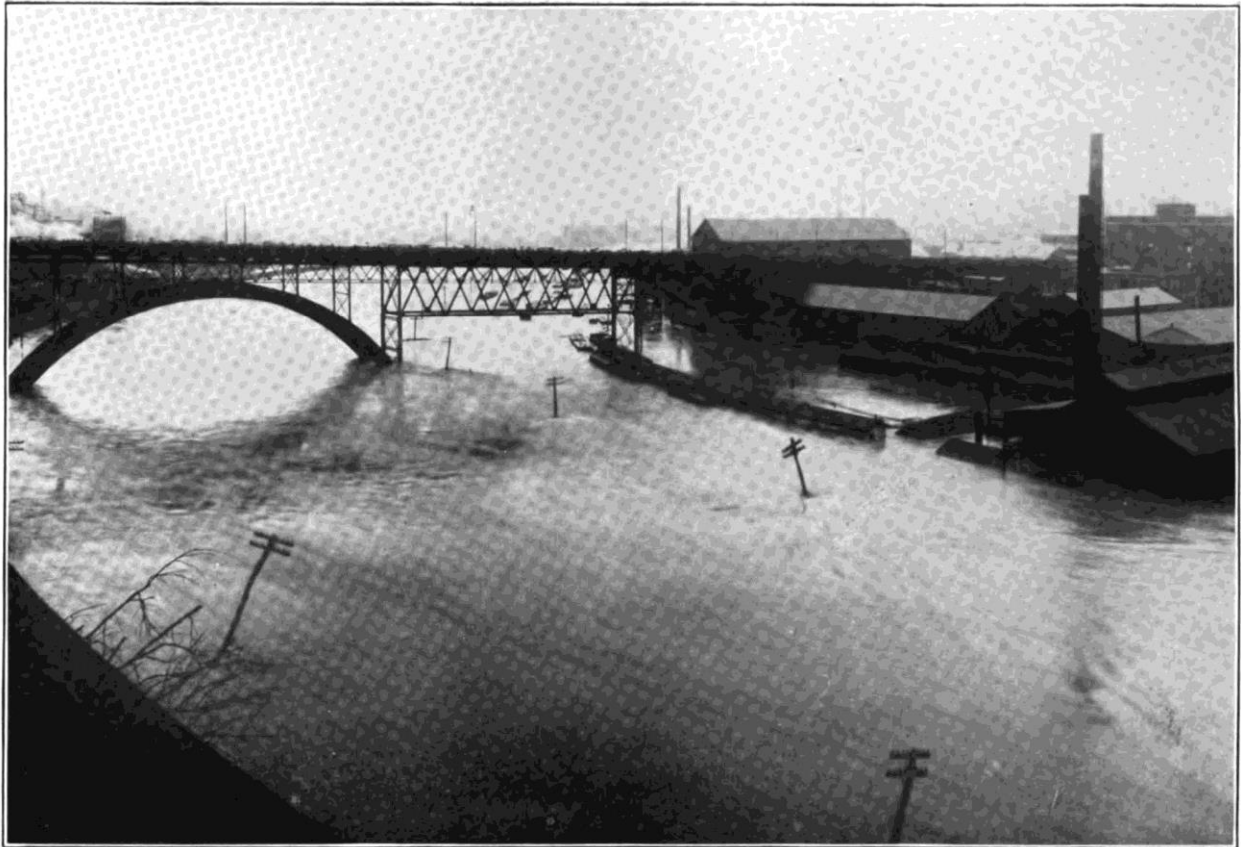
52 – Market Street Bridge over Mahoning River in Youngstown, Ohio.

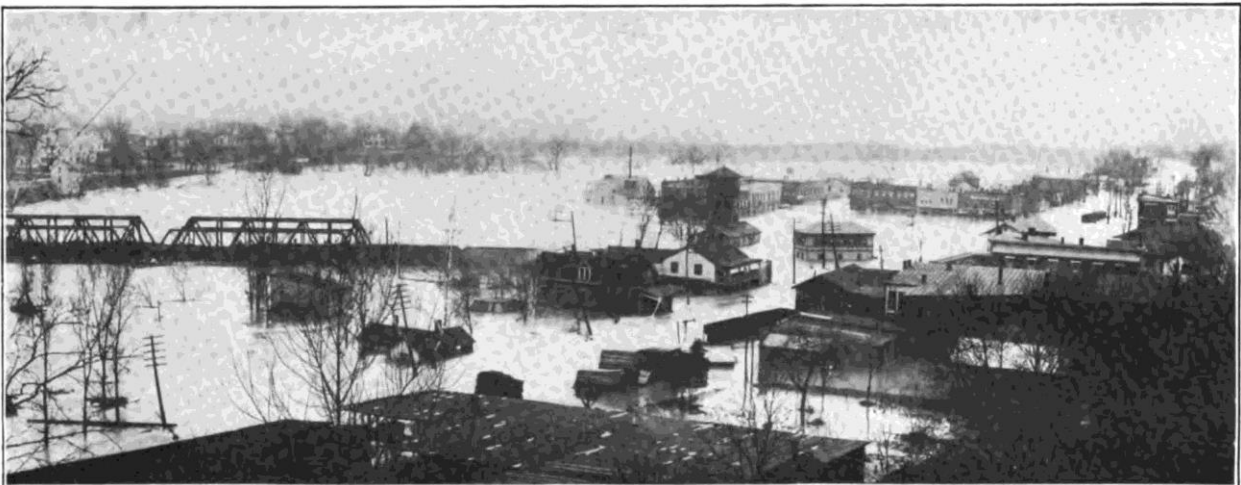
55 – B&O SW bridge weighted down. Loveland, Ohio (near Cincinnati).

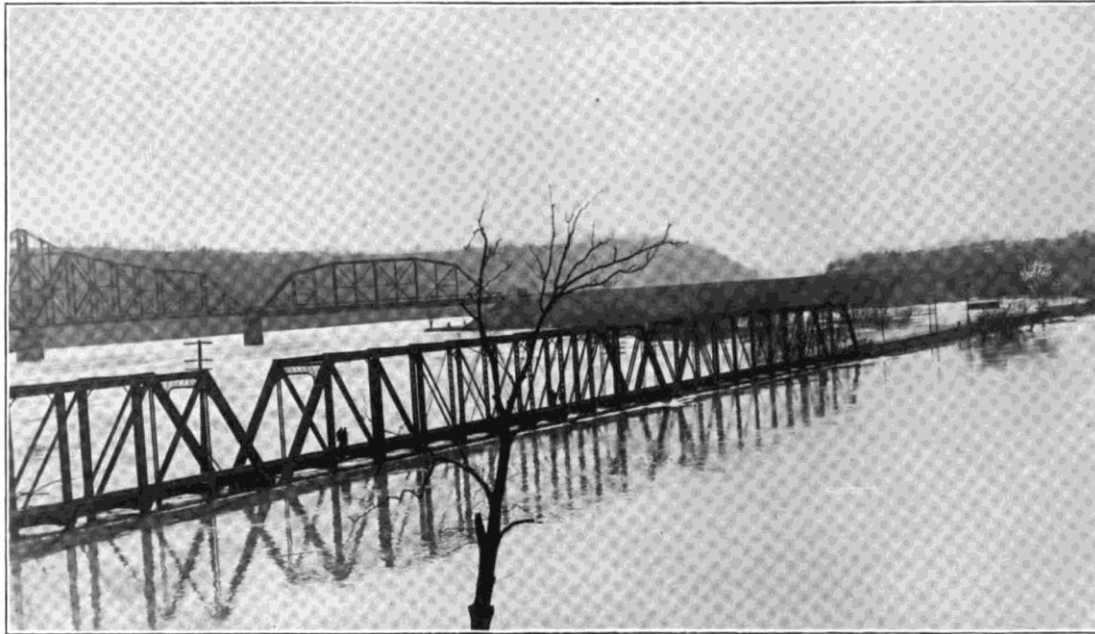
60 – C. & P. Division Bridge over Beaver River in Rochester, PA. The enormous Beaver Bridge over Ohio River is in the background. The Ohio River Bridge remains standing today. As for the Beaver River Bridge, the bridge standing today is a through truss reportedly built in 1913, suggesting the bridge pictured here was damaged or destroyed in the flood.

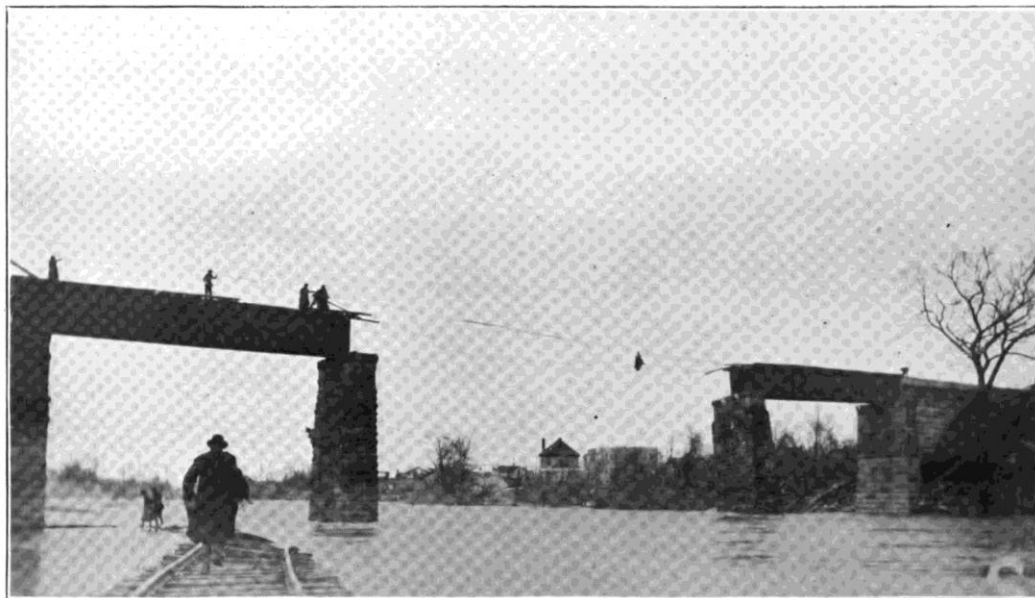
60 – Big Four Bridge over Olentangy River in Delaware, Ohio. One of the spans was destroyed. The caption reads "The only means of getting from the east side to the west side of the town was by means of a basket pulled across this cableway, and used for several days continuously."

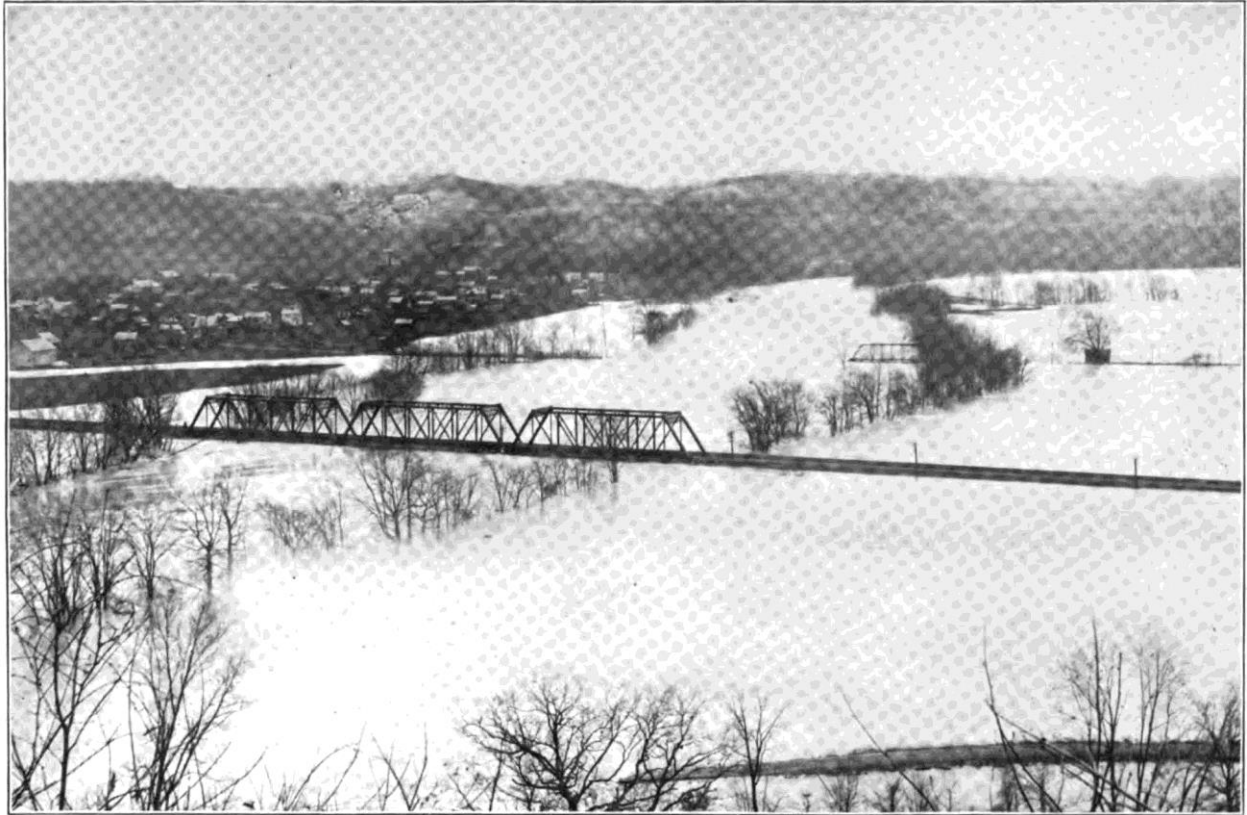
62 – Gnadenhutten, Ohio. Bridge 92, Pittsburgh Division over Tuscarawas River. The bridge in the background is captioned as the "county bridge" and noted to be washed away.

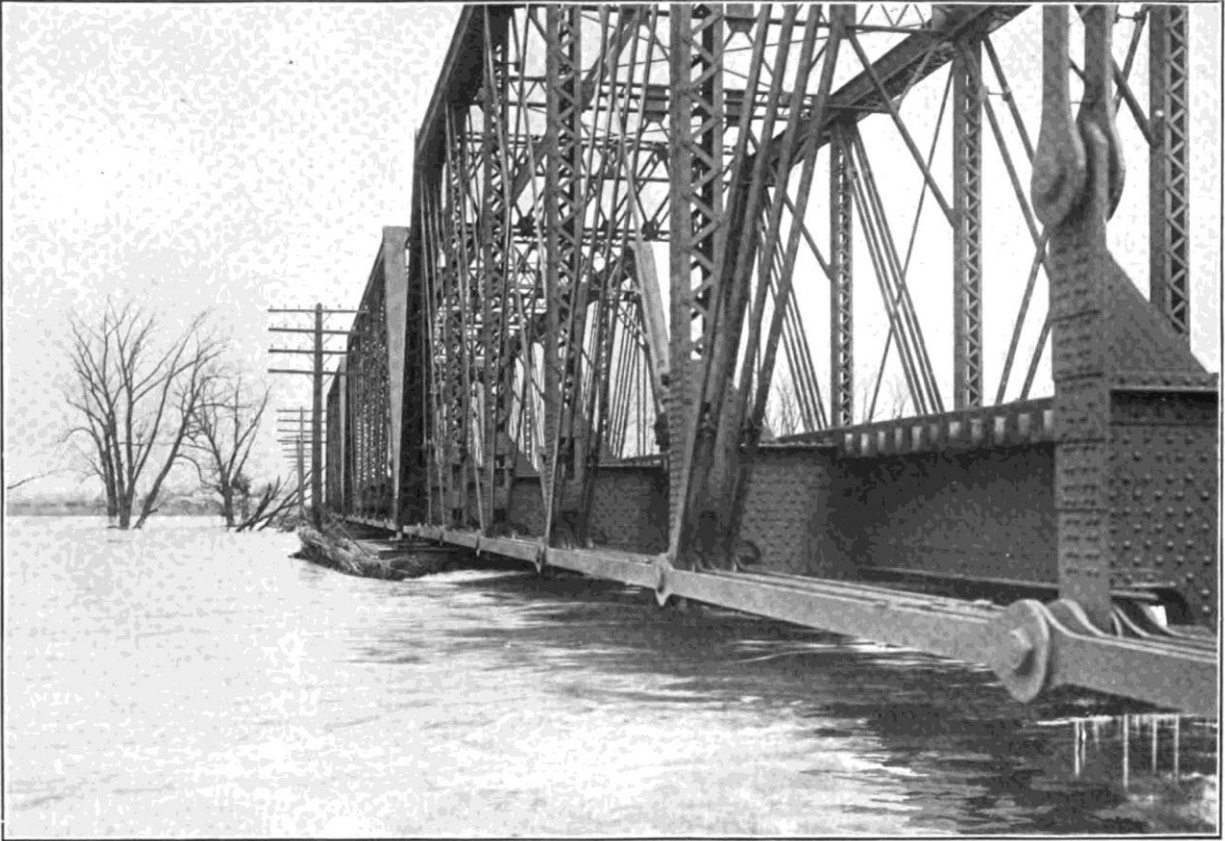
145 - Gnadenhutten, Ohio. Bridge 92, Pittsburgh Division over Tuscarawas River.

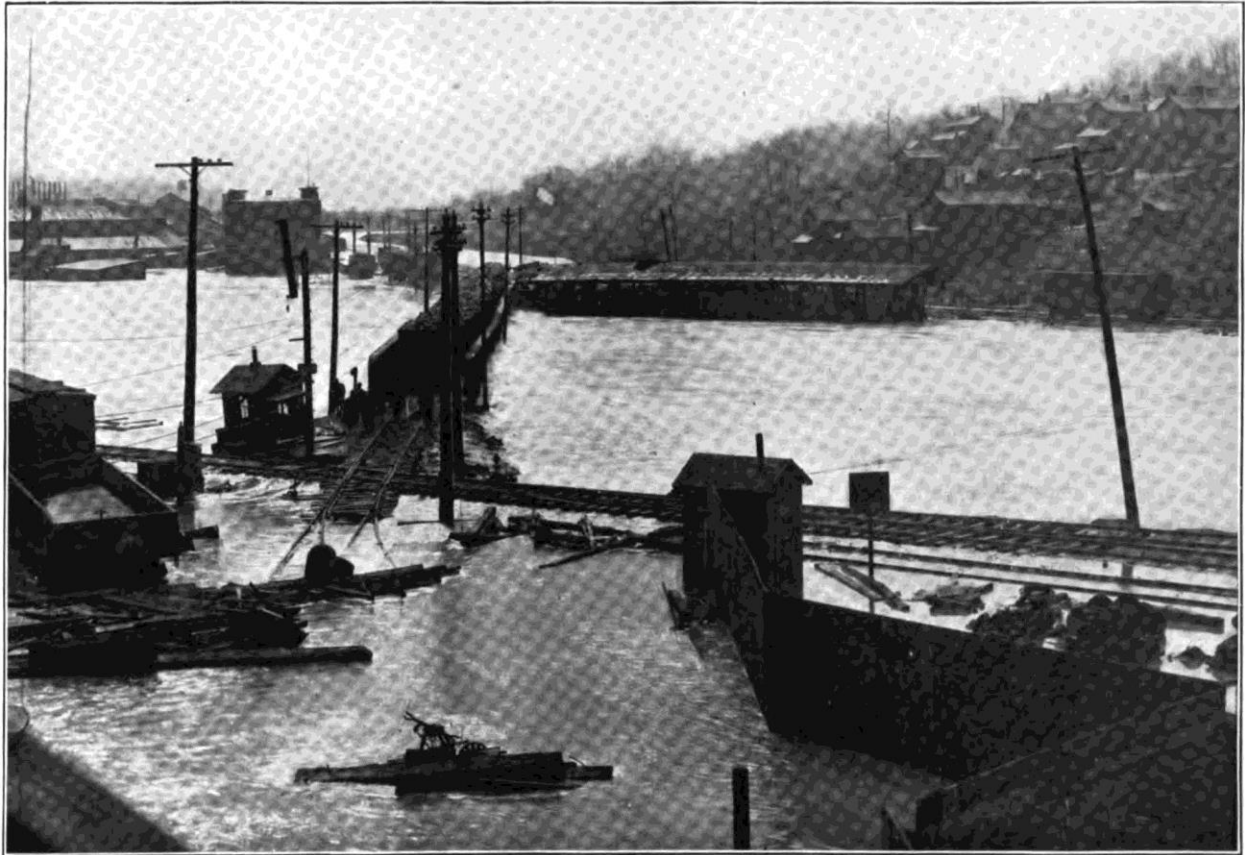
64 – New Castle, Pennsylvania. A covered bridge captioned as the "Black Bridge" is shown after it had been swept off its substructure and floated into the Pennsylvania Lines "Franklin" Bridge No. 68 over the Shenango River. The railroad bridge later "went down." Another photo showing the river mentions that the "city bridge" at Grant Street has been destroyed as well. This bridge was replaced in 1914 by a Pennsylvania through truss that remained standing until 2009 when it was demolished and replaced.

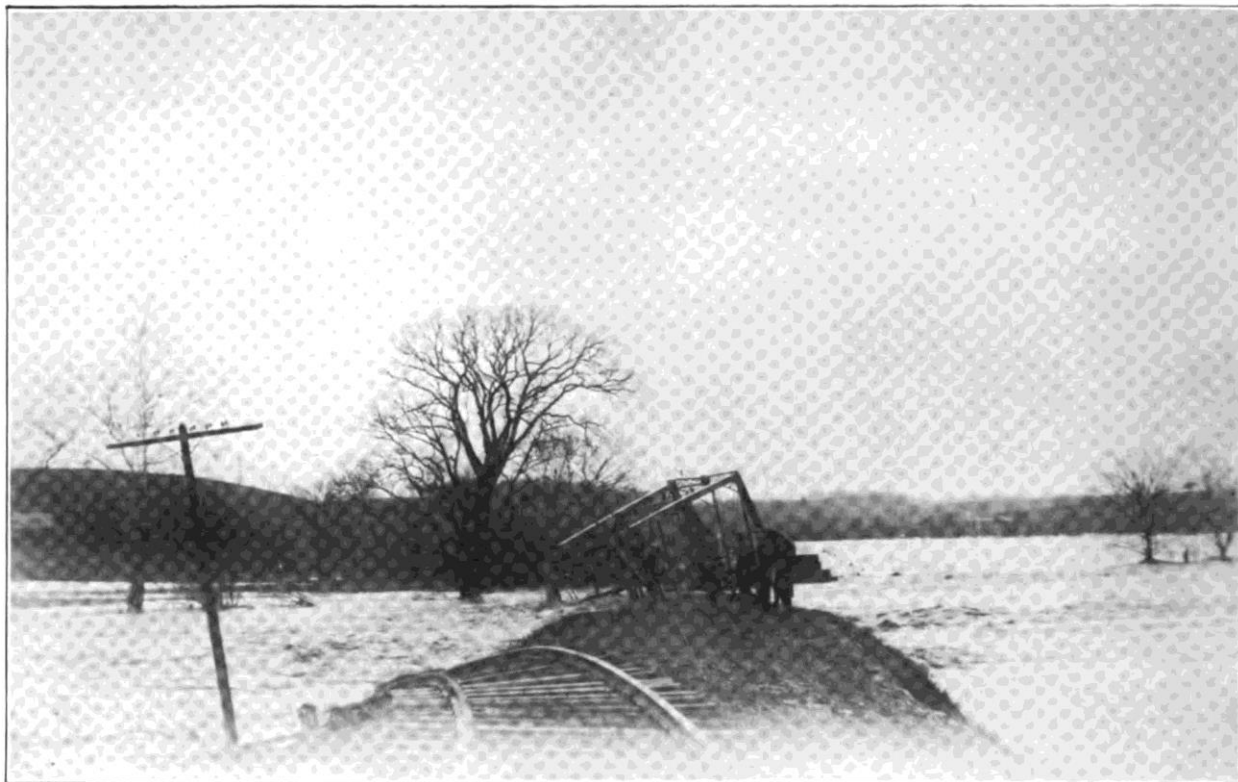
72 – Bridge 83, Akron Division over the Kokosing River in Gambier, Ohio is shown destroyed here.

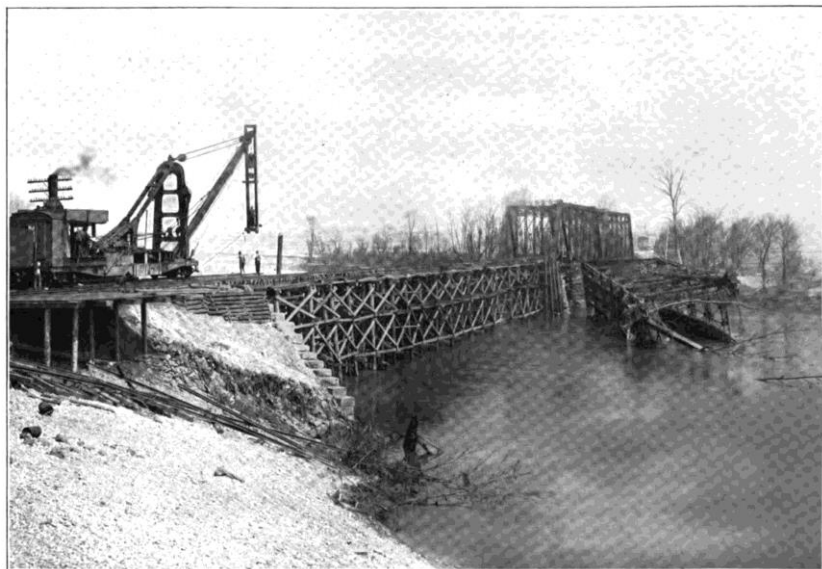
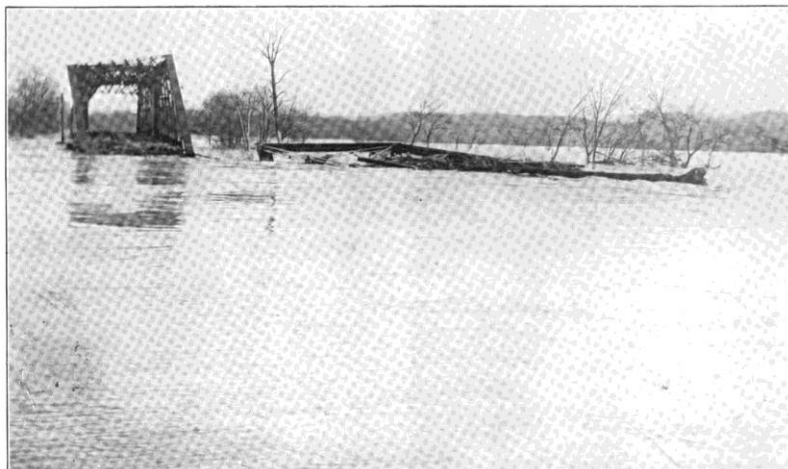
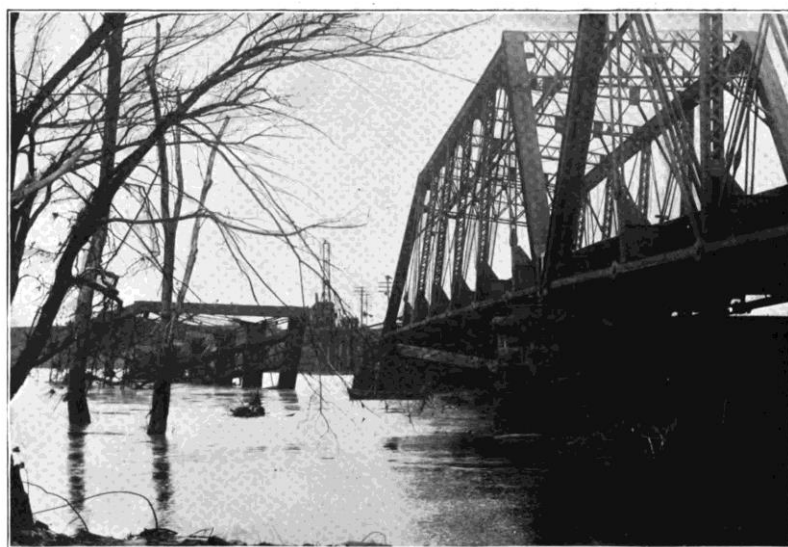
84 and 157 and 164 – Bridge 100, Pittsburgh Division over Muskingum River in Coshocton, Ohio. This bridge was only partially damaged, and so the substructure and approaches were repaired after the flood.

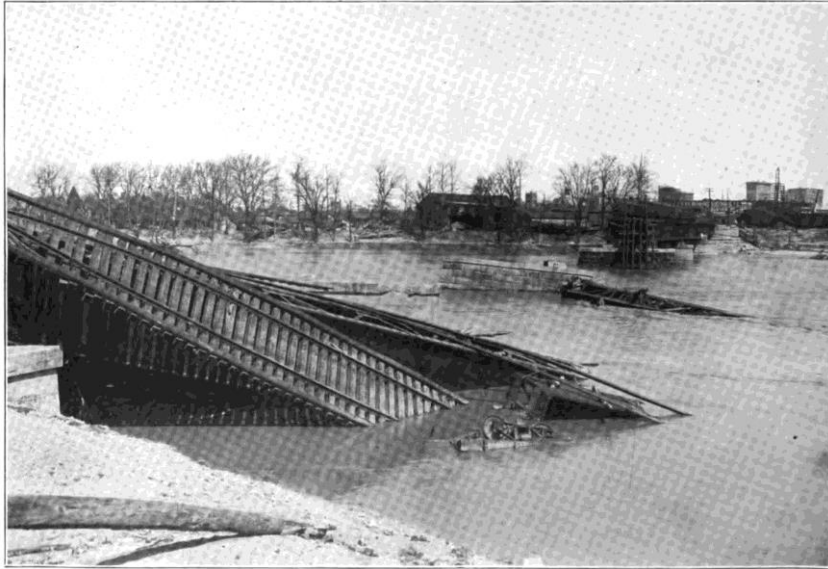
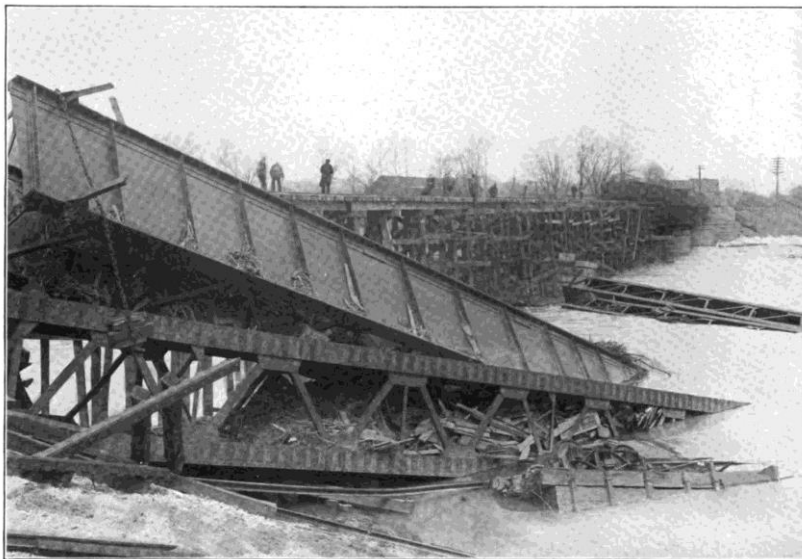
90 and 195 – Dayton, Union Bridge over Miami River in Dayton, Ohio. A temporary bridge was already under construction by the time the first photo was taken.

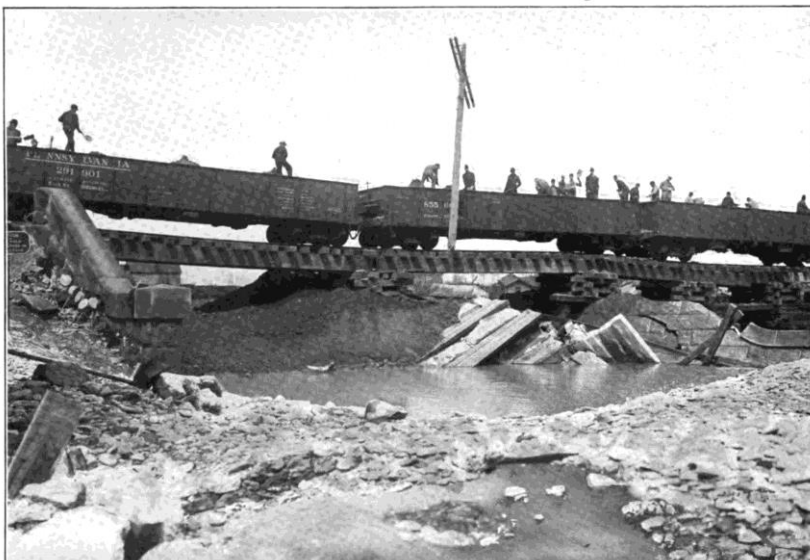
97 – West Columbus, Ohio – The caption reads "Replacing Central Avenue viaduct, which was destroyed, with temporary fill from cribbed trestle."

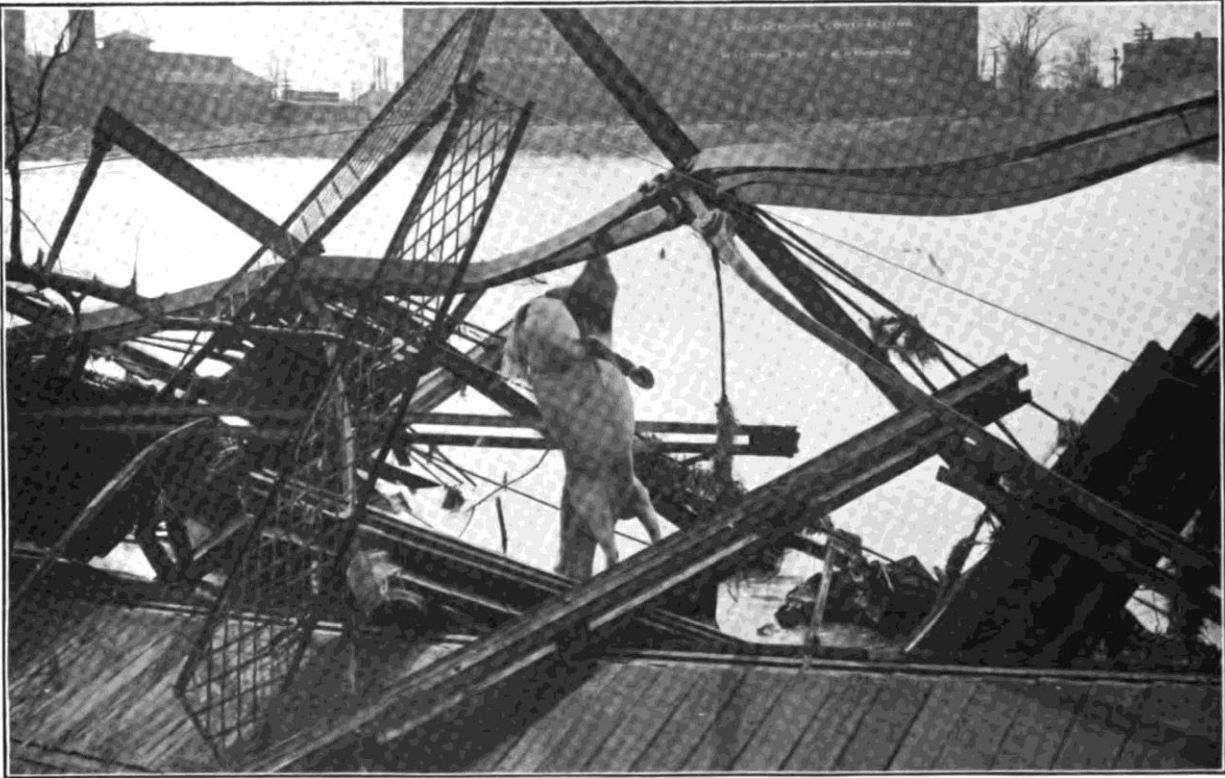
102 – Dayton, Ohio. This gruesome photo shows the ruins of the 5th Street Bridge, and a dead horse tangled in the trusses as well. The caption notes that 1,400 horses were drowned in Dayton alone. The bridge was a product of the Dayton-based Columbia Bridge Works; enough of the company's unusual design details are visible in this photo to confirm this.

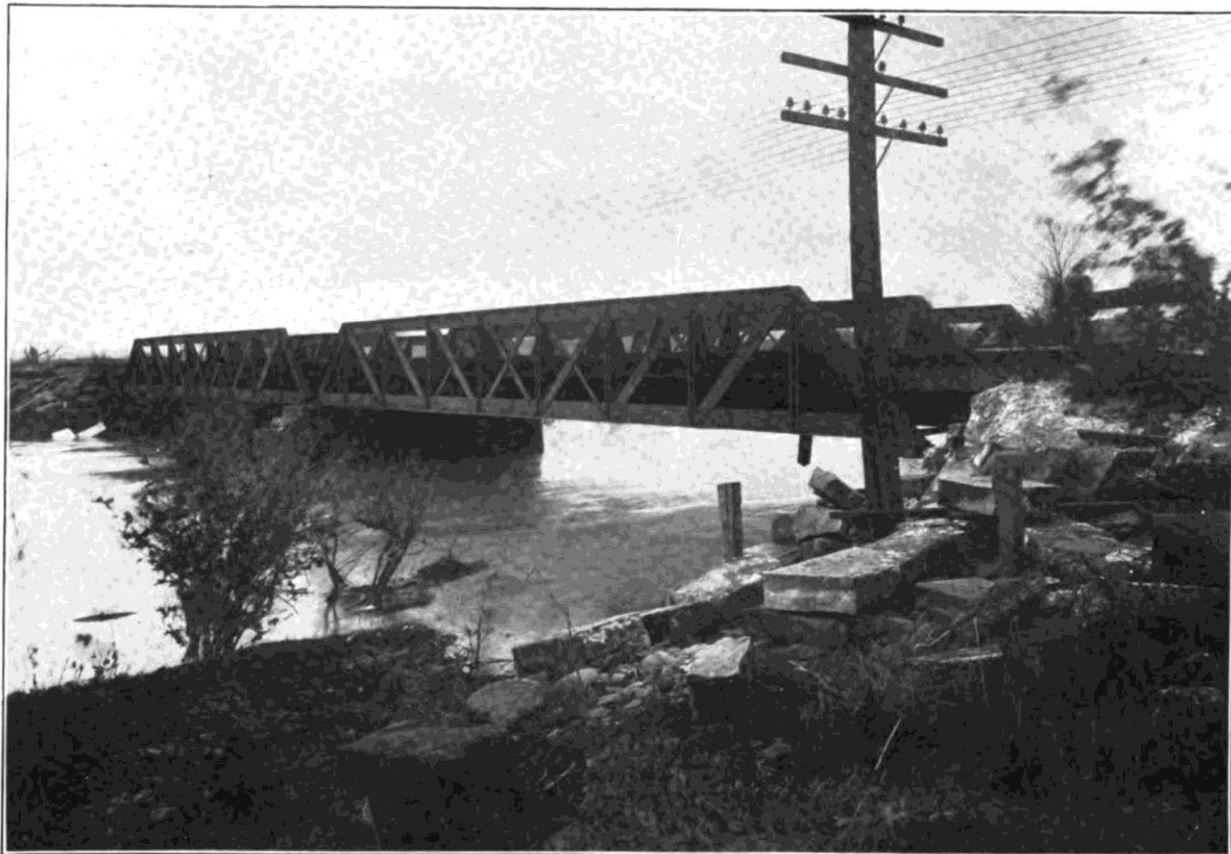
131 – Bridge 143 over Black Fork in Perrysville, Ohio. The caption notes that (apparently before the flood) a new bridge abutment was already under construction, but the new bridge abutment was destroyed.

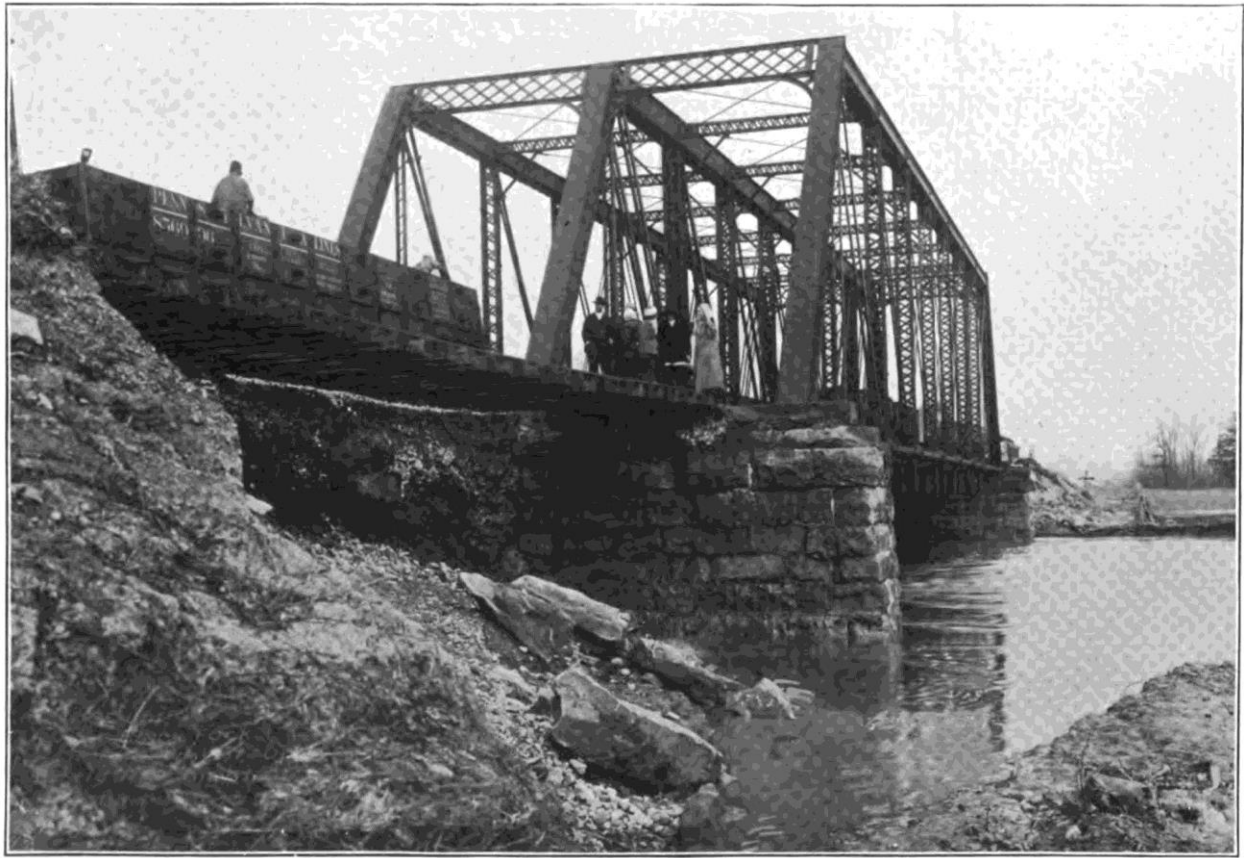
131 – Bridge 144 over Black Fork in Coulter, Ohio. The approach span was washed out.

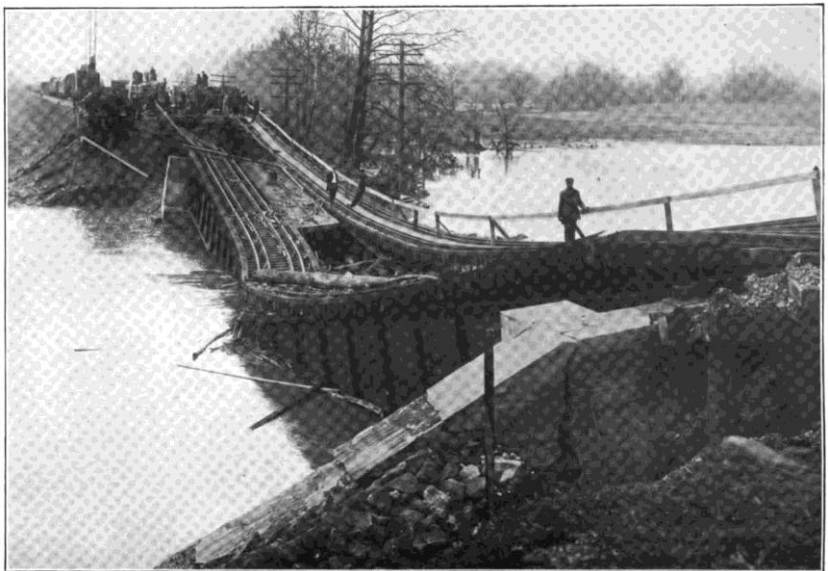
132 and 133 - Bridge 145 over Black Fork east of Lucas, Ohio. A temporary bypass was installed while a replacement bridge was built.

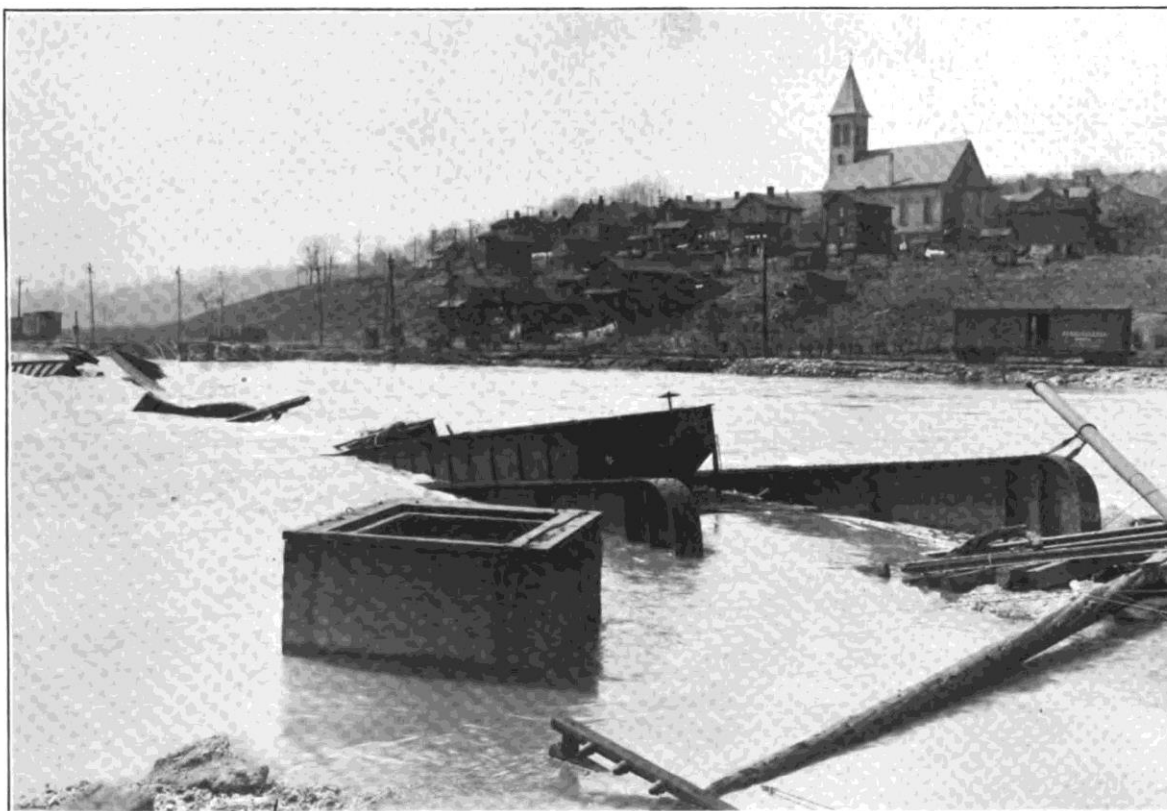
141 – "Franklin" Bridge Number 68 over Shenango River in New Castle, PA.

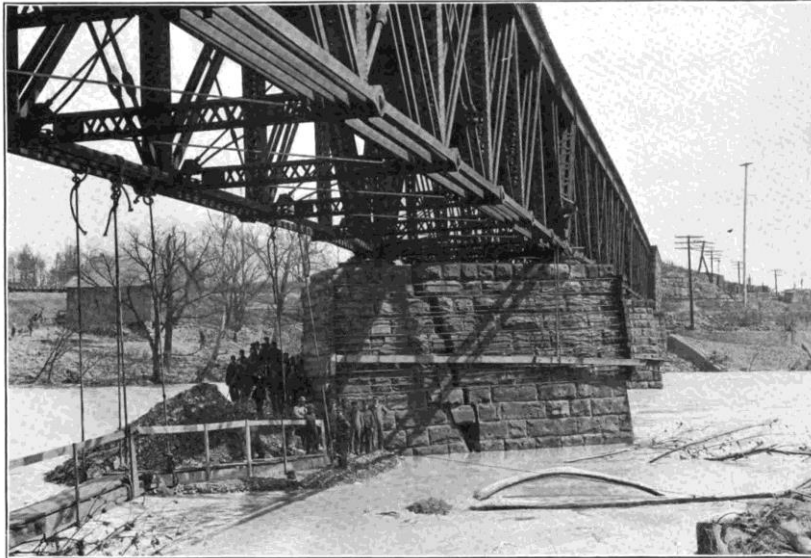
171 (2 photos). Marble Cliff, Ohio (near Columbus). Bridge 3 over Scioto River. This bridge survived and remains today.

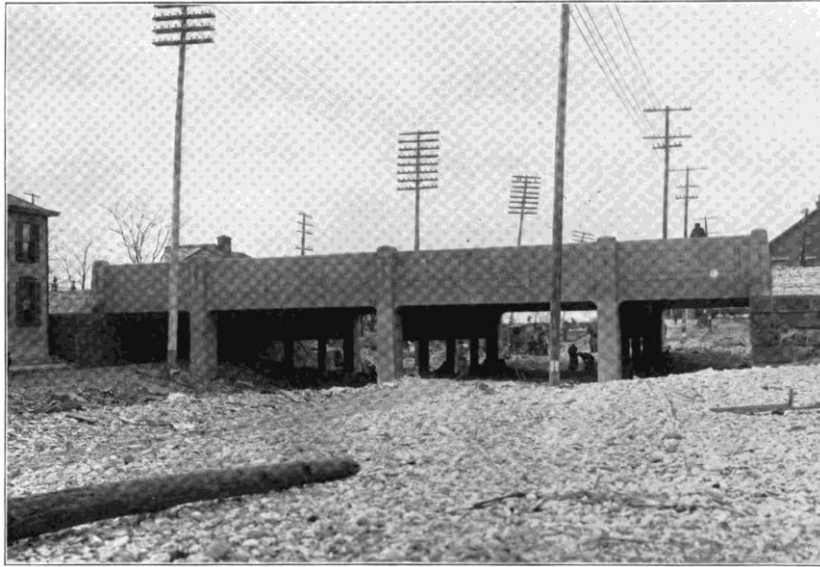
172 and 173 – Rodgers Avenue and Sandusky Street overpasses in Columbus after the flood.

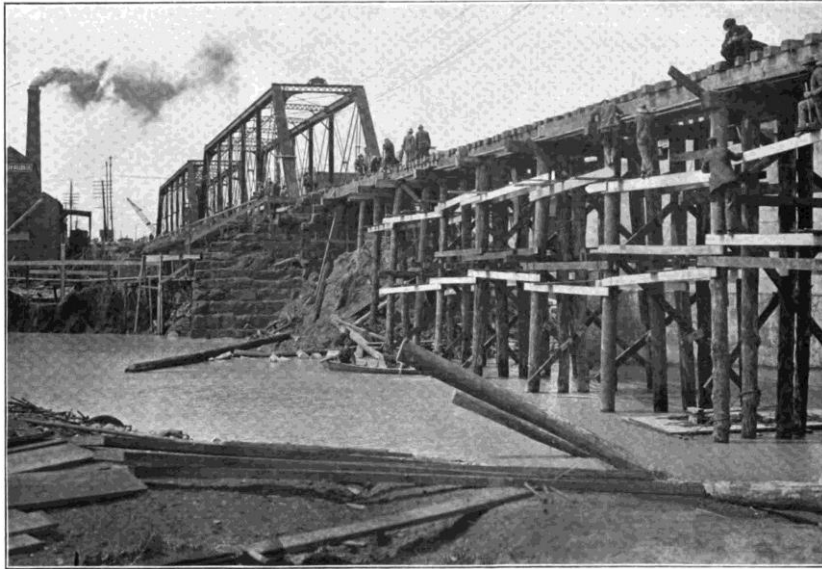
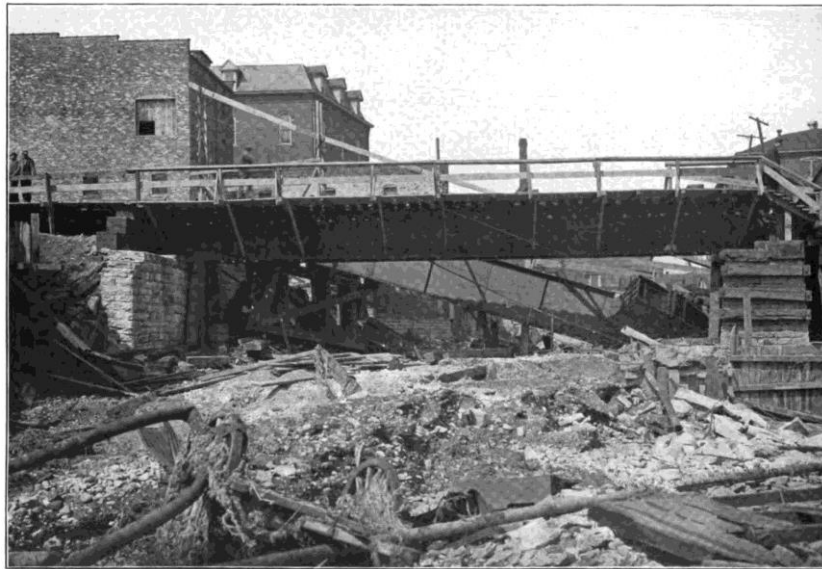
Piqua, Ohio. Bridge 50 over Miami River. The approach was washed away. The through truss spans required temporary supports to be added, while a totally new replacement bridge was built. Note the ornate builder plaque on the portal bracing of the bridge.

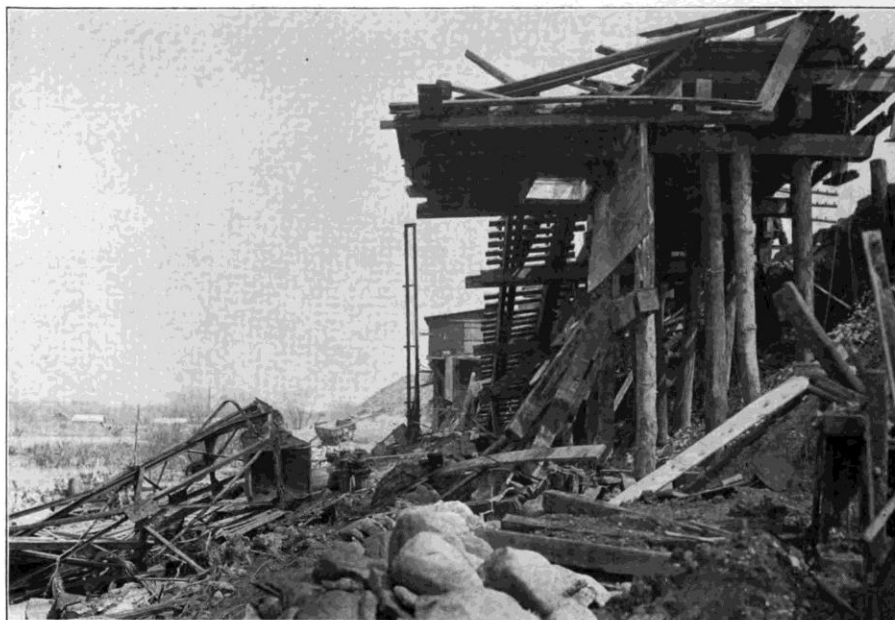
Looking east from Bridge 50, showing ruins of contractor's outfit engaged in track elevation work.

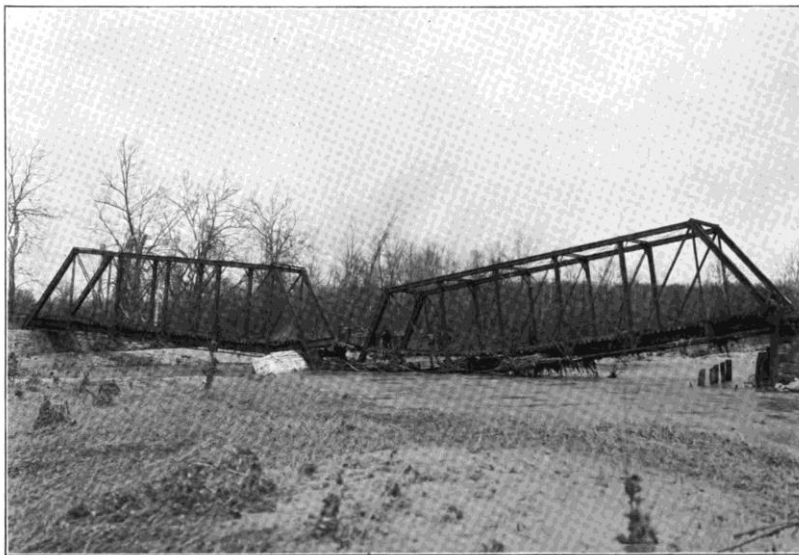
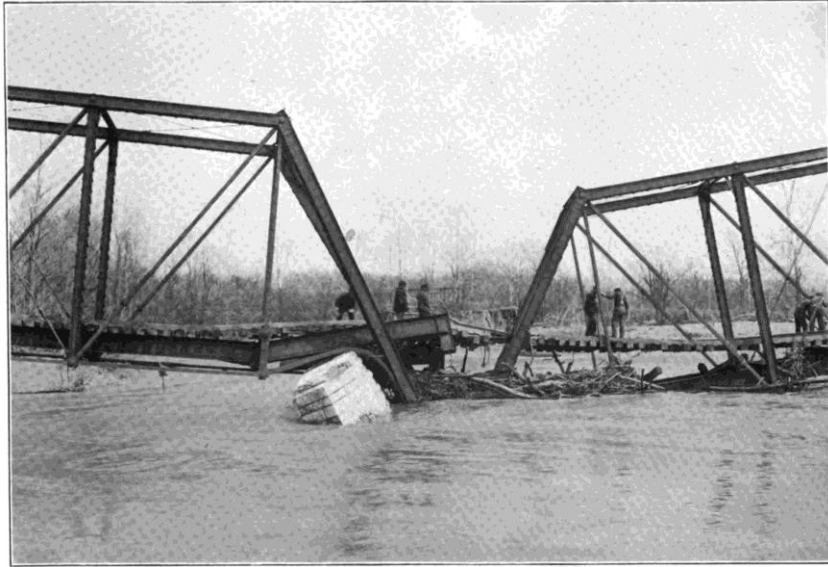
198b and 199 - Somerville, Ohio. Bridge 48 over Seven Mile Creek. This interesting bridge had two different designs of pin-connected Pratt trusses: one with a pedimented portal bracing, the other with a latticed portal bracing with numbers (likely the construction date, possibly 81 for 1881) on them. One or both of the spans had likely been relocated and reused in this location.

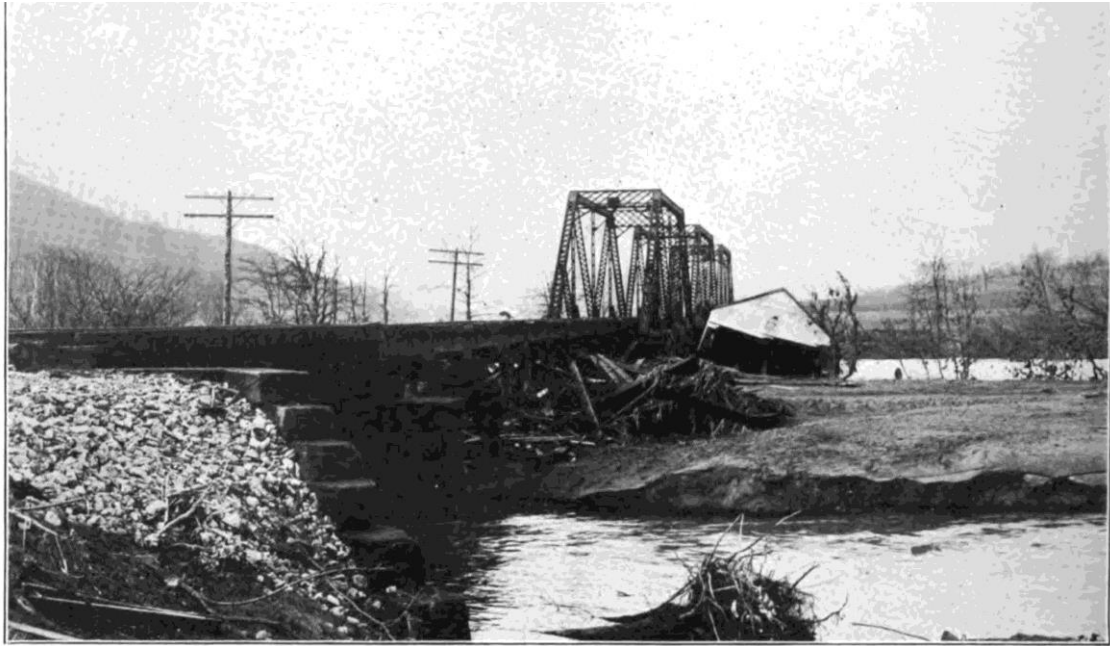
237 – Brink Haven, Ohio. Bridge 68 with a building carried away by the flood lodged against it. This bridge was an unusual structure with three short through truss spans and laced end posts.

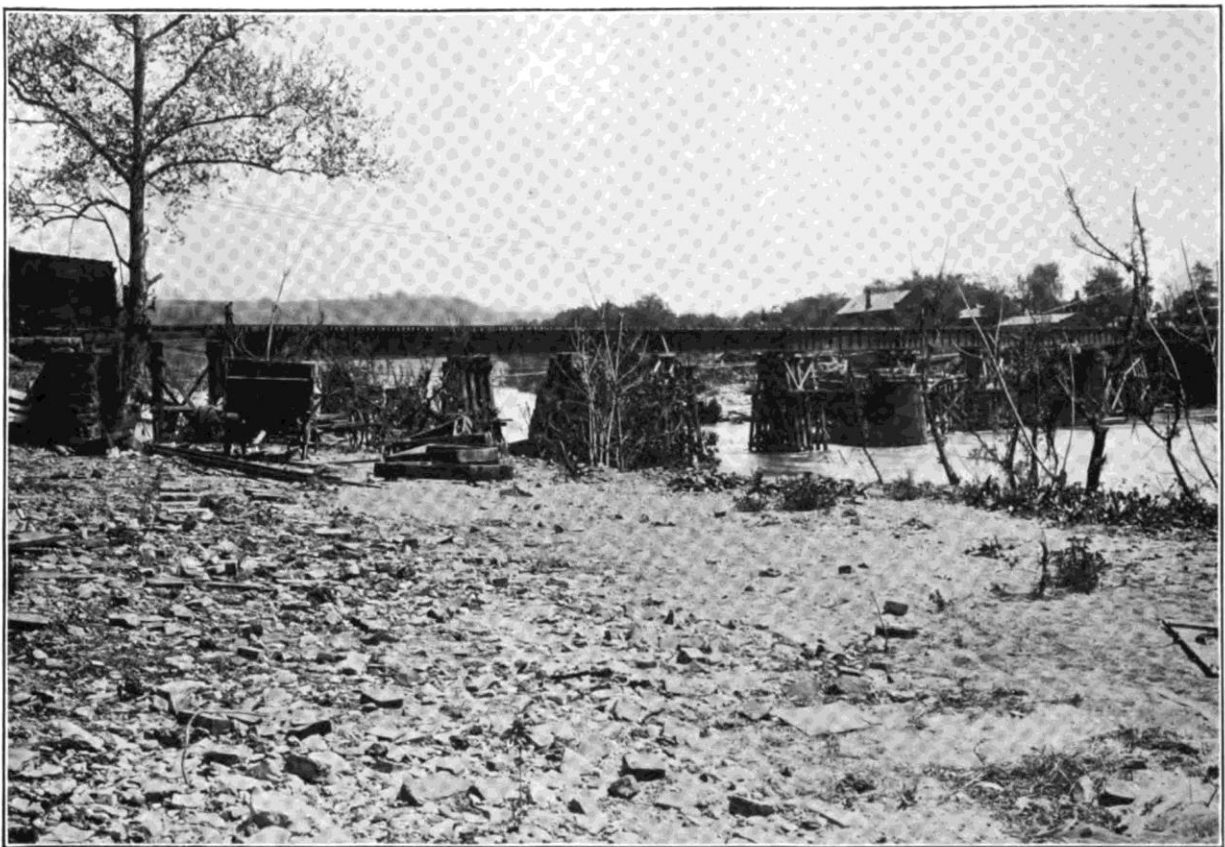
250 - Zanesville, Ohio – Temporary Bridge after flood for Bridge 20 over Muskingum River.

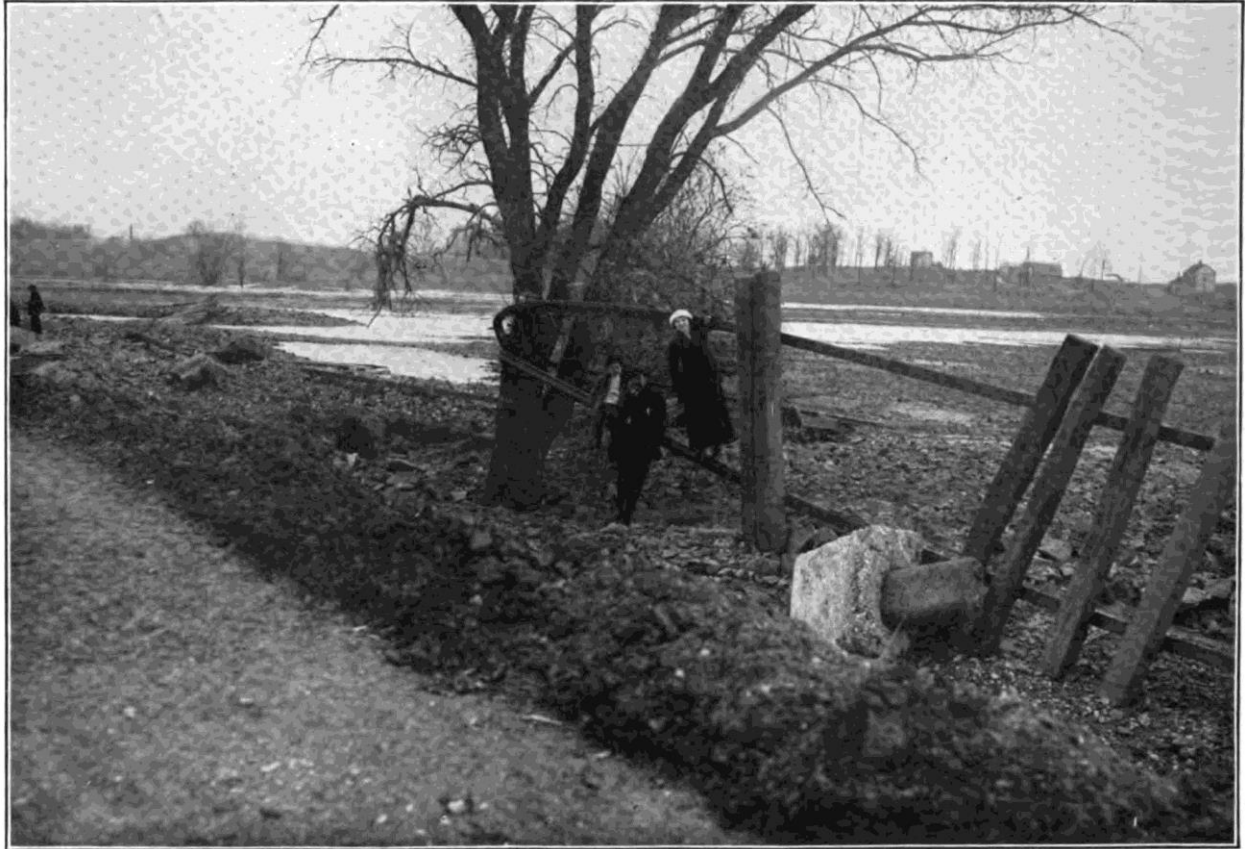
251 – If the houses and bridges that were washed down the river were not enough evidence of the power of the flood waters, this section of track over the Scioto River in Ohio was literally wrapped around a tree!
