## Historic Bridge Foundation Facebook Archives

### Focus Bridge: Rio Hondo Bridge, Lincoln County, New Mexico

Focus Bridge: Rio Hondo Bridge, Lincoln County, New Mexico

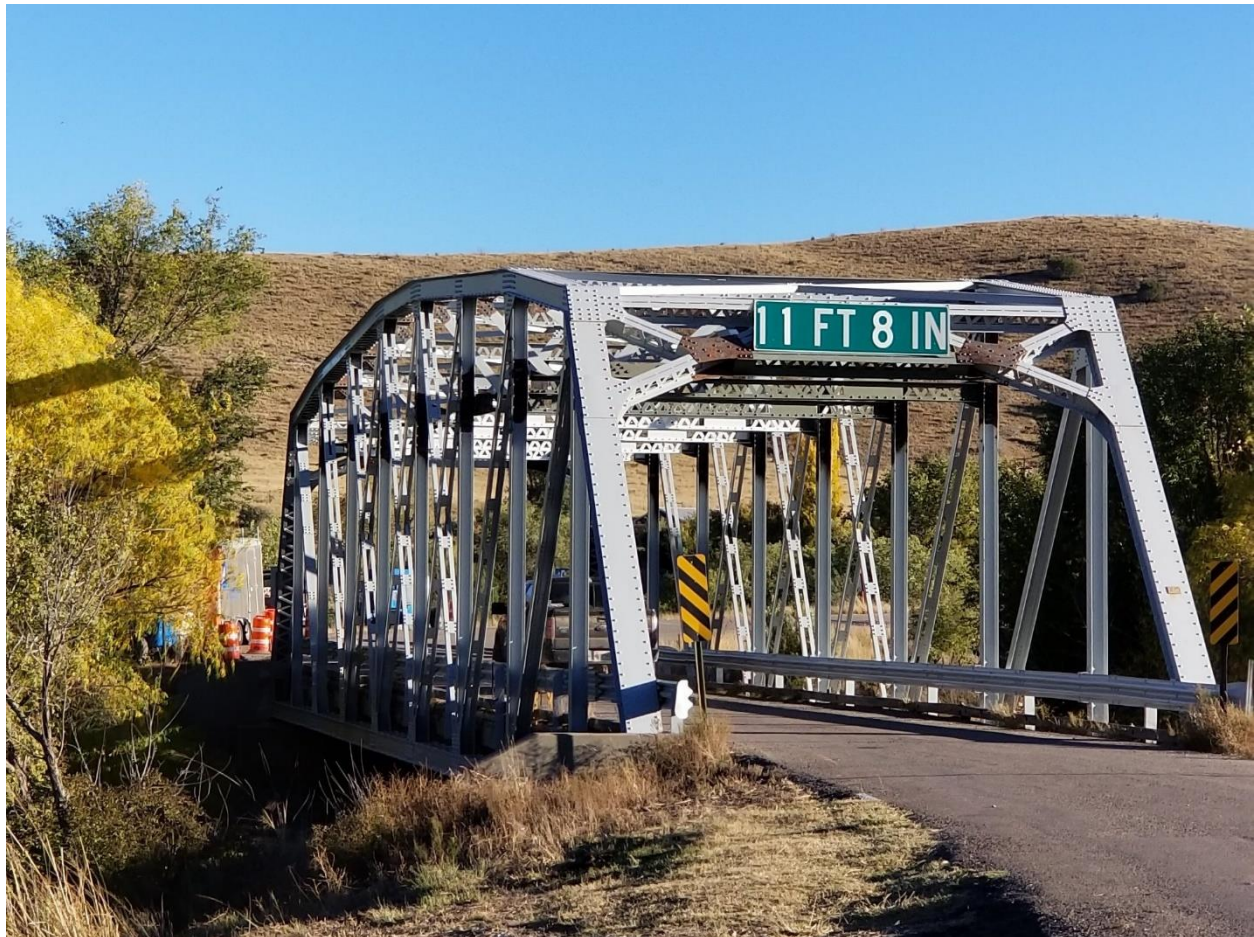
Bridge after restoration by Bach Steel, awaiting repainting.

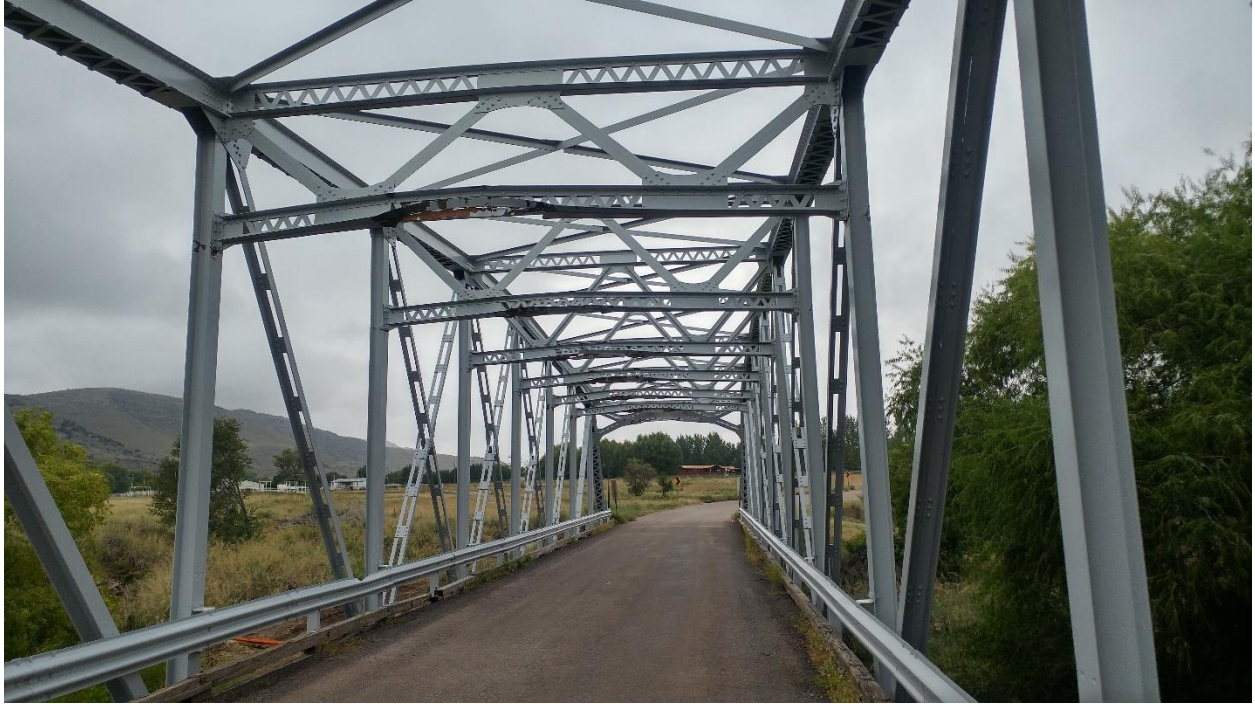
General view of bridge prior to repair. Note the damaged overhead sway bracing.

The Rio Hondo Bridge carries Highway 395 over Rio Hondo in Lincoln County, New Mexico. The bridge was originally built in 1927 to carry the famous Route 66 over Arroyo Laguna near Montoya, Quay County, New Mexico. In 1953, a new bridge replaced it and the 1927 bridge was relocated to this location to Highway 395 in Lincoln County. The bridge was listed in the State Register of Cultural Resources in 1979, and is considered eligible for listing in the National Register of Historic Places. Unfortunately, the bridge became the victim of an over height truck that drove across the bridge, colliding with and damaging all of the overhead sway and portal braces. In order to repair this damage, the New Mexico Department of Transportation (NMDOT) proposed to repair the bridge using heat straightening to repair existing members where possible, and to replace the remainder of damaged members in-kind. Although not a busy bridge, the bridge is locally important with no short detour available. As such, fieldwork on the bridge was limited to no more than 30 days. Initially, the project proposed using bolts for the connections and built-up laced sway bracing instead of rivets. The State Historic Preservation Office supported this decision, concurring with a letter from NMDOT stating that “the rivets used for connections as the bridge was originally constructed are no longer used for the industry,” a statement which later turned out to be inaccurate. NMDOT awarded this project to TMI Coatings of St. Paul Minnesota. TMI Coatings in turn subcontracted the steel repair work to Bach Steel of Holt, Michigan. As a firm specializing in the in-kind restoration of historic metal truss bridges, including hot riveting, Bach Steel proposed using rivets for all repairs rather than bolts, with no increase in price. NMDOT agreed to this proposal, and the project proceeded using rivets in all areas of the work, making this the first known modern-day highway bridge project in New Mexico to use rivets. Bach Steel conducted a site visit to the bridge to take field measurements of the existing sway bracing, including not just basic dimensions, but also details such as the curved shapes of the gusset plates. The new steel was fabricated in the Bach Steel shop. For the built-up bracing members, this included shop riveting the v-lacing and angles. These fabricated parts were then shipped to New Mexico. Before the new bracing could be installed, the existing vertical members, which had been bent by the force of the truck’s

impact, required heat straightening. Additionally, the existing bracing had to be non-destructively removed from the bridge. Following this, the new bracing was field riveted into place. After completion of the steel work, TMI Coatings followed through with painting of the repaired portions of the bridge. The result of this project is a historic bridge that looks exactly the way it was when first fabricated in 1927, thanks to the combination of shop and field riveting employed for the project. Both field riveting and shop riveting for this project was completed using pneumatic rivet hammers and holder-ons, with the rivets being heated in a propane forge. Rivets were sourced from Jay-Cee Sales Inc. of Farmington, Michigan.

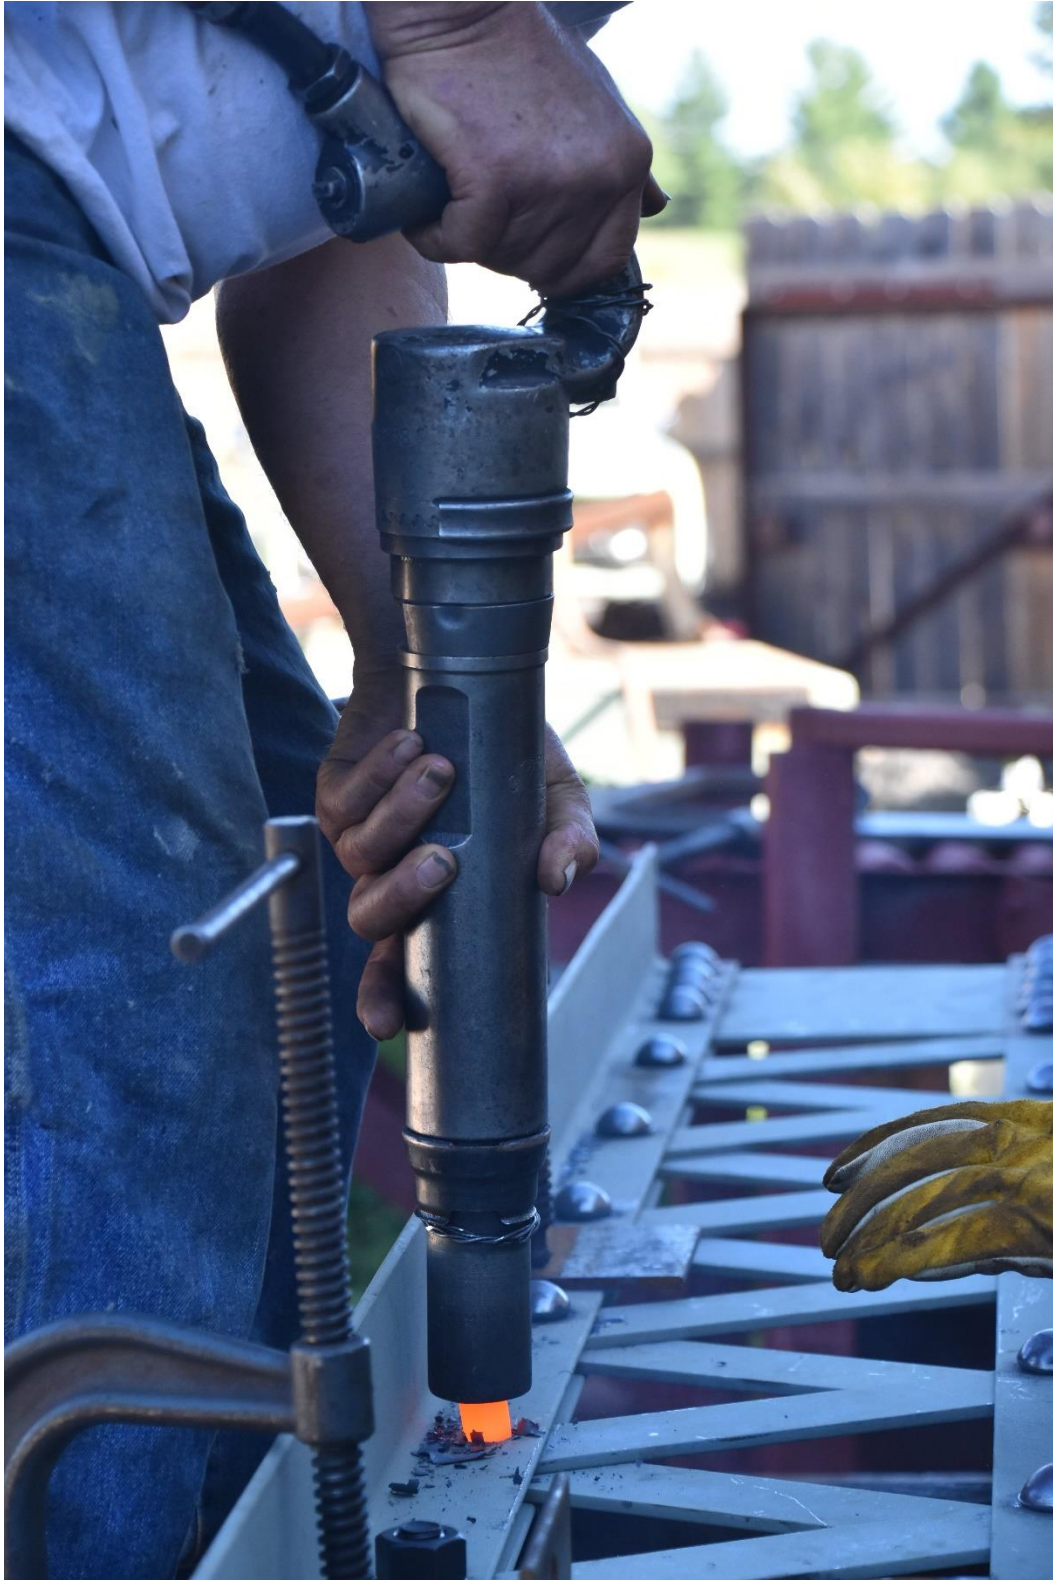
Riveting the replica sway bracing at the Bach Steel shop.

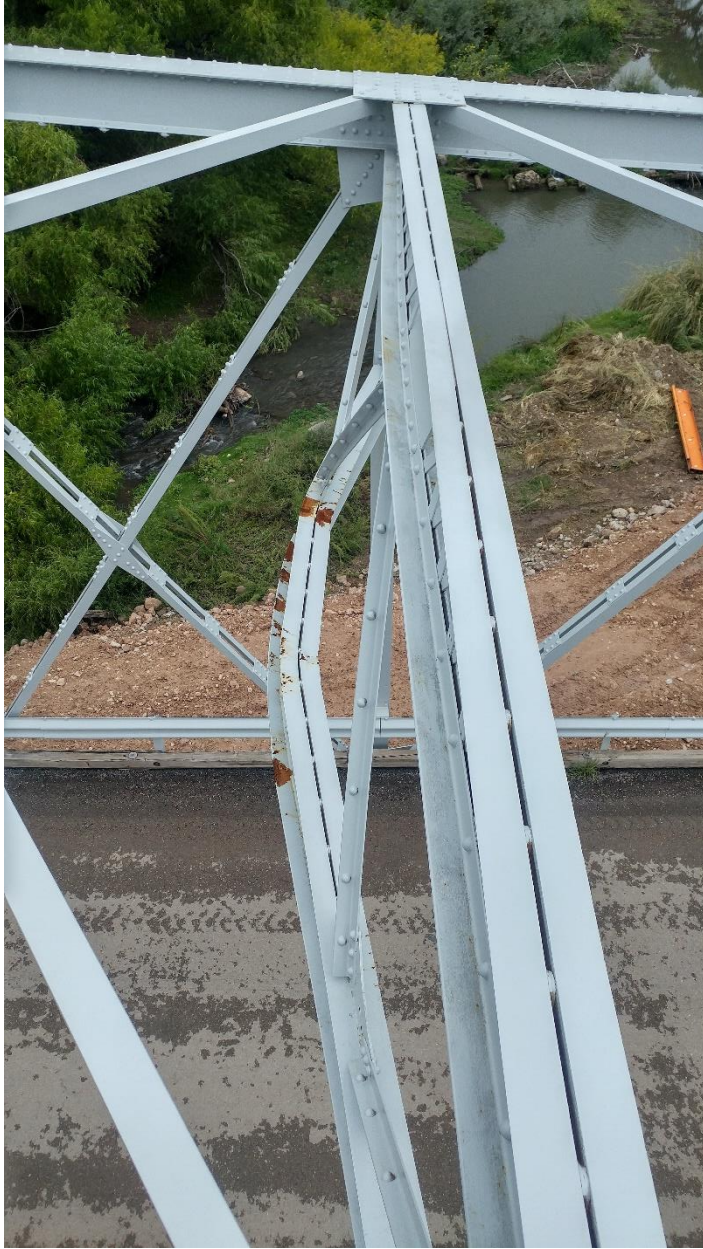
Bridge prior to repair. Note the bowed out and bent sway bracing beam.

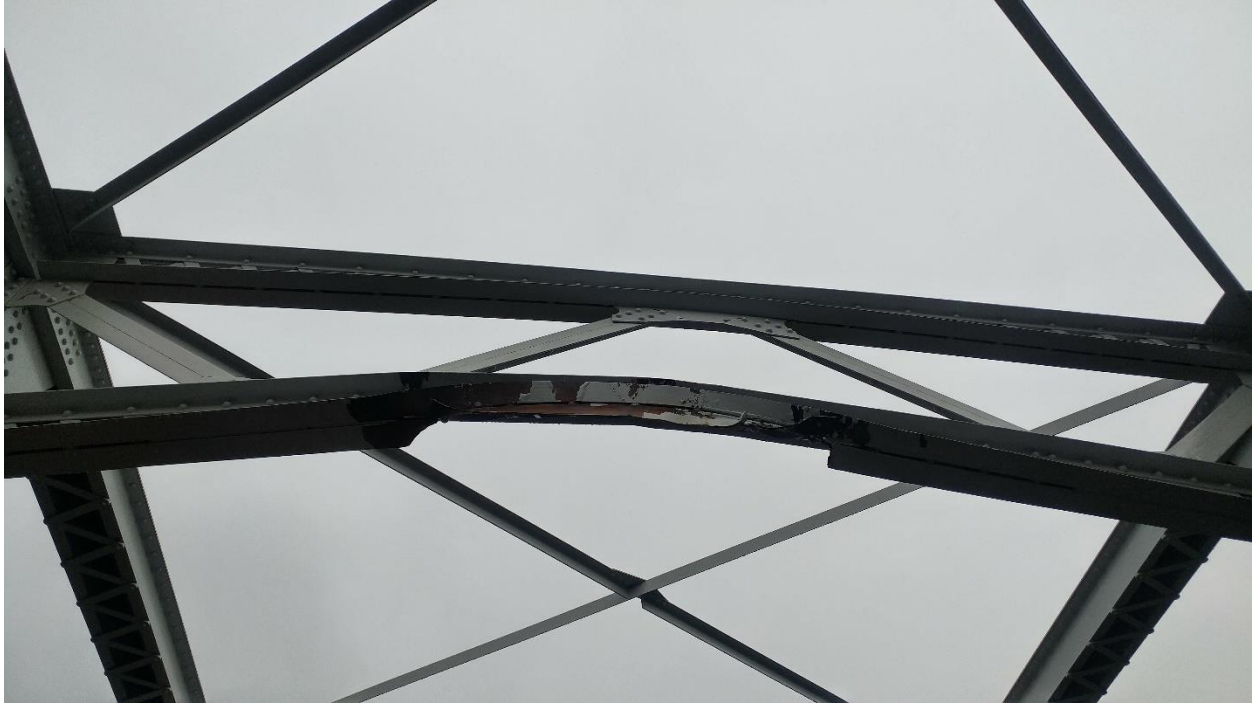
Bridge prior to repair. Note the damaged sway bracing angle.

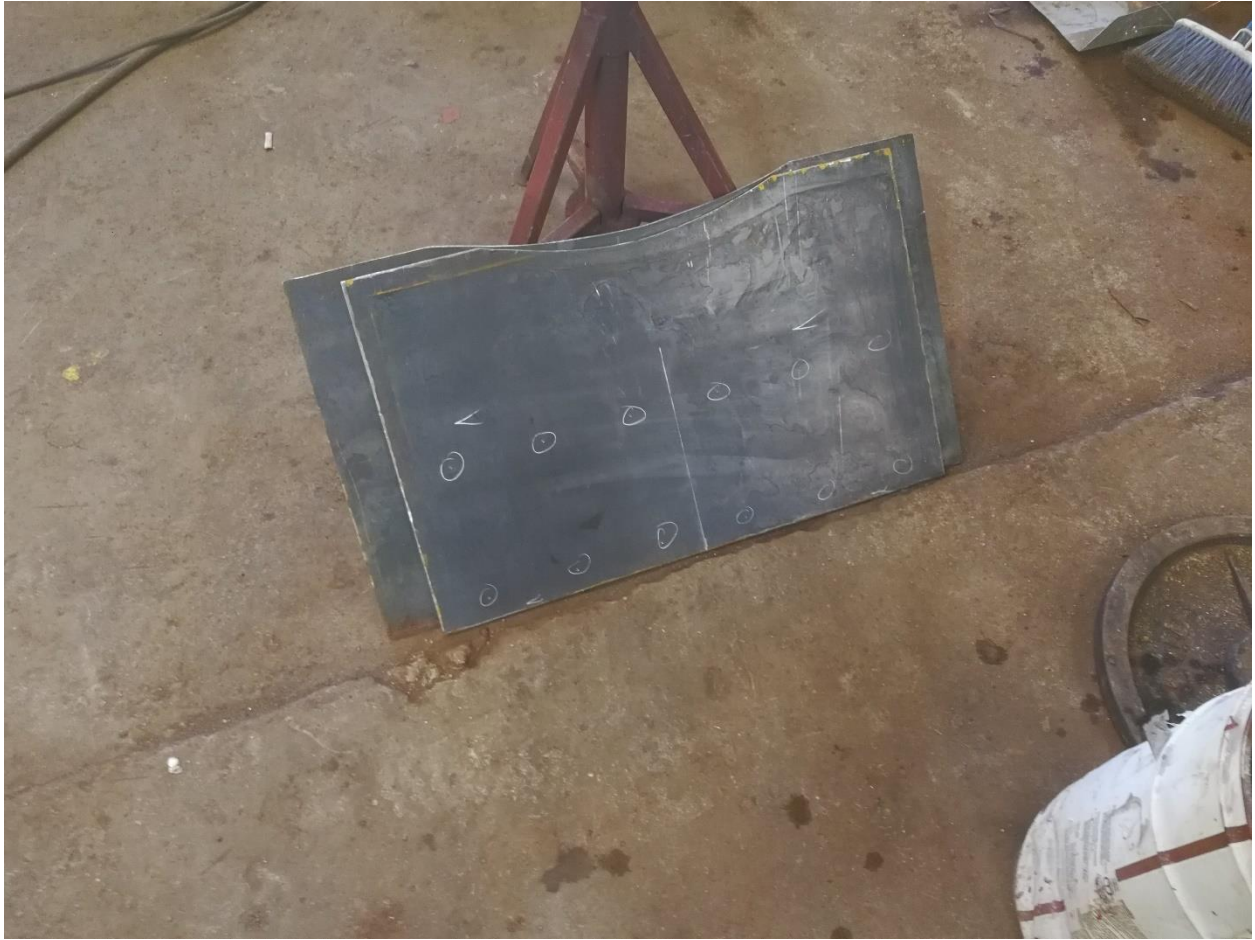
Shop fabrication of gusset plate.

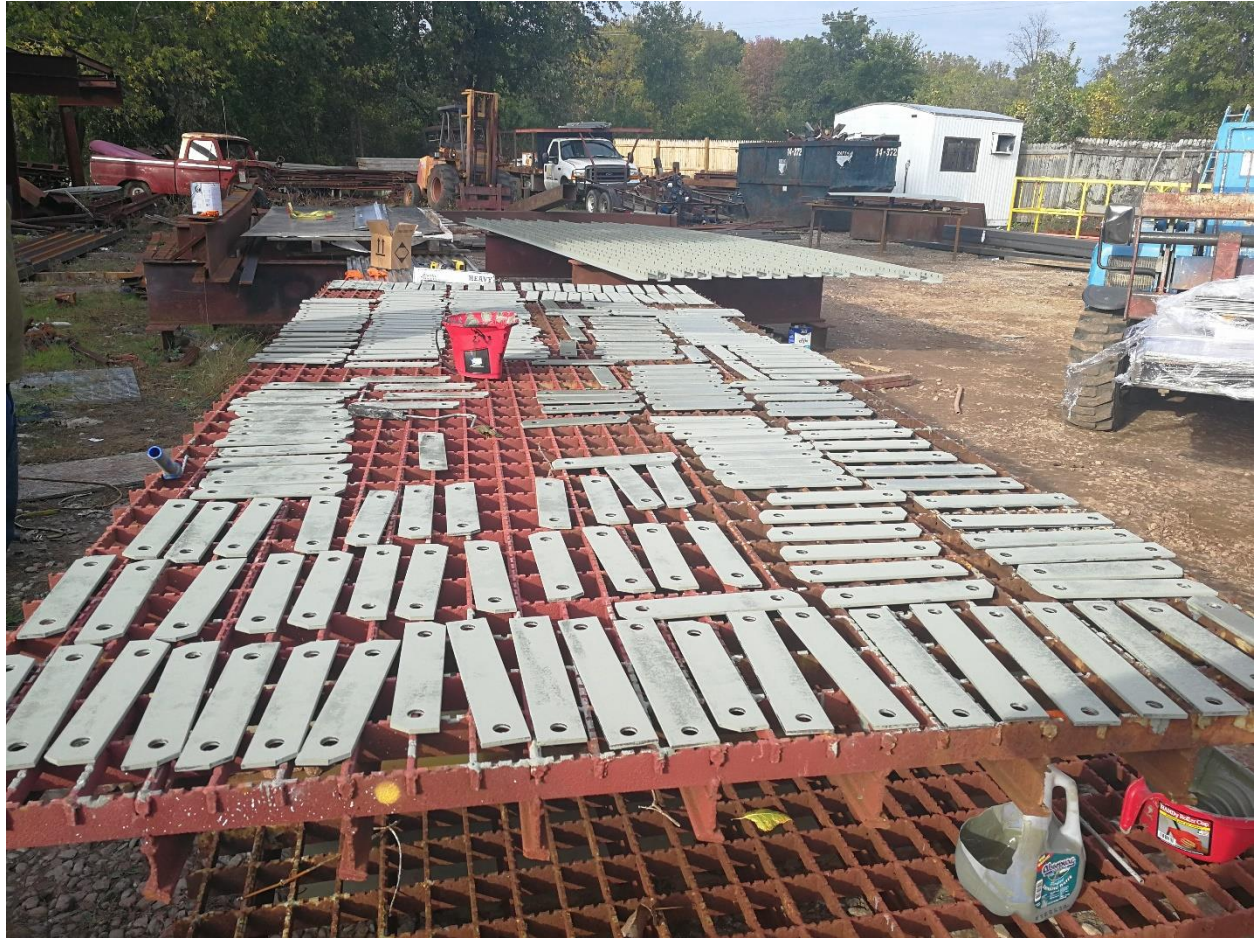
Shop fabricated lacing bars.

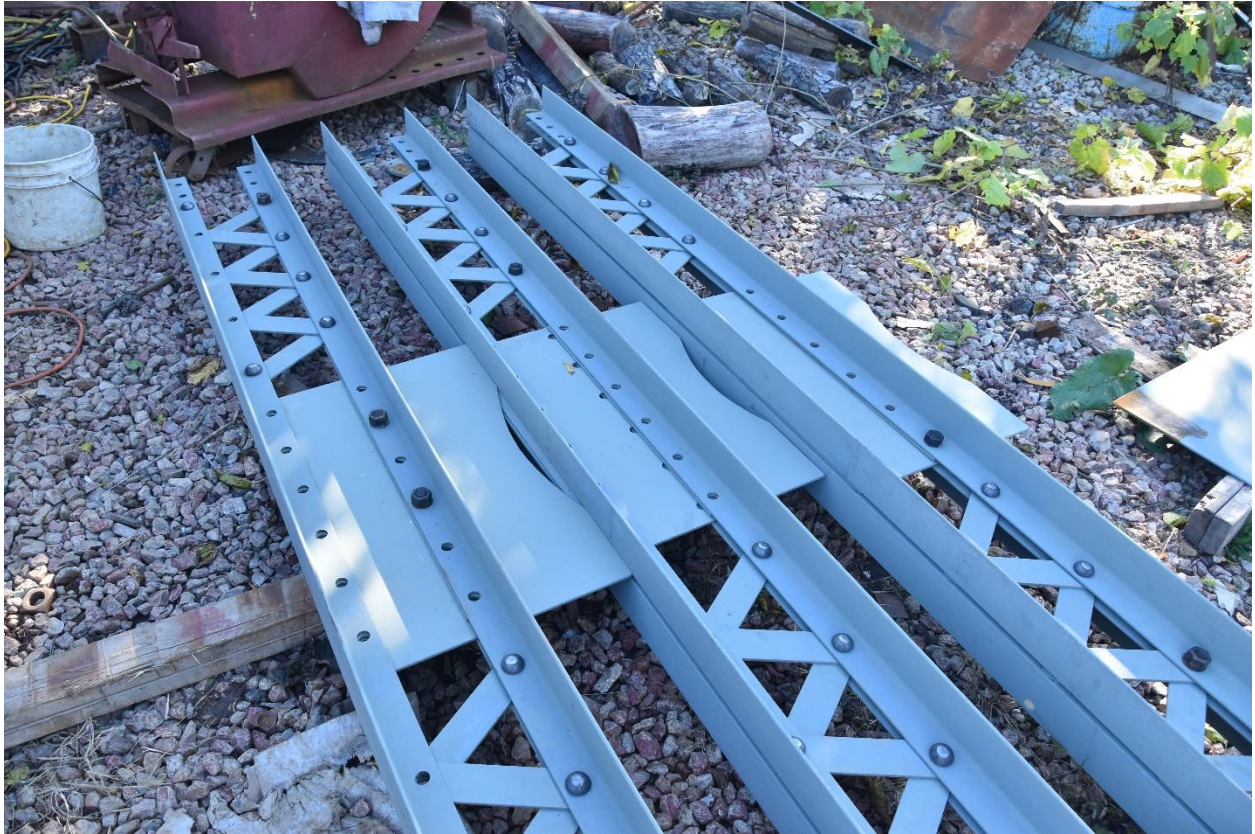
Shop fabrication showing completed fit-up of replica sway bracing, which prepared them for being riveted.

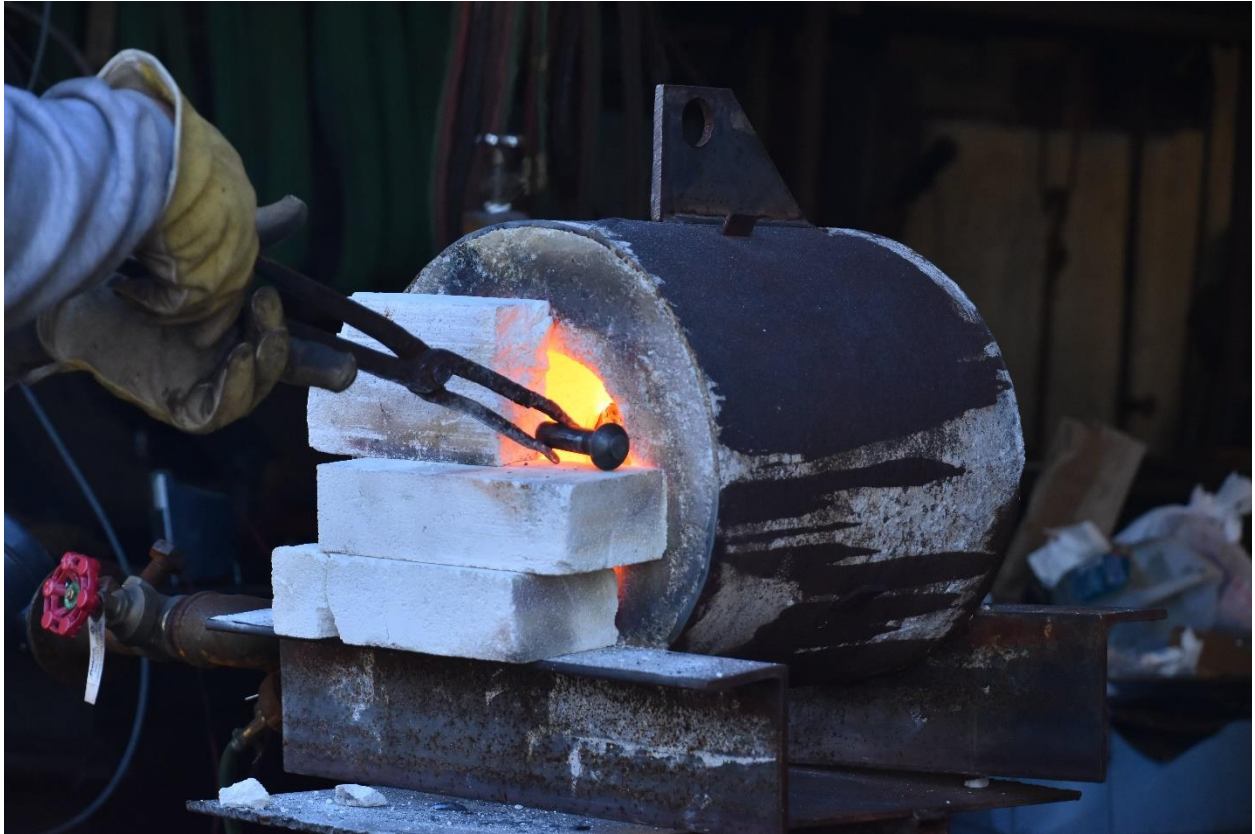
Shop riveting. This photo shows a cold rivet being inserted into the forge to be heated.

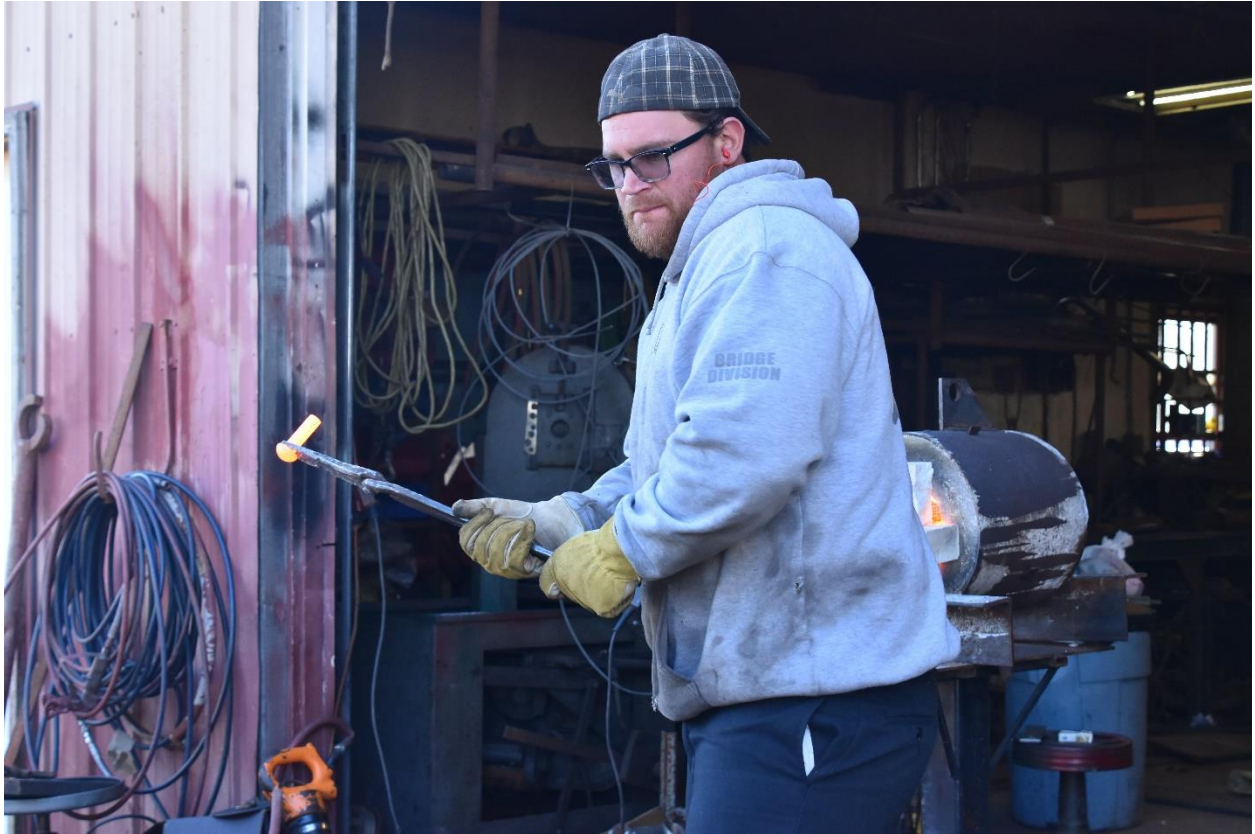
Shop riveting. This photo shows a hot rivet being removed from the forge for installation.

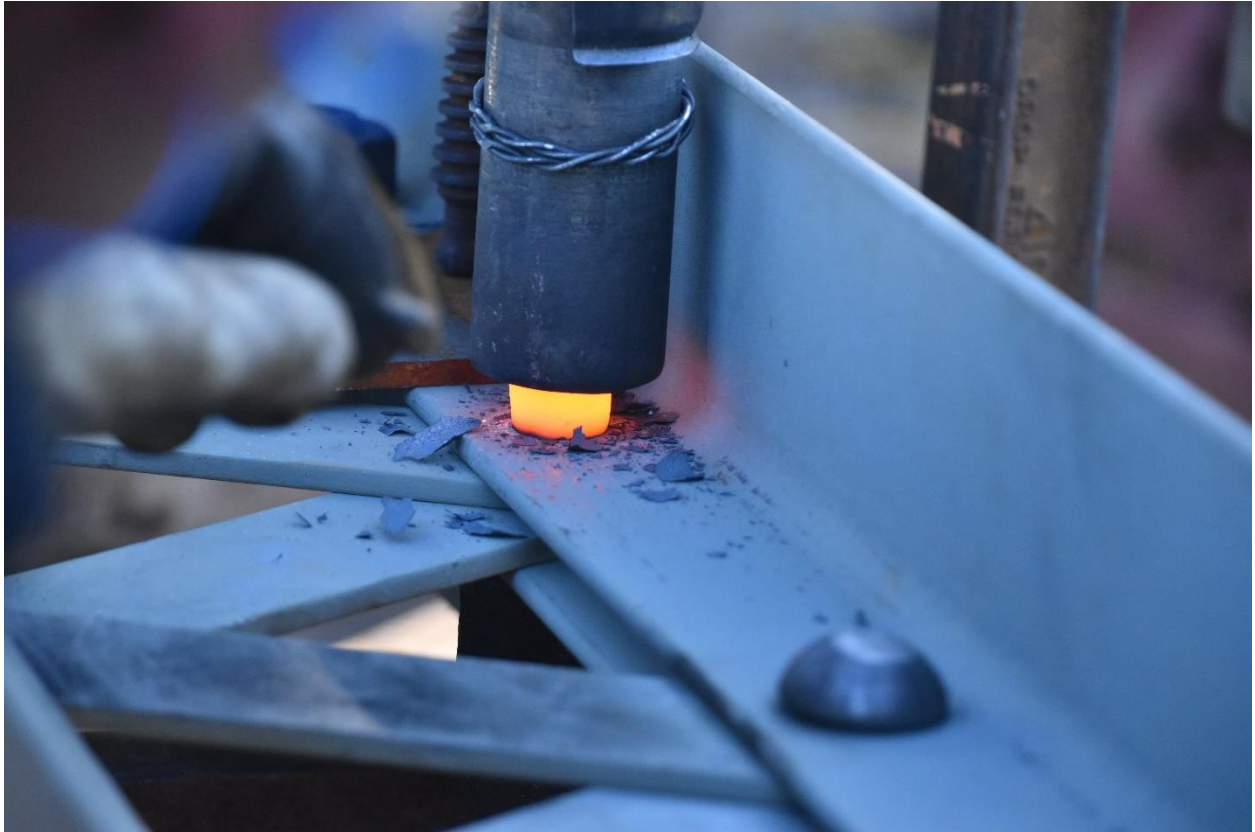
Shop riveting. This photo shows a rivet being driven into place on the replica sway bracing.

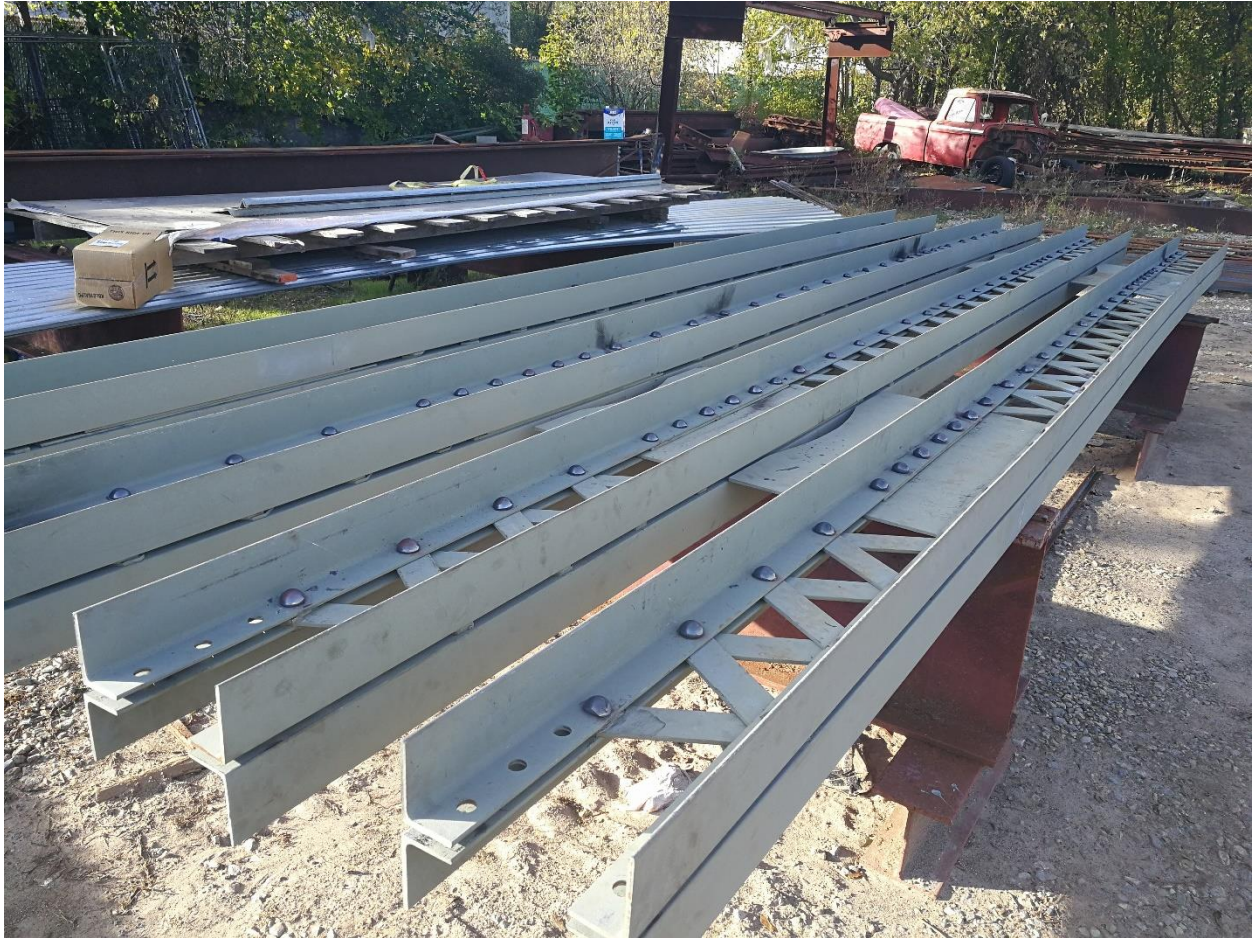
Completed replica sway bracing, with all shop rivets installed.

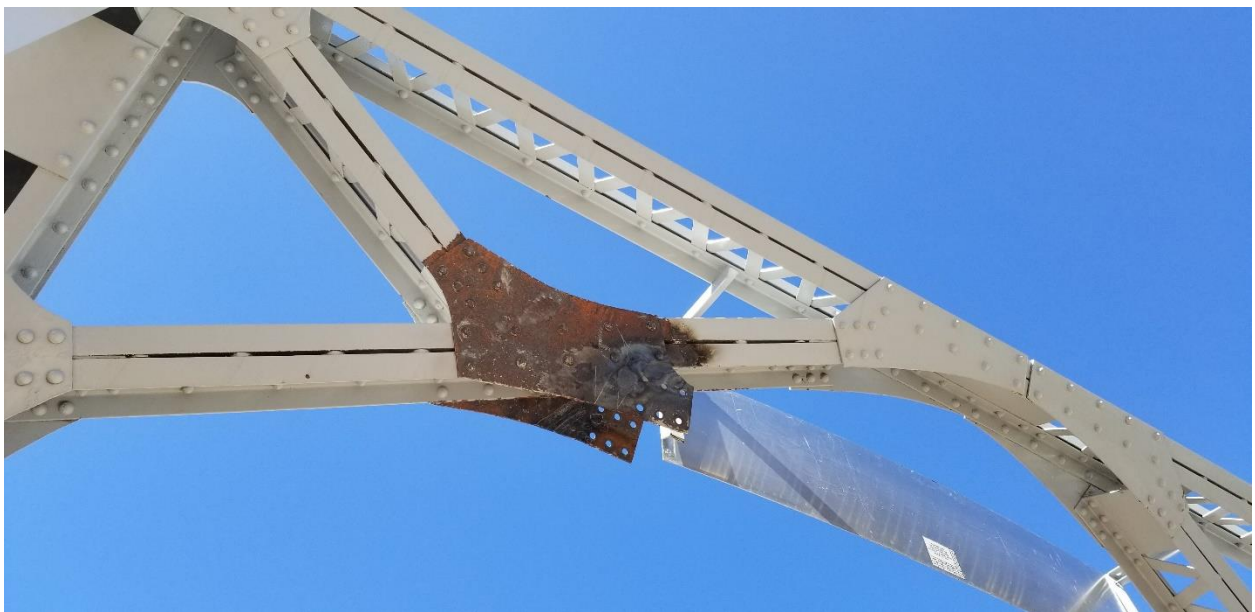
Field repairs in progress. Note the removed section of damaged portal bracing to the right in the photo.

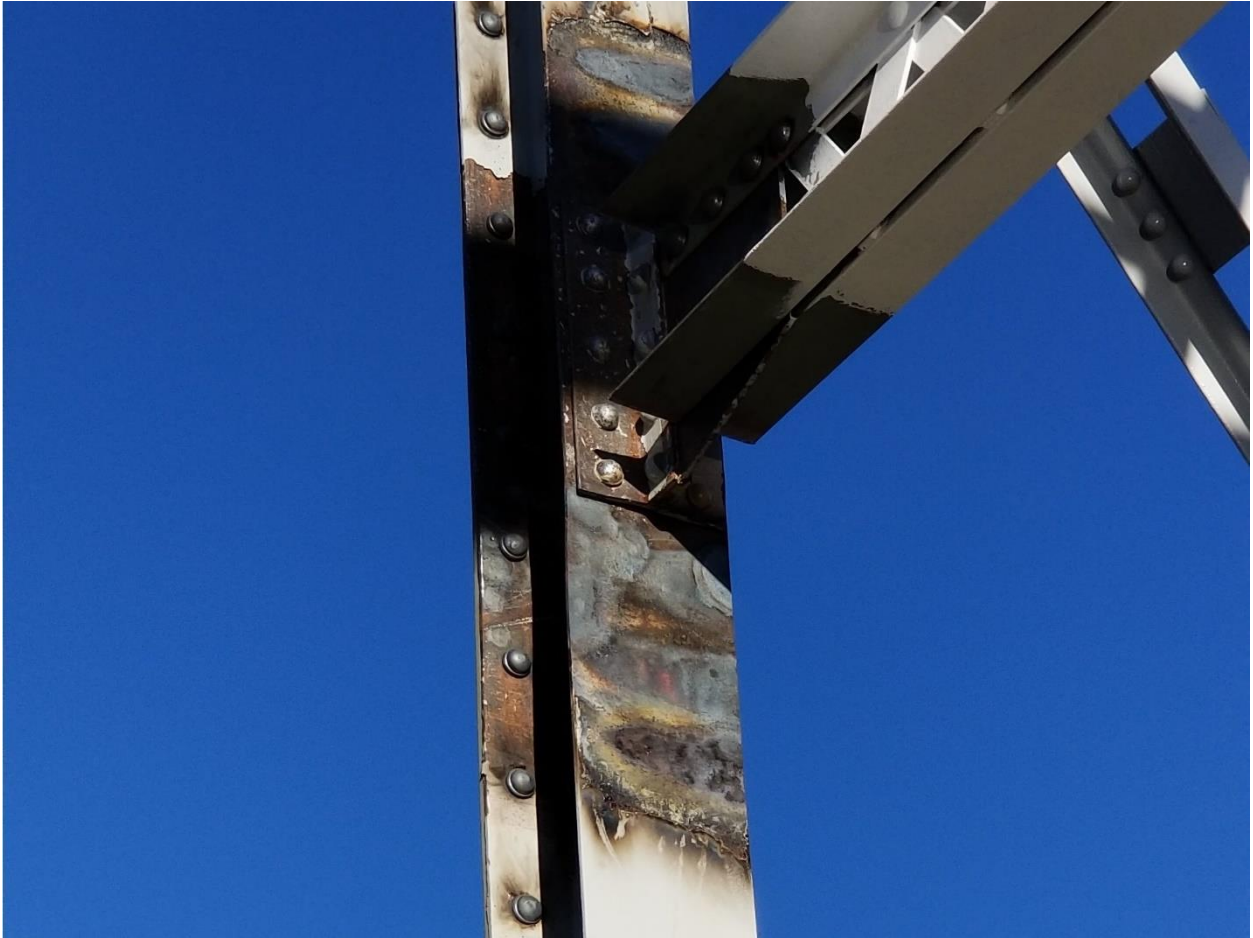
Field repairs in progress. The photo shows the newly installed replica sway bracing. Note the new field rivets connecting the sway bracing to the vertical member.

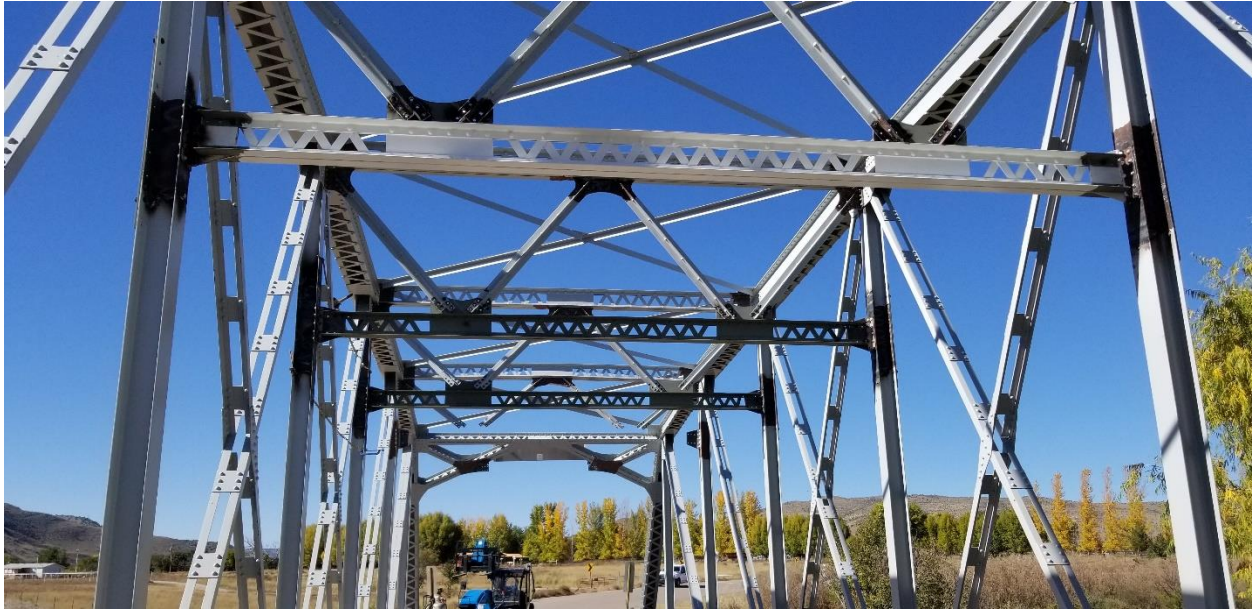
Field repairs in progress. The photo shows the newly installed replica sway bracing. Note the new field rivets connecting the sway bracing to the vertical member.

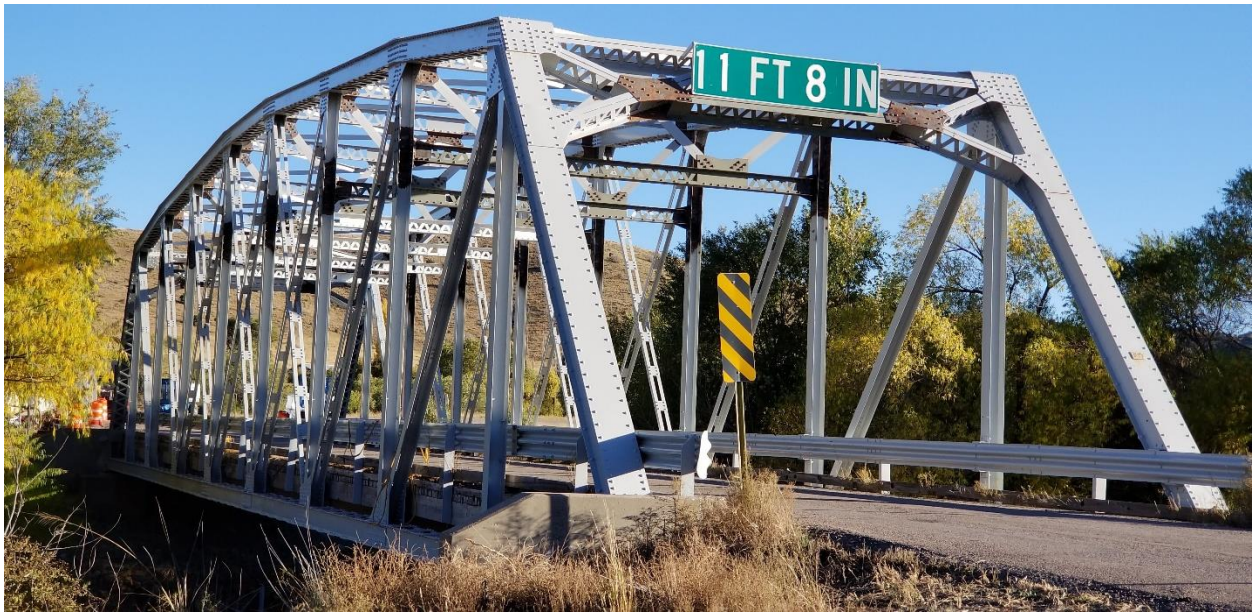
Bridge after restoration by Bach Steel, awaiting repainting.
