Historic Bridge Foundation Facebook Archives

Did You Know... That all of Budapest's bridges were bombed and nearly destroyed in World War II?

August 2017

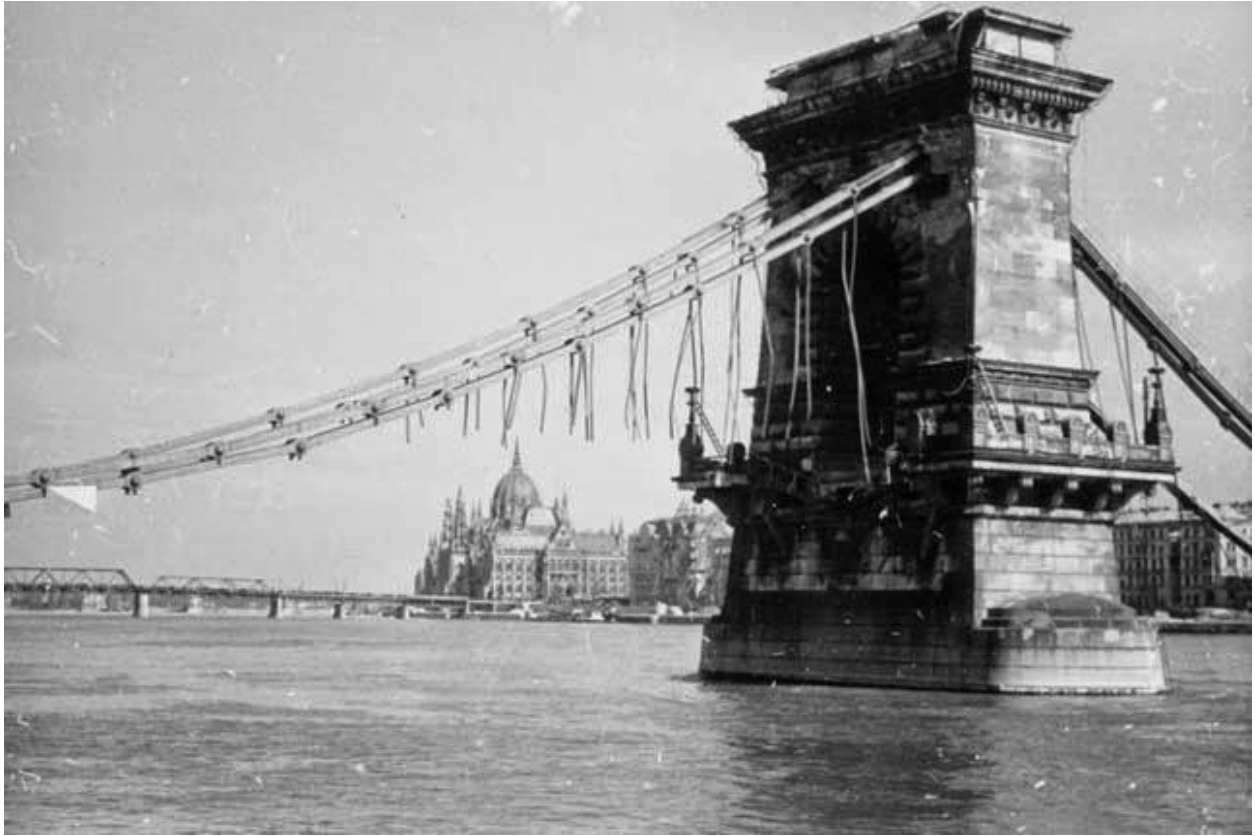
Chain Bridge after destruction showing surviving towers and main eyebar chain.

siege that had put holes in the deck, a final bombing tore the entire deck, stiffening trusses, and most of the suspenders from the main eyebar chains. Historical photos show even the lions were not spared destruction, however the towers remained largely intact. The bridge was rebuilt in 1949, reusing at least the towers, and replicating the original design to a surprising extent. The most significant change may be that the possible original cast iron stiffening trusses (located between the sidewalks and the roadway) were replaced with riveted steel trusses. The sidewalk railings which originally appear to have had the same design as the stiffening trusses were replicated in-kind as cast iron/steel.

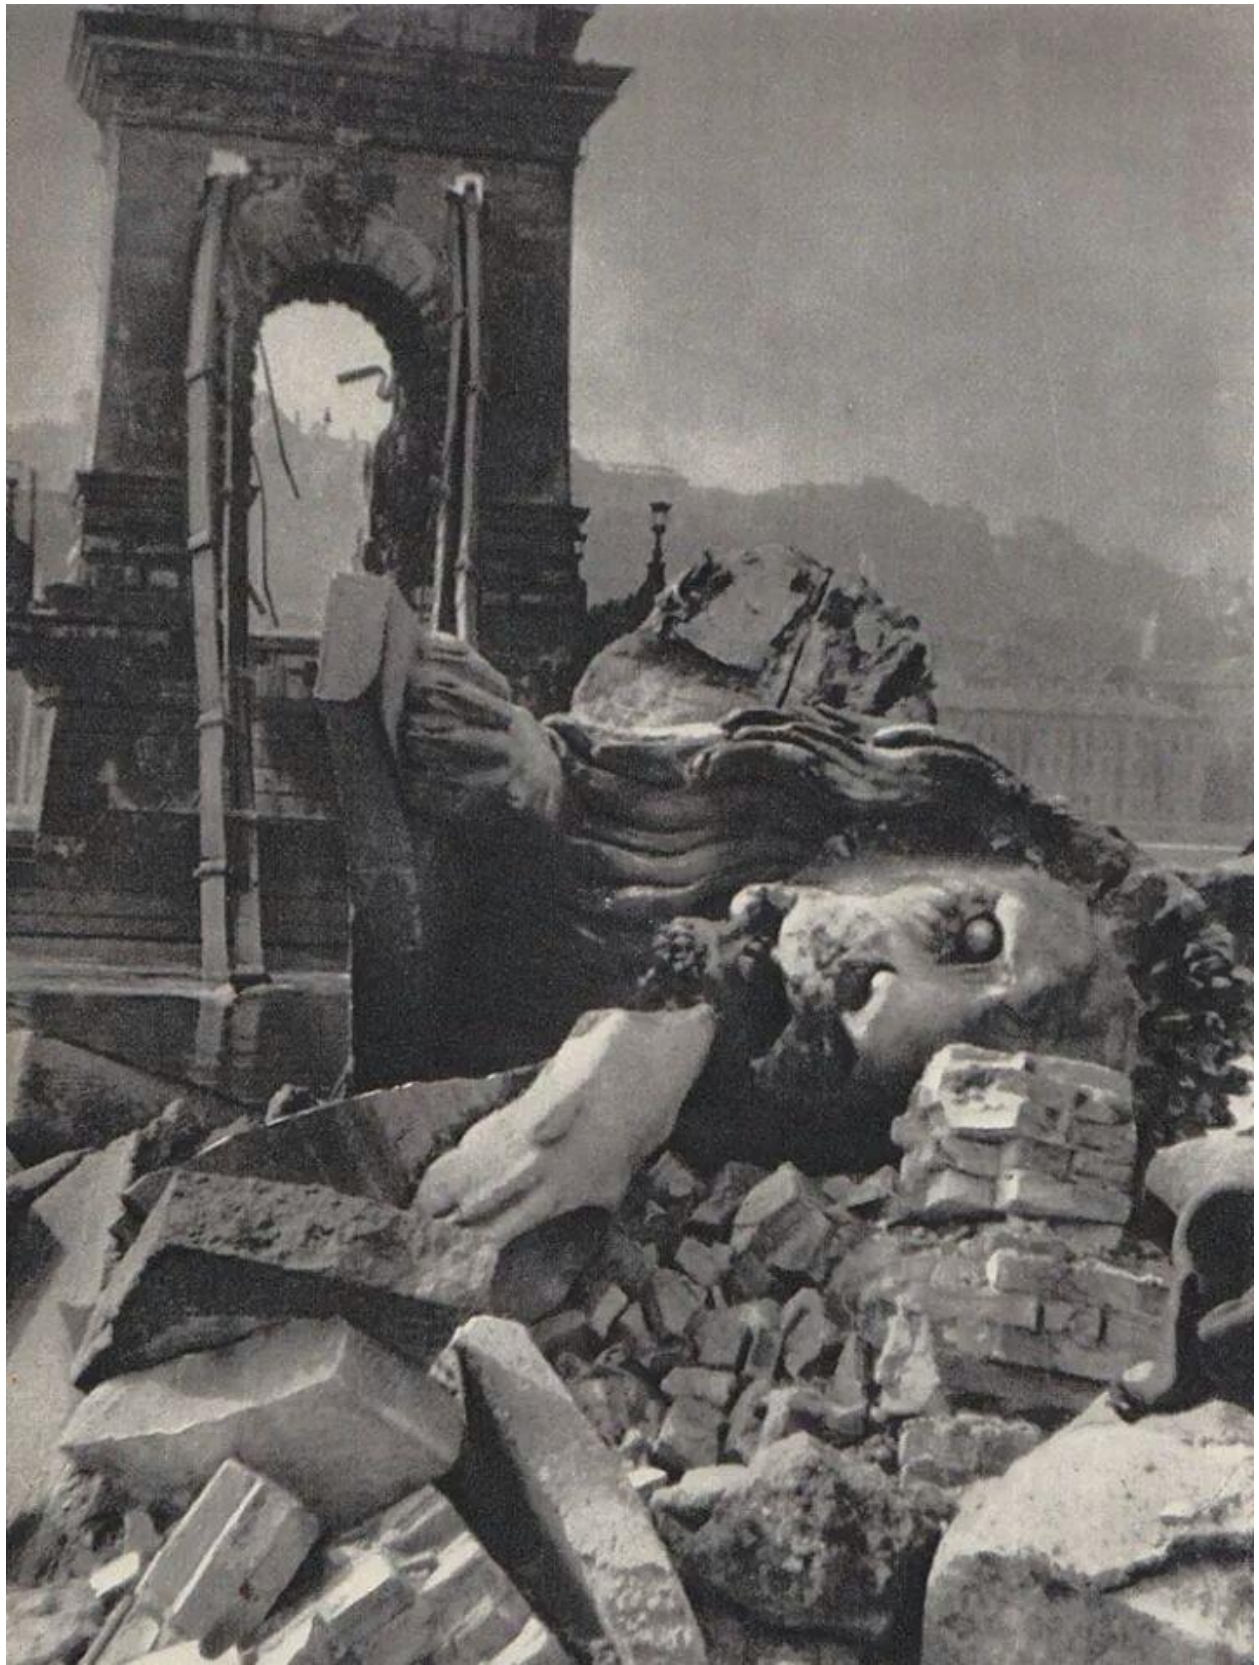
Chain Bridge after destruction showing destroyed lion statue.

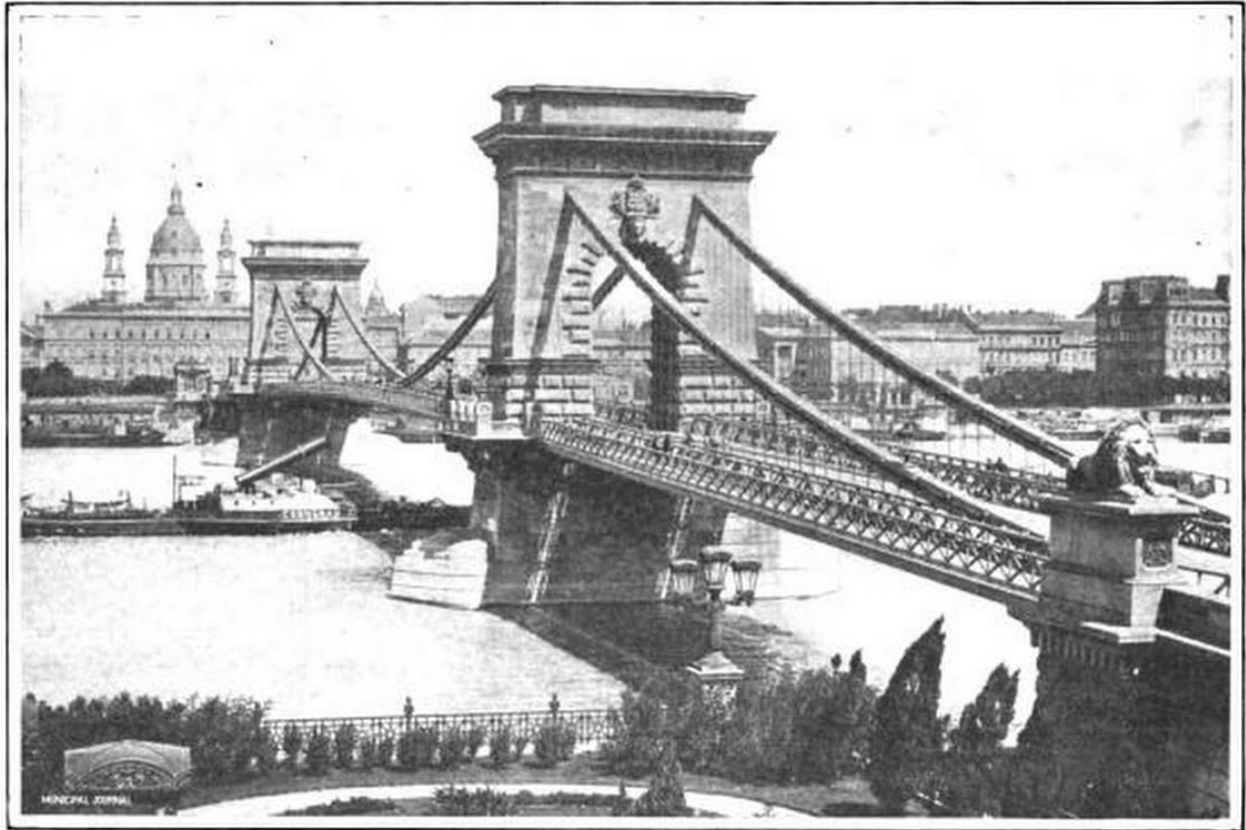
Taken around 1904, this photo shows the Chain Bridge before the war.

The oldest and most famous of the bridges in Budapest, the Széchenyi Chain Bridge (Széchenyi Lánchíd), often called simply the Chain Bridge, was built in 1849, and is an eyebar chain suspension bridge with stone towers and distinctive lion statues at the ends of the bridge. After suffering damage during the

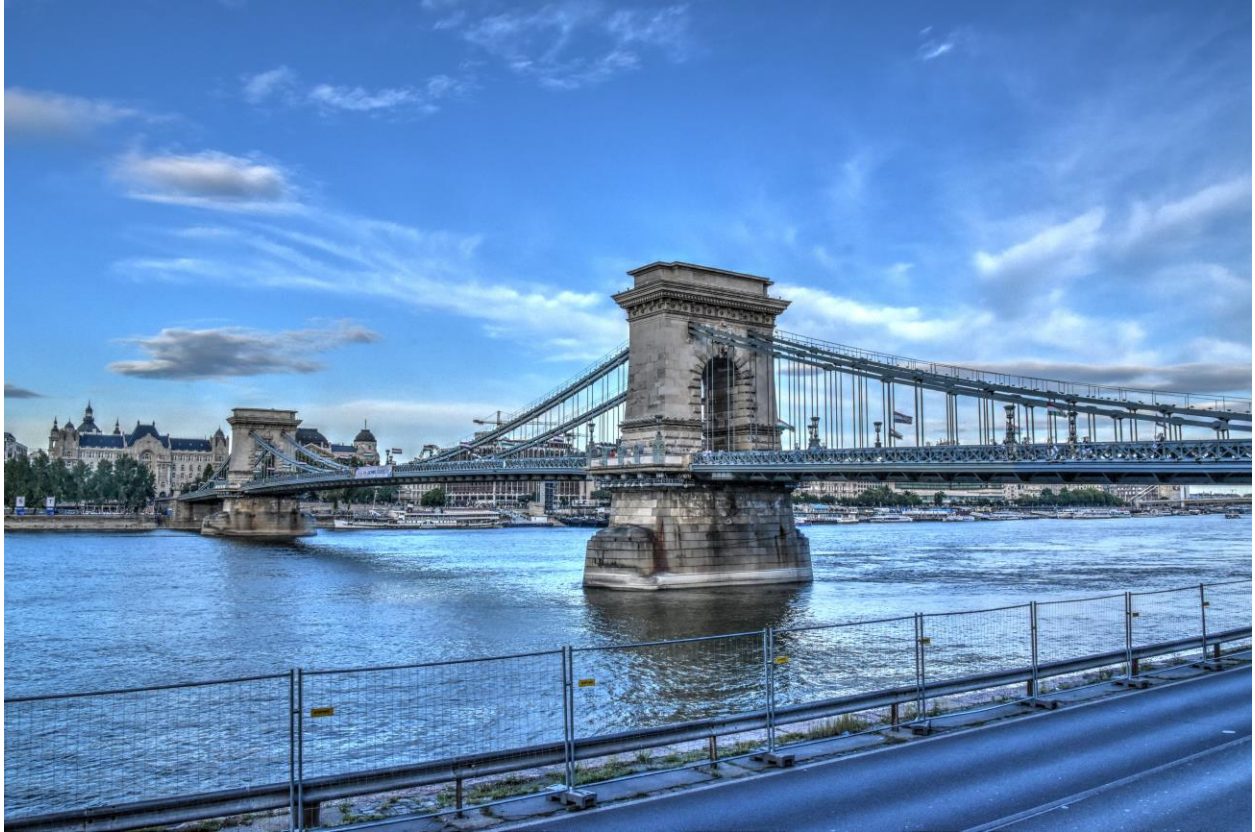
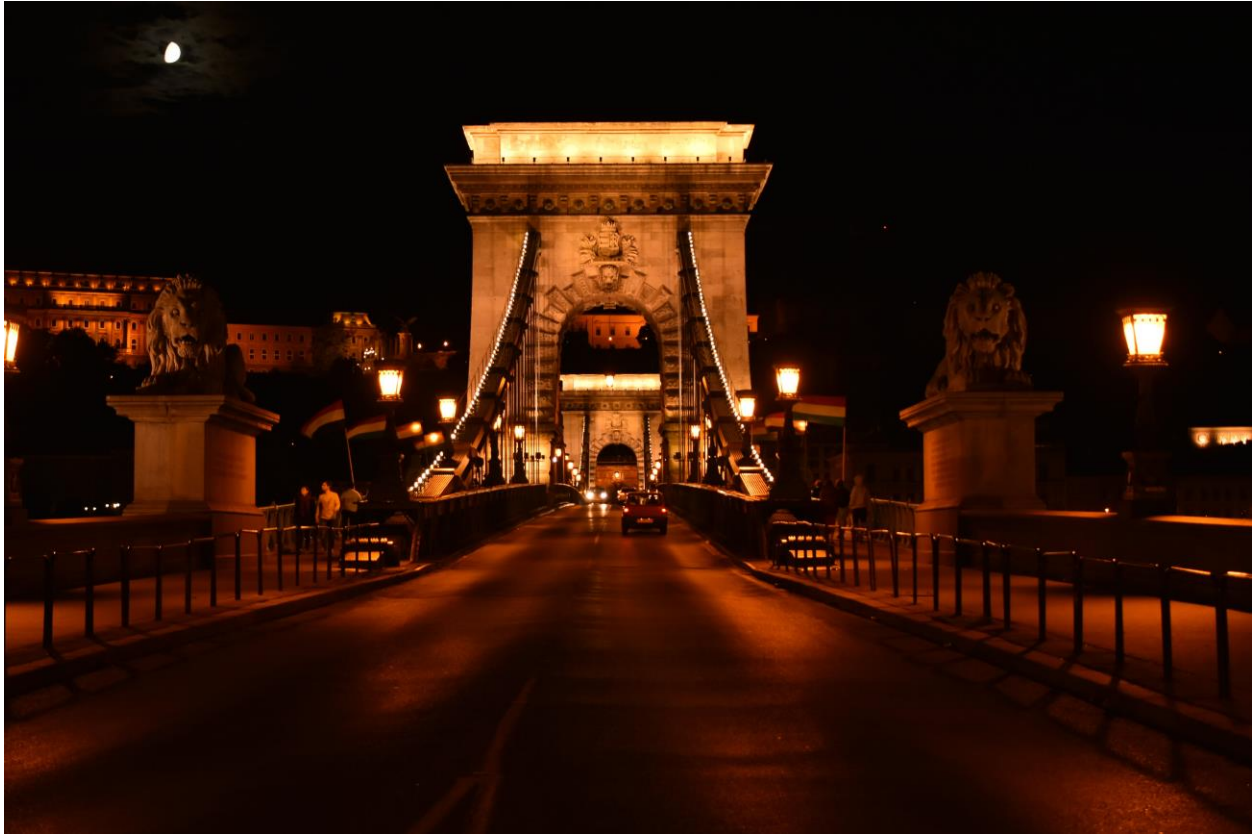
Chain Bridge as seen in 2017.

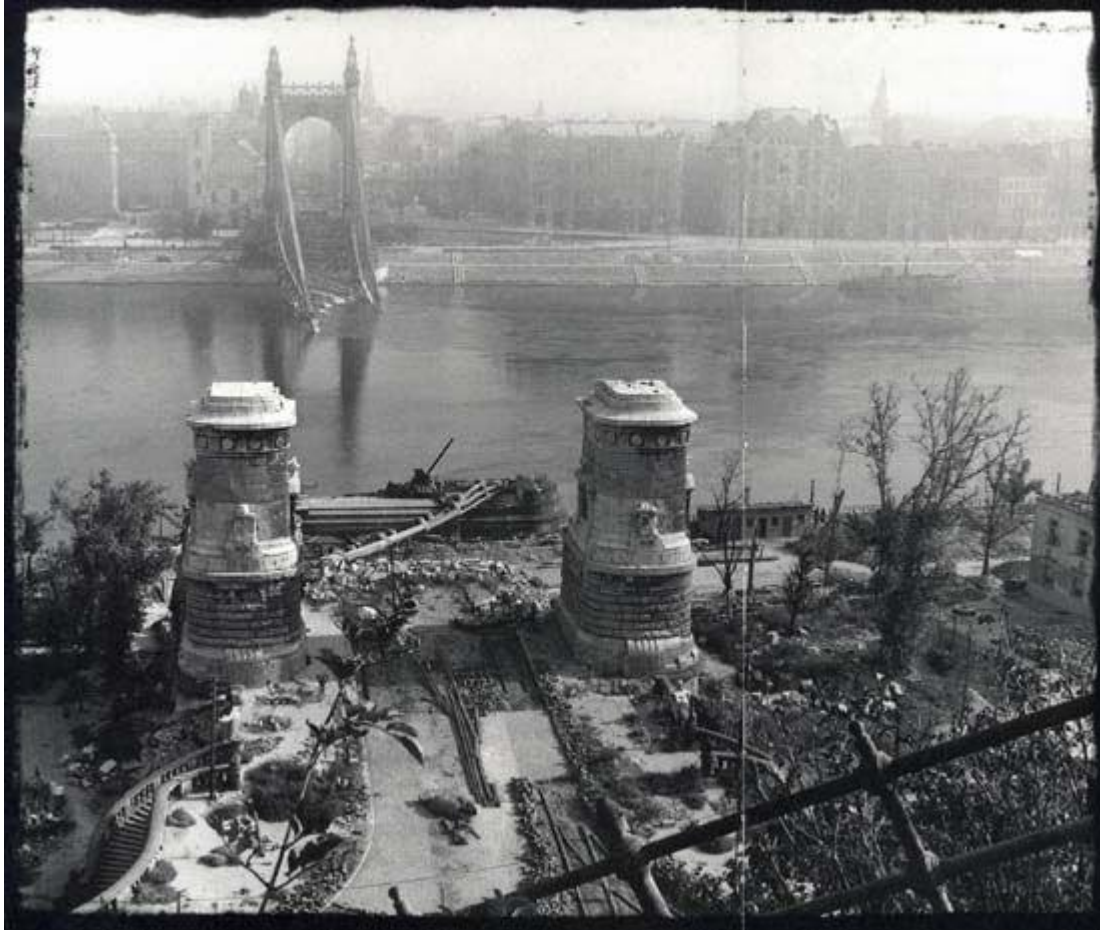
The 1903 Elisabeth Bridge as seen after destruction. Note that one tower was completely destroyed, but the other one is mostly intact.

The Elisabeth Bridge (Erzsébet híd) stands out because the pre-war design was not replicated. The original bridge was built in 1903, and it received significant attention in the engineering periodicals of the time. The bridge was an eyebar chain suspension bridge with rich ornamentation. The design and aesthetics of the bridge was purposely made to be different from other bridges in the city because it was felt that replicating the design of one of the other bridges would have been too monotonous. The war destroyed most of the bridge, with the exception of one tower and one adjacent backstay span. These ruins remained standing until a simple, modern wire cable suspension bridge with steel riveted towers and stiffening girders was erected in its place in 1964.

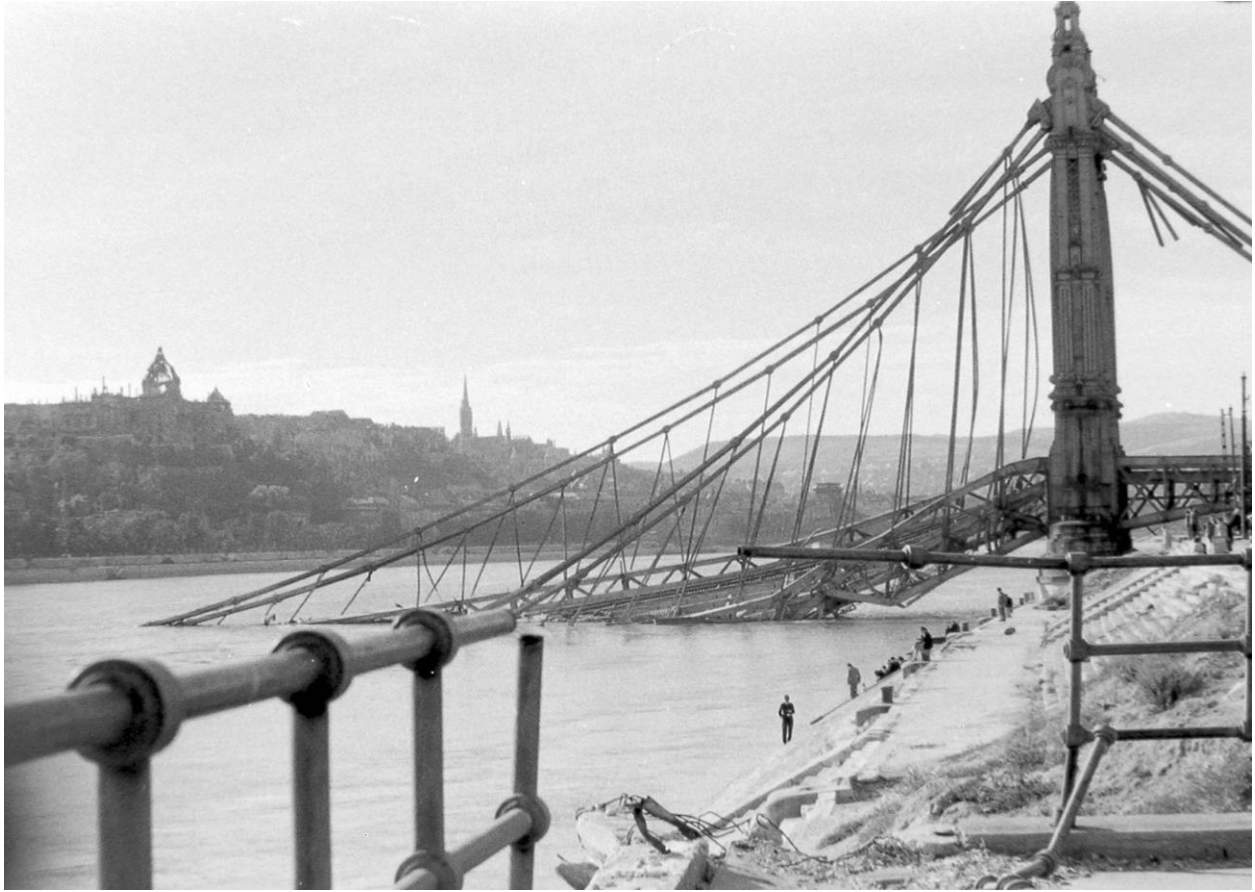
The 1903 Elisabeth Bridge as seen after destruction, showing the tower that did not collapse. Also note to the far right that the non-suspended truss span appears to be intact.

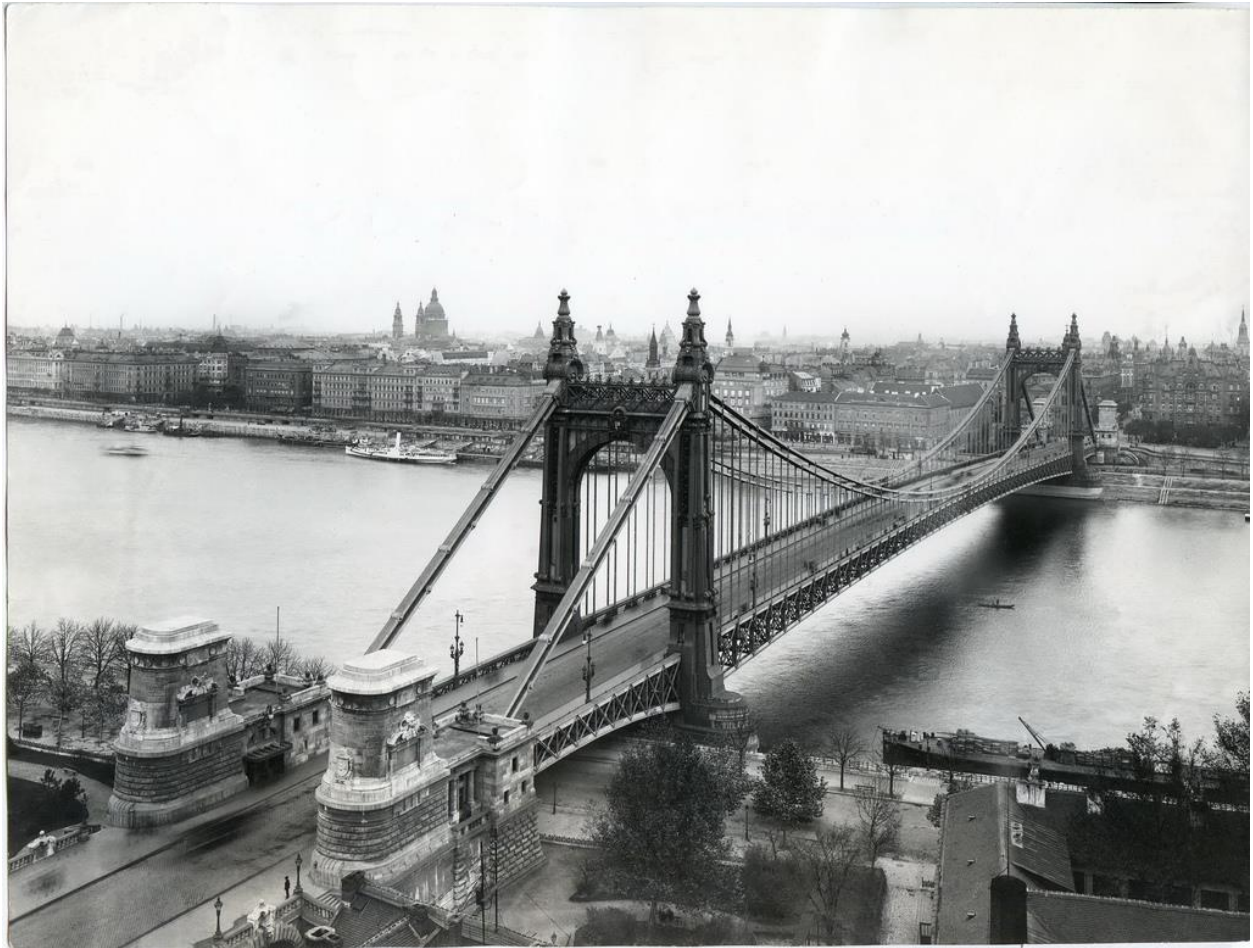
The 1903 Elisabeth Bridge as seen before the war.

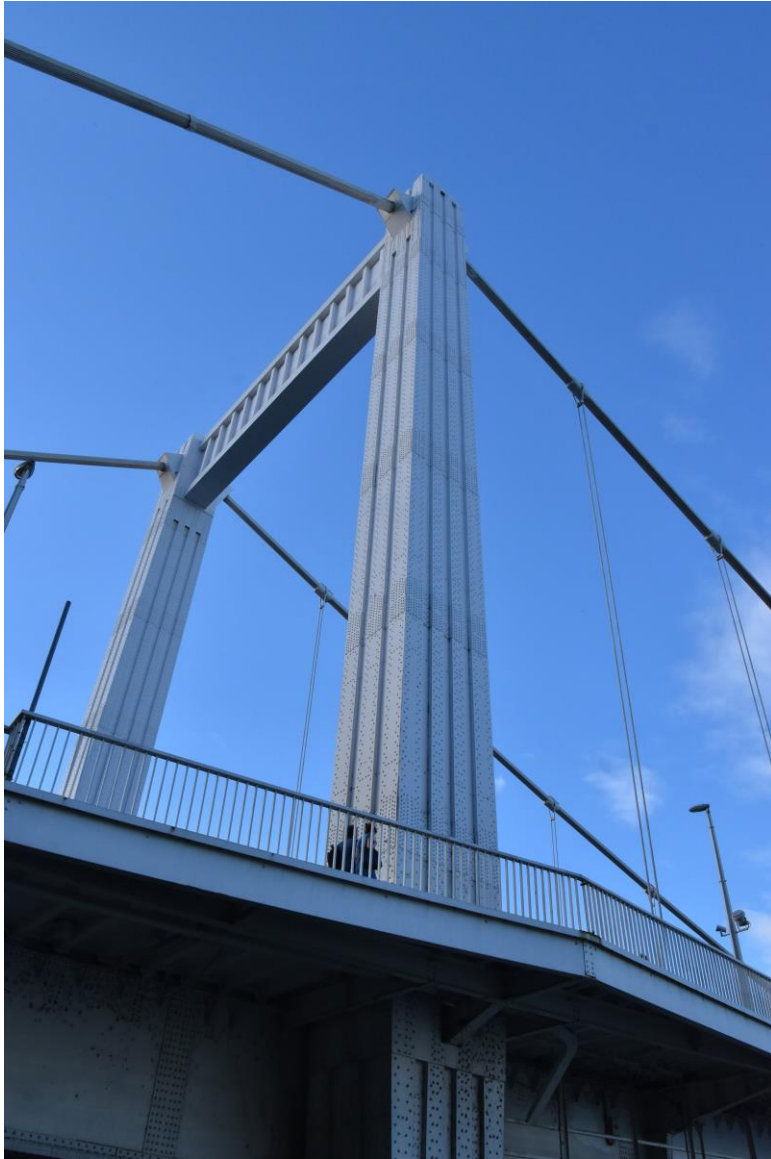
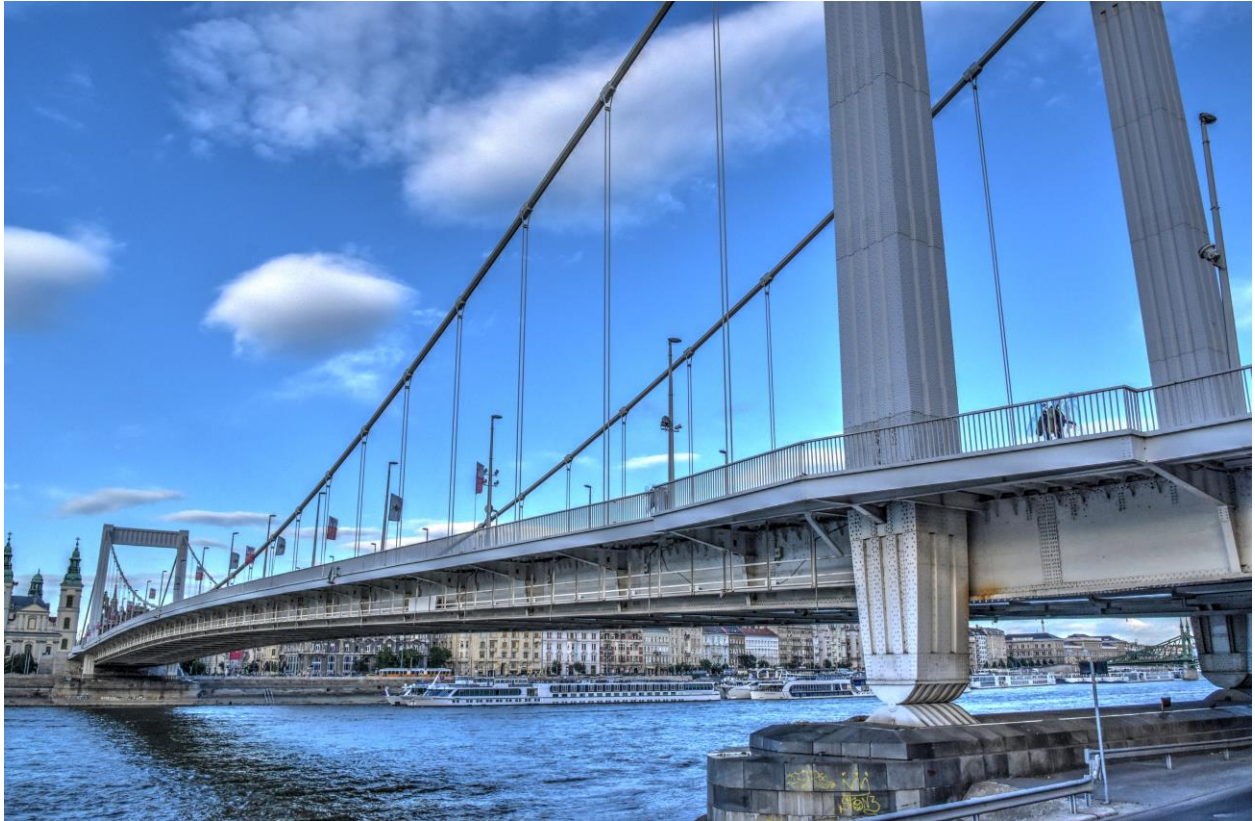
The 1964 Elisabeth Bridge as seen in 2017.

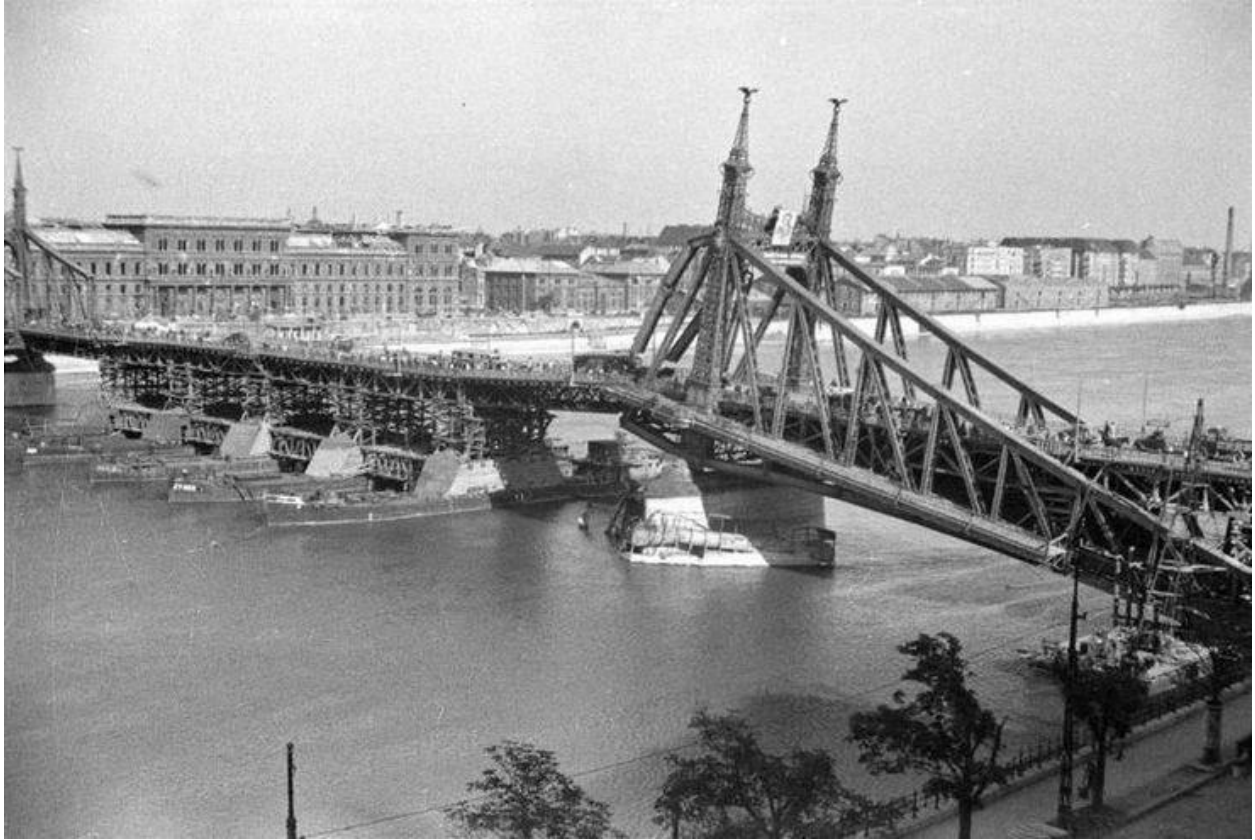
Liberty Bridge after destruction showing the temporary structure erected by the Soviets shortly after the destruction. Note the near anchor arm is largely intact despite having tipped over into the water at the abutment end.

The Liberty Bridge (Szabadság híd) is a cantilever through truss bridge that was built in 1896 and has extensive ornamentation. The war destroyed the cantilever arms and suspended span of the bridge, but the main post towers and the anchor arms remained intact, despite one of the anchor arms dropping into the water at the abutment end. In this state, the bridge may have been one of the least damaged of the bridges in the city. Soon after the destruction, a makeshift temporary structure was erected that connected the surviving portions of the bridge. In 1946 this bridge became the first bridge to be rebuilt after the war. Portions of the surviving bridge that could be salvaged were repaired and reused, including the ornamentation on the towers. Portions needed to be rebuilt from scratch were made following the original design. The replication of this bridge's destroyed parts was very accurate, and even when inspected closely, it is not clear where the original and new parts are.

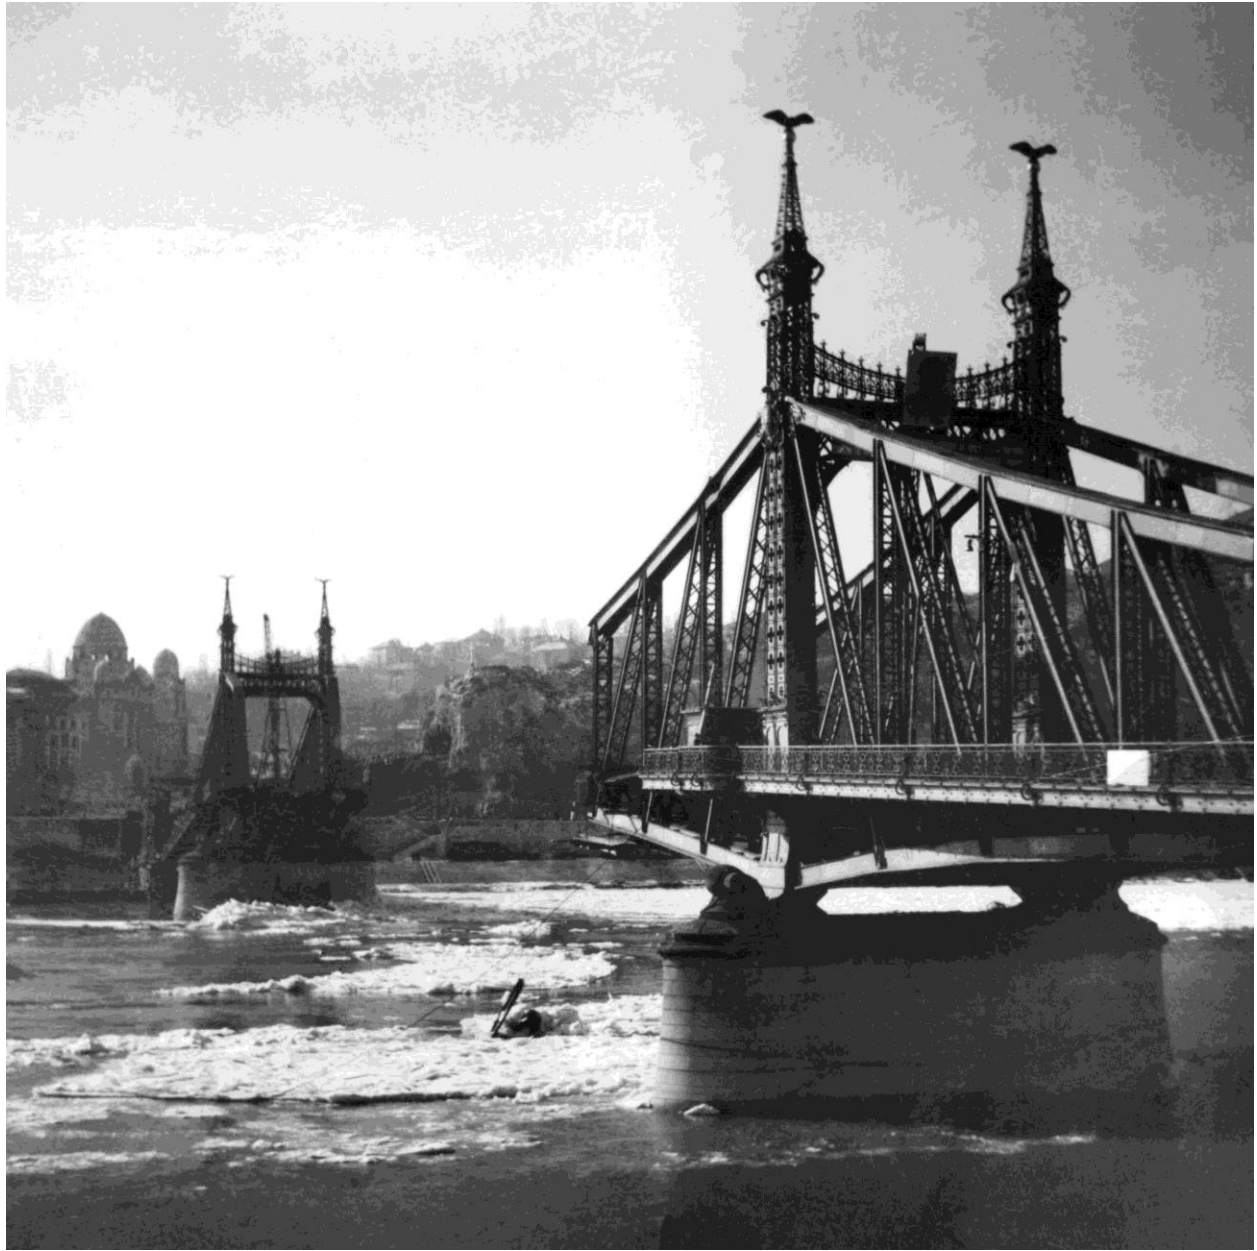
Liberty Bridge after destruction, showing the center section totally destroyed, the far anchor arm tipped into the water, and the near anchor arm largely intact.

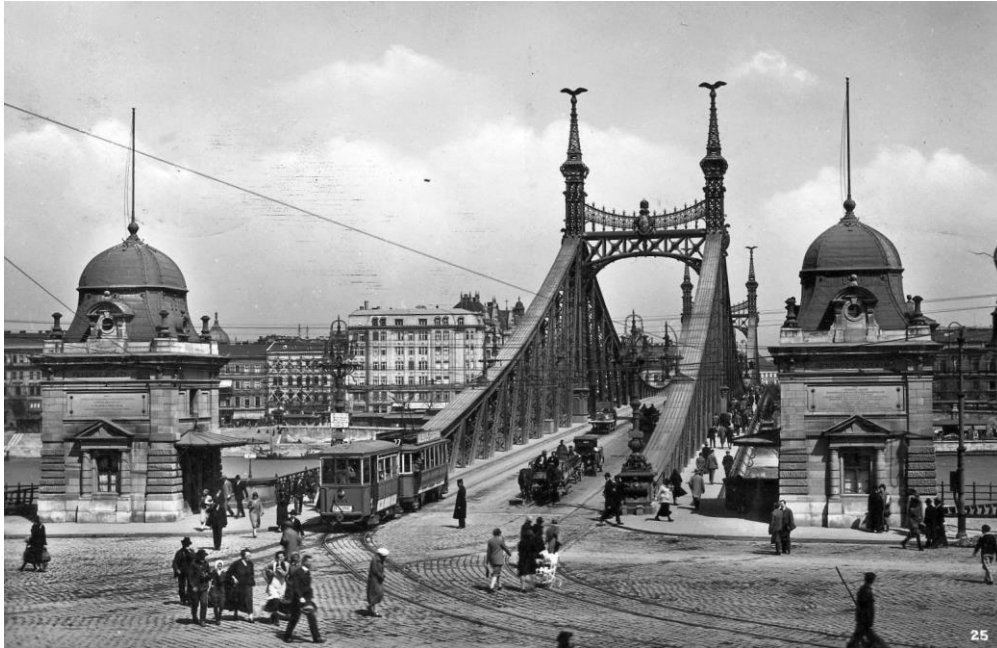
Liberty Bridge before the war.

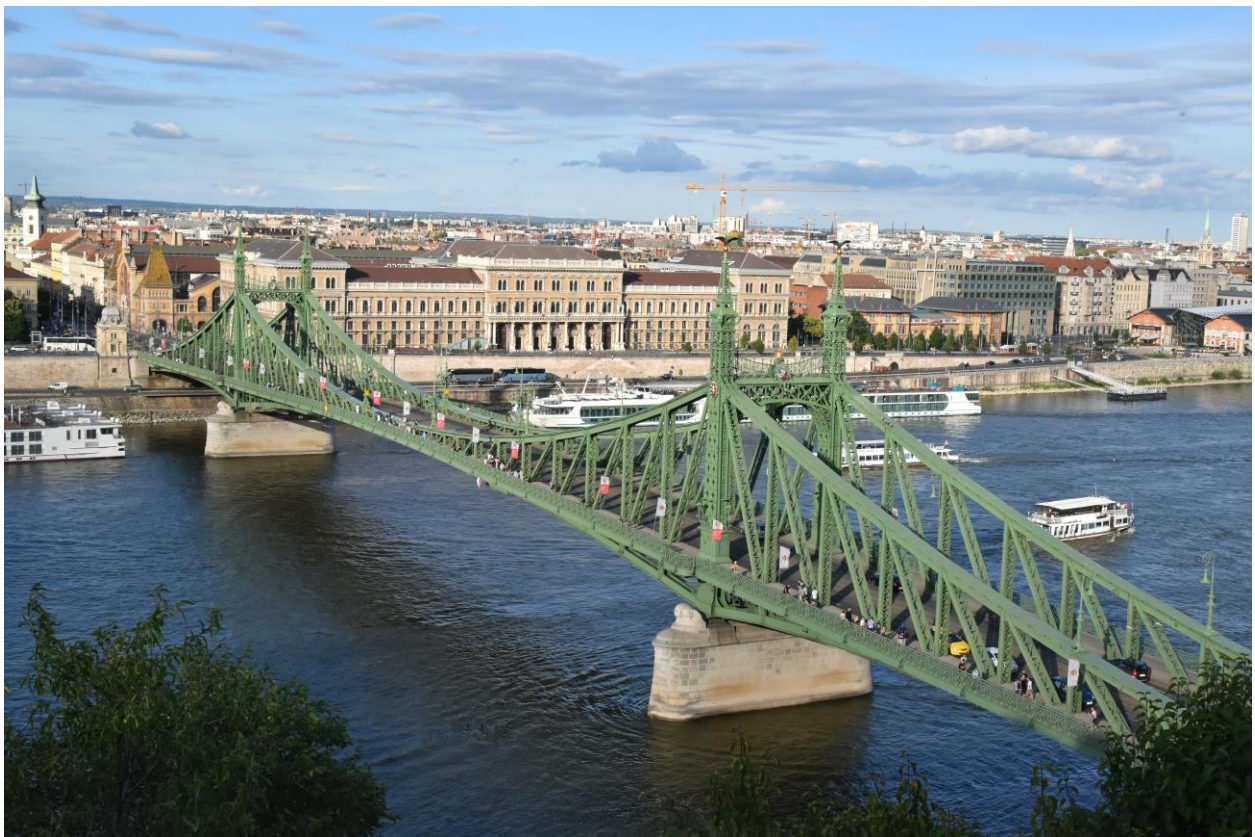
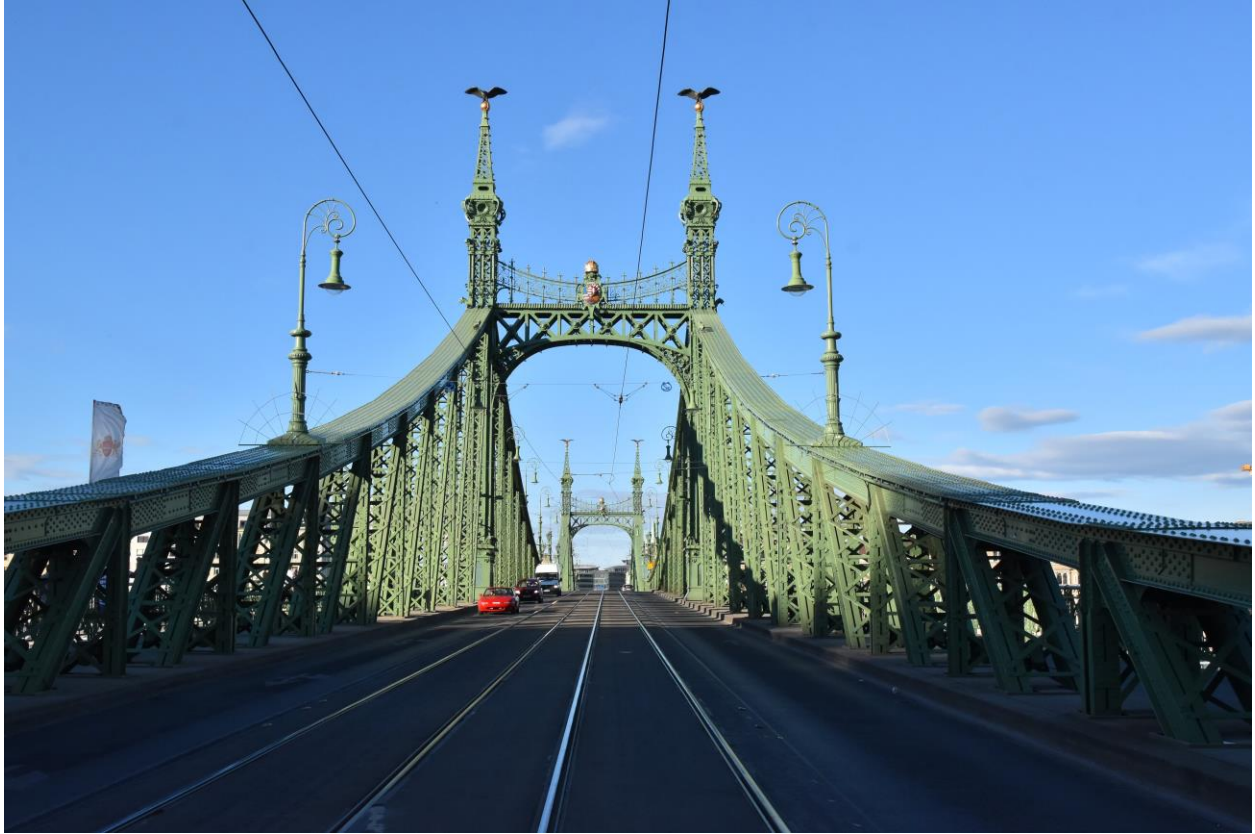
Liberty Bridge as seen in 2017.

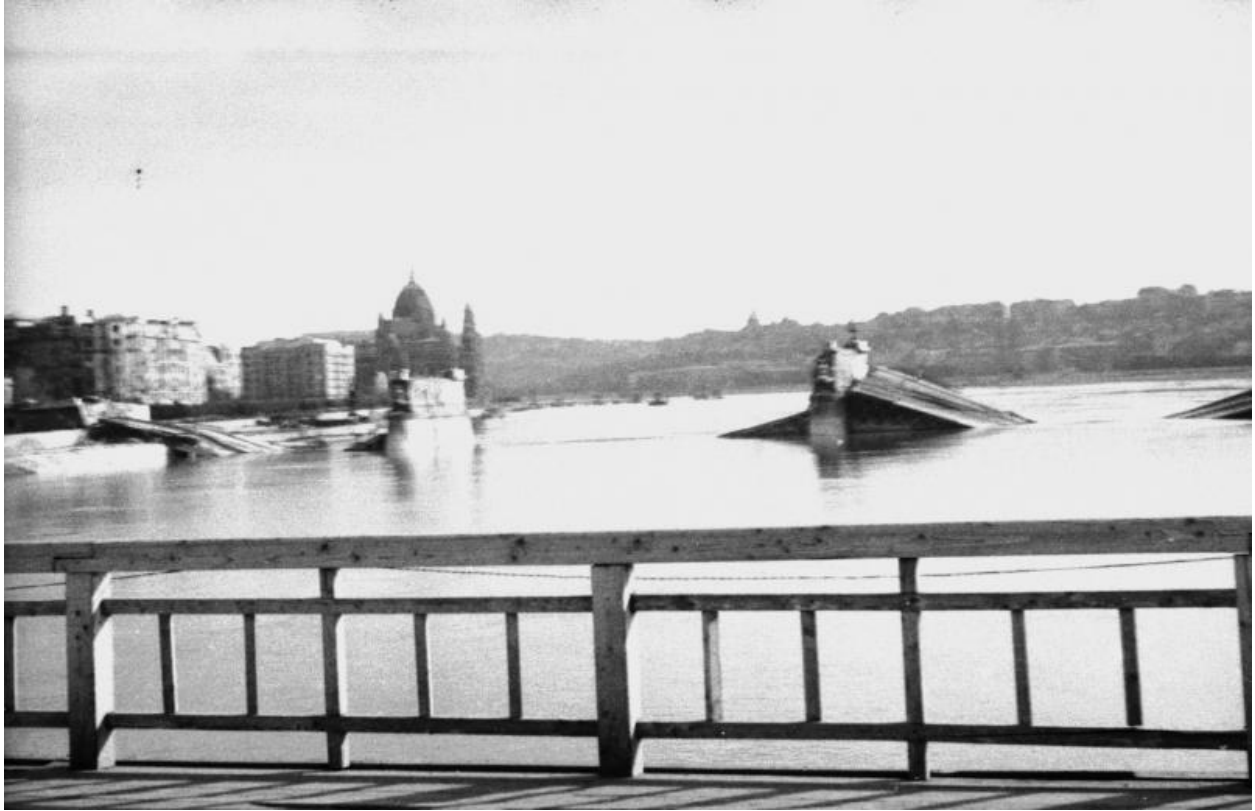
Margaret Bridge after destruction. Note that the piers appear to be intact.

The Margaret Bridge (Margit híd) was built in 1876 as a metal arch bridge. The Margaret Island Extension was added ca. 1896 which turned the bridge into a T-shaped bridge. This bridge was the first to be destroyed in the war, although its destruction was actually an accident. German troops were placing explosives on the bridge, preparing for a possible need to destroy the bridge in the future for defensive reasons. During this time, a boat passing under the bridge accidentally ignited a fuse that set off the explosives and collapsed the arch spans, killing 640 soldiers plus hundreds of civilians on the bridge as well. 73 days later, all the other bridges in Budapest were blown up during the Siege of Budapest. After the war, the Margaret Bridge was rebuilt in 1948 as a riveted steel deck arch bridge, and appears to have reused the original piers. Also, the span leading to Margaret Island is more ornamented than the other steel arches, which may indicate that this 1896 extension was spared destruction in 1944 and is what remains in use today. The bridge was restored with the intent of returning the bridge to a 1937 (pre-war) appearance in 2009-2011.

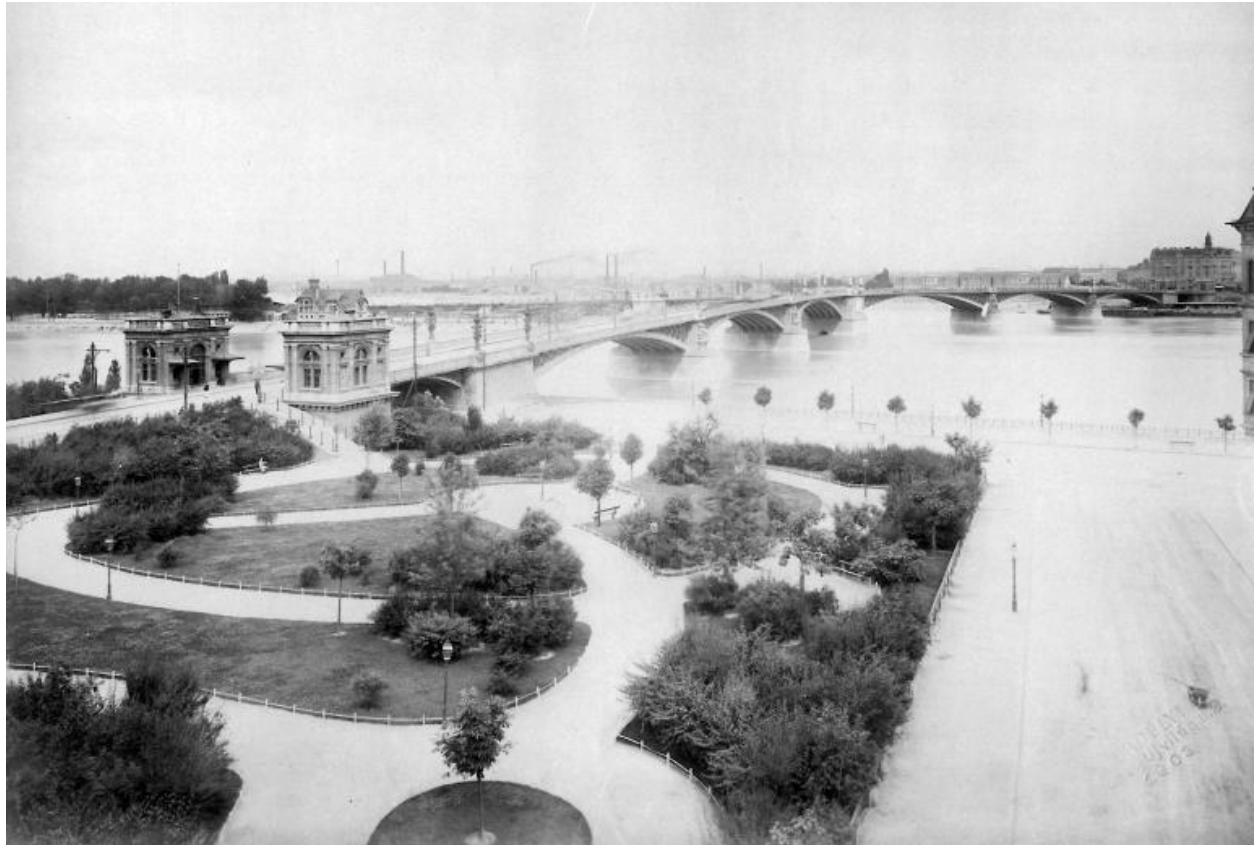
Margaret Bridge before the war, ca. 1900.

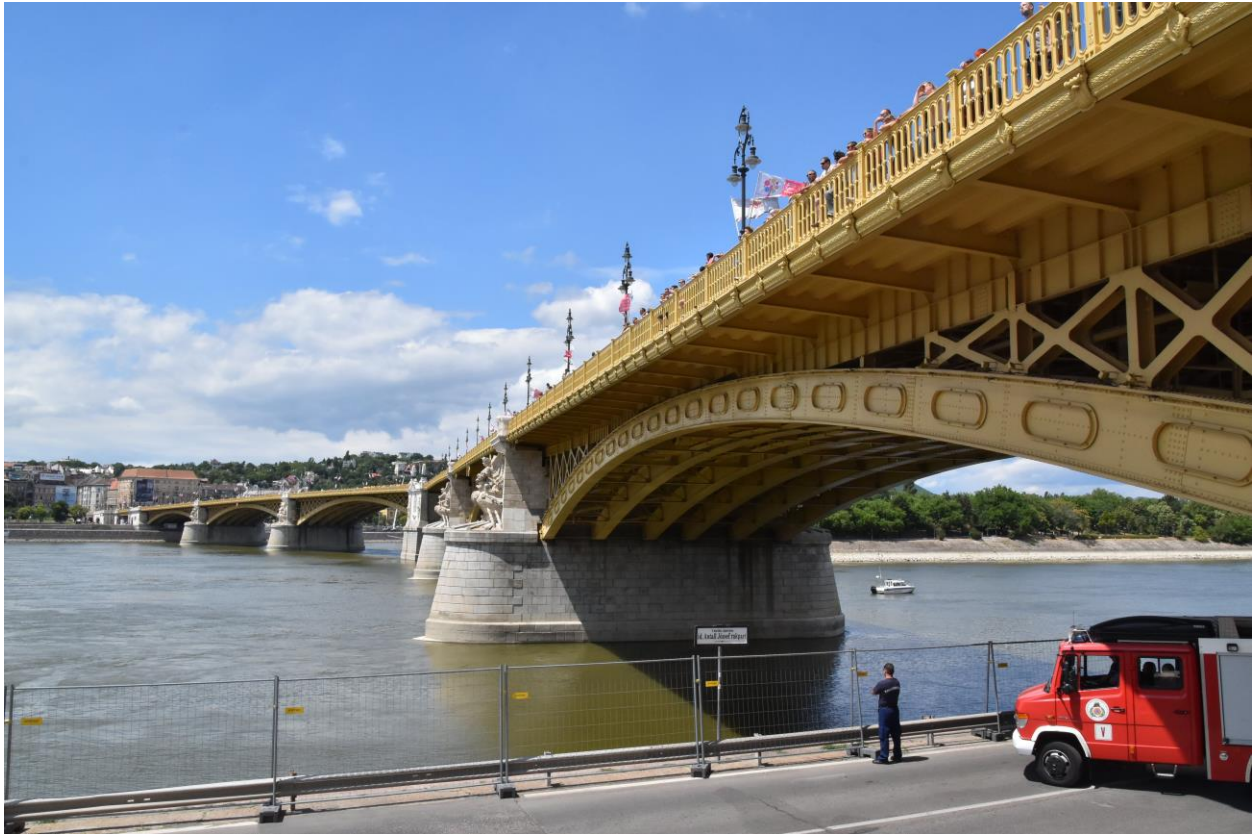
Margaret Bridge as seen in 2017.

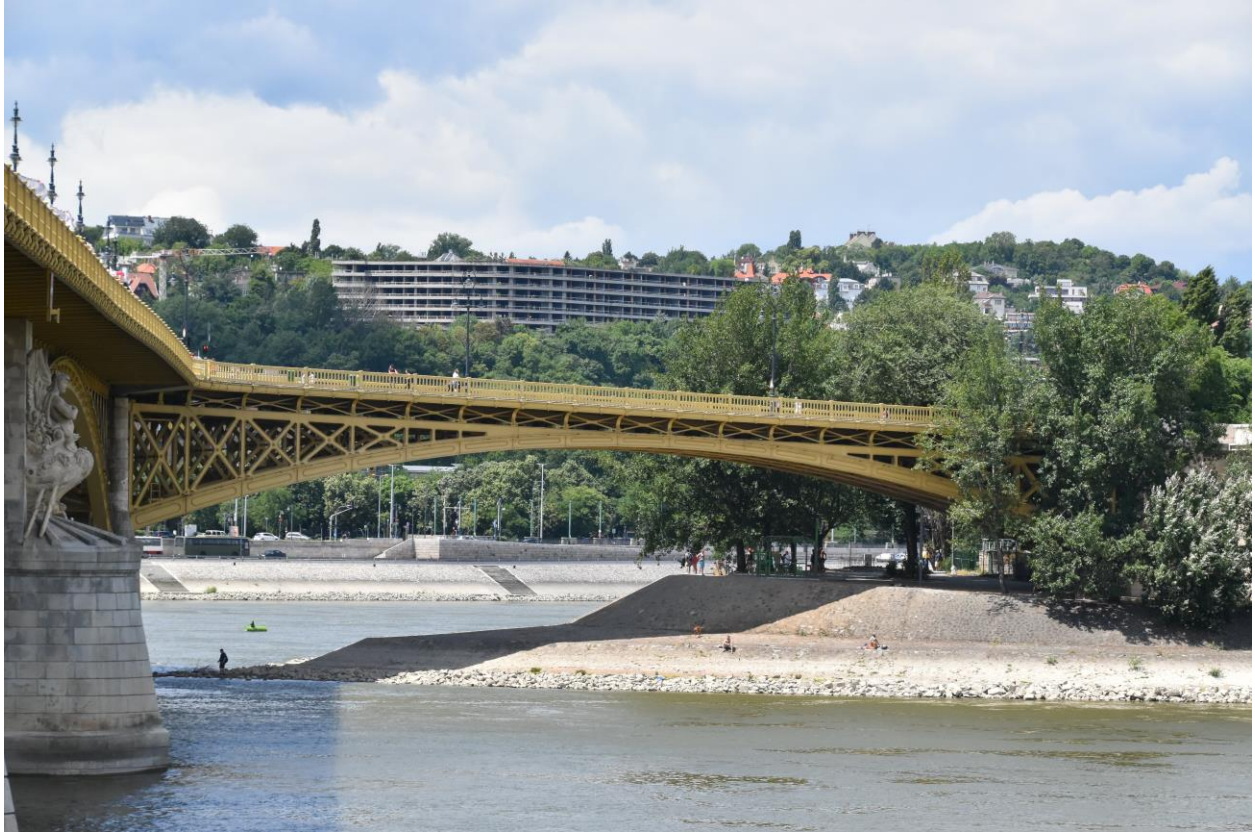
Margaret Bridge as seen in 2017. This view shows the Margaret Island Extension. Notice how the Margaret Island spans have a different, more detailed arch rib design. This may suggest these spans are original and were reused after the war.
