Historic Bridge Foundation Facebook Archives

Did You Know: Ellis Bridge

December 2016

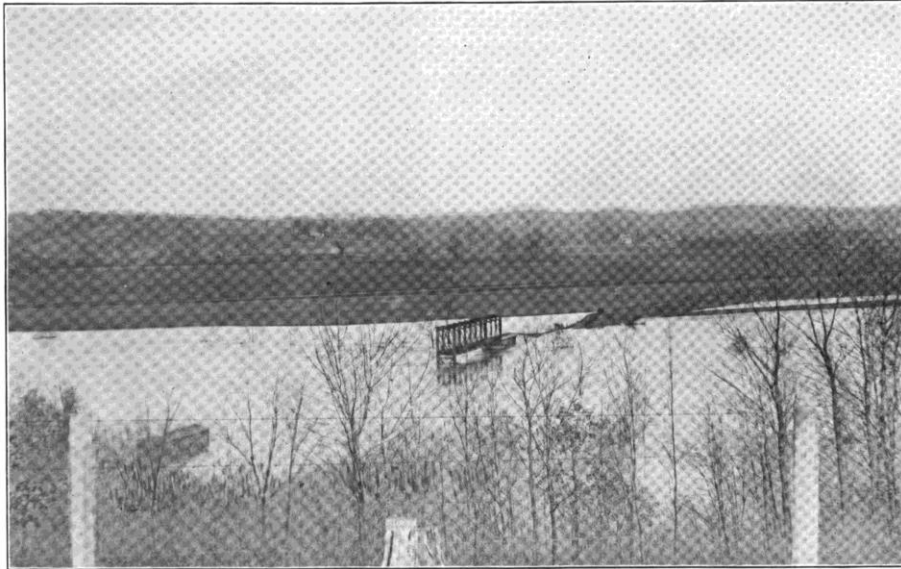
Photo of bridge in 1913 after the flood showing only the one Whipple through truss span still standing.

These changes to the through truss actually saved this span from destruction in March of 1913 when a massive flood destroyed all the unaltered deck truss spans. The through truss span however was high enough that it was spared destruction, which was quite a feat considering that the flood in question was none other than the infamous Great Flood of 1913 which destroyed an enormous number of bridges in Ohio and beyond. Learn more about the flood at https://en.wikipedia.org/wiki/Great_Flood_of_1913

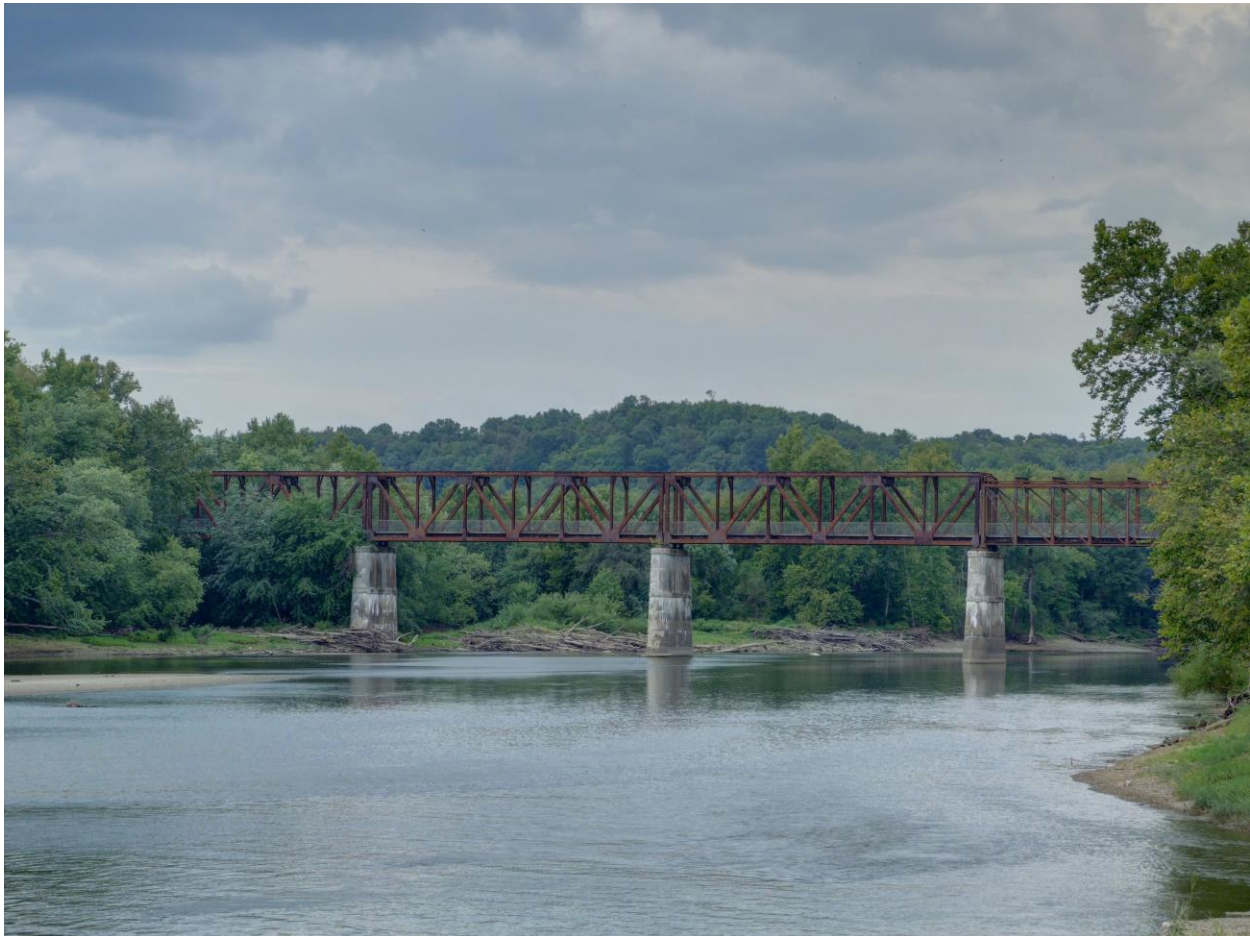
ellisbridge2190_1_2f – Elevation of bridge. The Whipple truss span is to the far right.

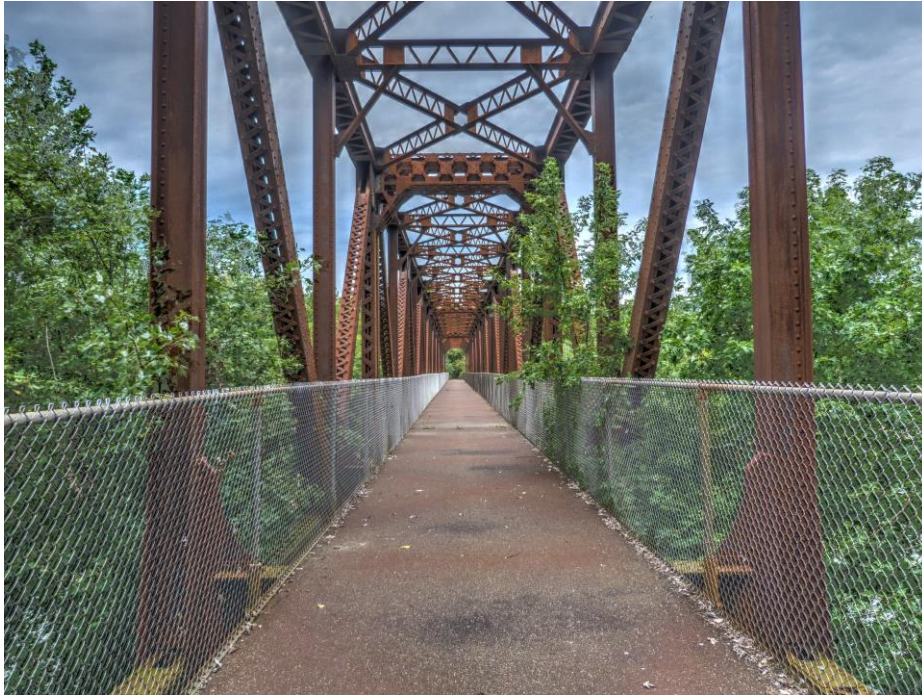
ellisbridge2165_6_7 – A view on one of the Warren truss spans, showing the heavy, all-riveted construction.

fabricated by the American Bridge Company and installed on new concrete piers. These 1913 spans have vertical end posts like the Whipple truss span, an unusual detail.

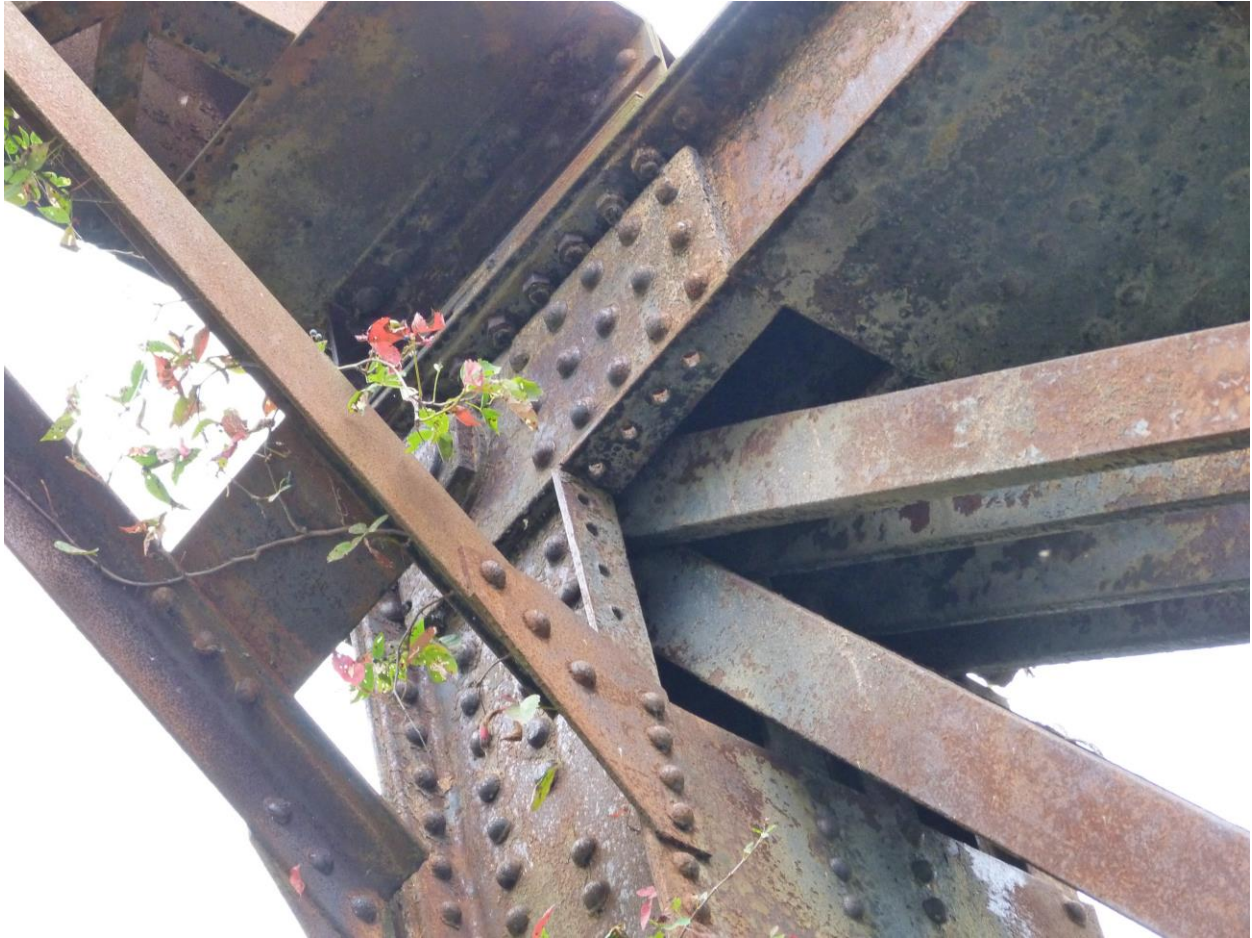
ellisbridge2066 – Upper chord connection on the Whipple truss span. Note the empty rivet holes on the ends of the angles. Empty rivet holes are an indication of prior alteration, in this case likely the conversion from a deck truss to a through truss.

Some years after this Whipple truss was built, a "slack water navigation" system was created on the river through a series of dams. At this time, to provide clearance for boats, one of the deck truss spans was raised up and turned into a through truss. This alteration would have required removing bracing inside the truss lines to allow for trains to pass through the truss, and installation of portal and sway bracing overhead where previously floorbeams had been located, while the floorbeams would have been installed between the bottom chords. Evidence of these changes remains today in the form of empty rivet holes that can be seen on the bridge. What is interesting is that the sway bracing shows empty rivet holes, so these elements probably were salvaged and reused from the deck truss.
