Historic Bridge Foundation Facebook Archives

Focus Bridge: Larimer Avenue Bridge

January 2016

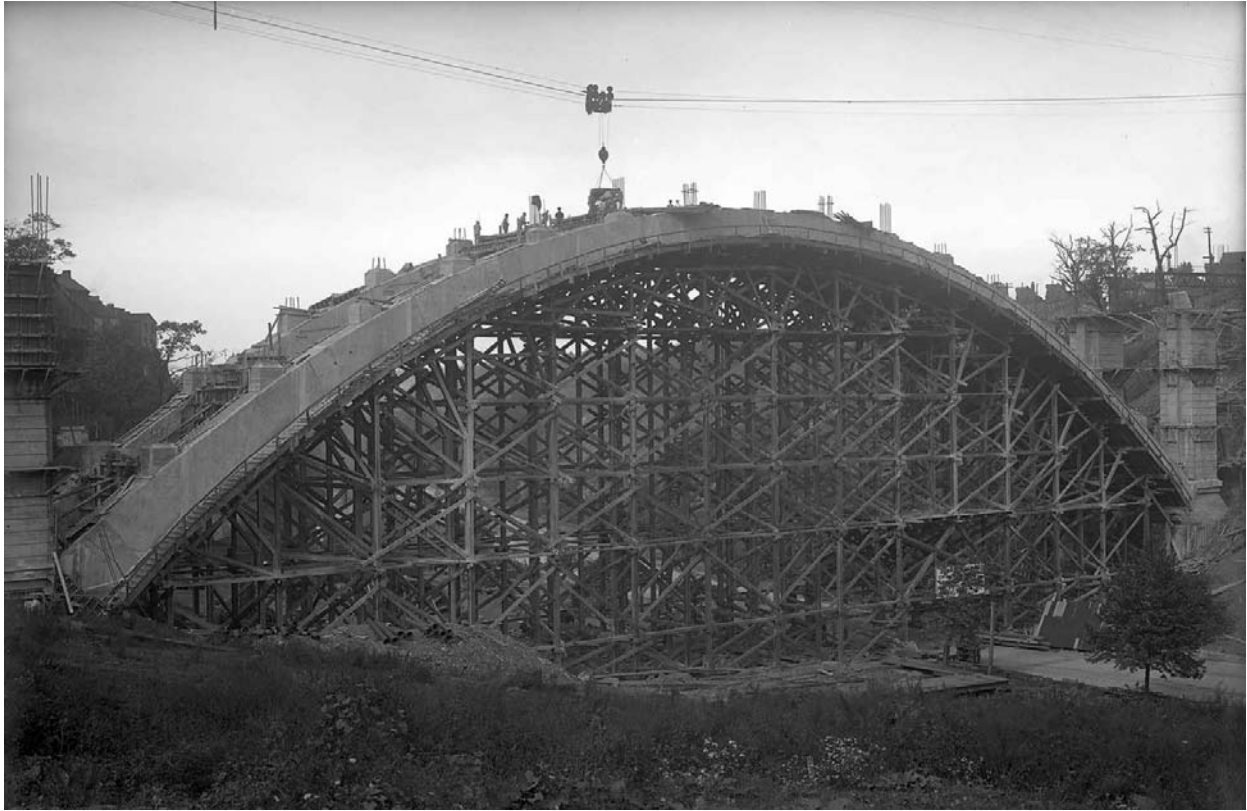
This photo shows the construction of the bridge, with the arch rib being constructed on top of the extensive timber centering. Also visible at the top is the temporary construction cableway.

The Larimer Avenue Bridge features a height of 113 feet, with the arch itself featuring a 67 foot rise. It was estimated by period articles that the bridge took 8,500 cubic yards of concrete and 436 tons of steel. The timber falsework (centering) used to support the bridge during construction totaled over 400,000 linear feet. Also, during construction, a temporary cableway spanned over the valley which was used to move equipment and materials around the job site.

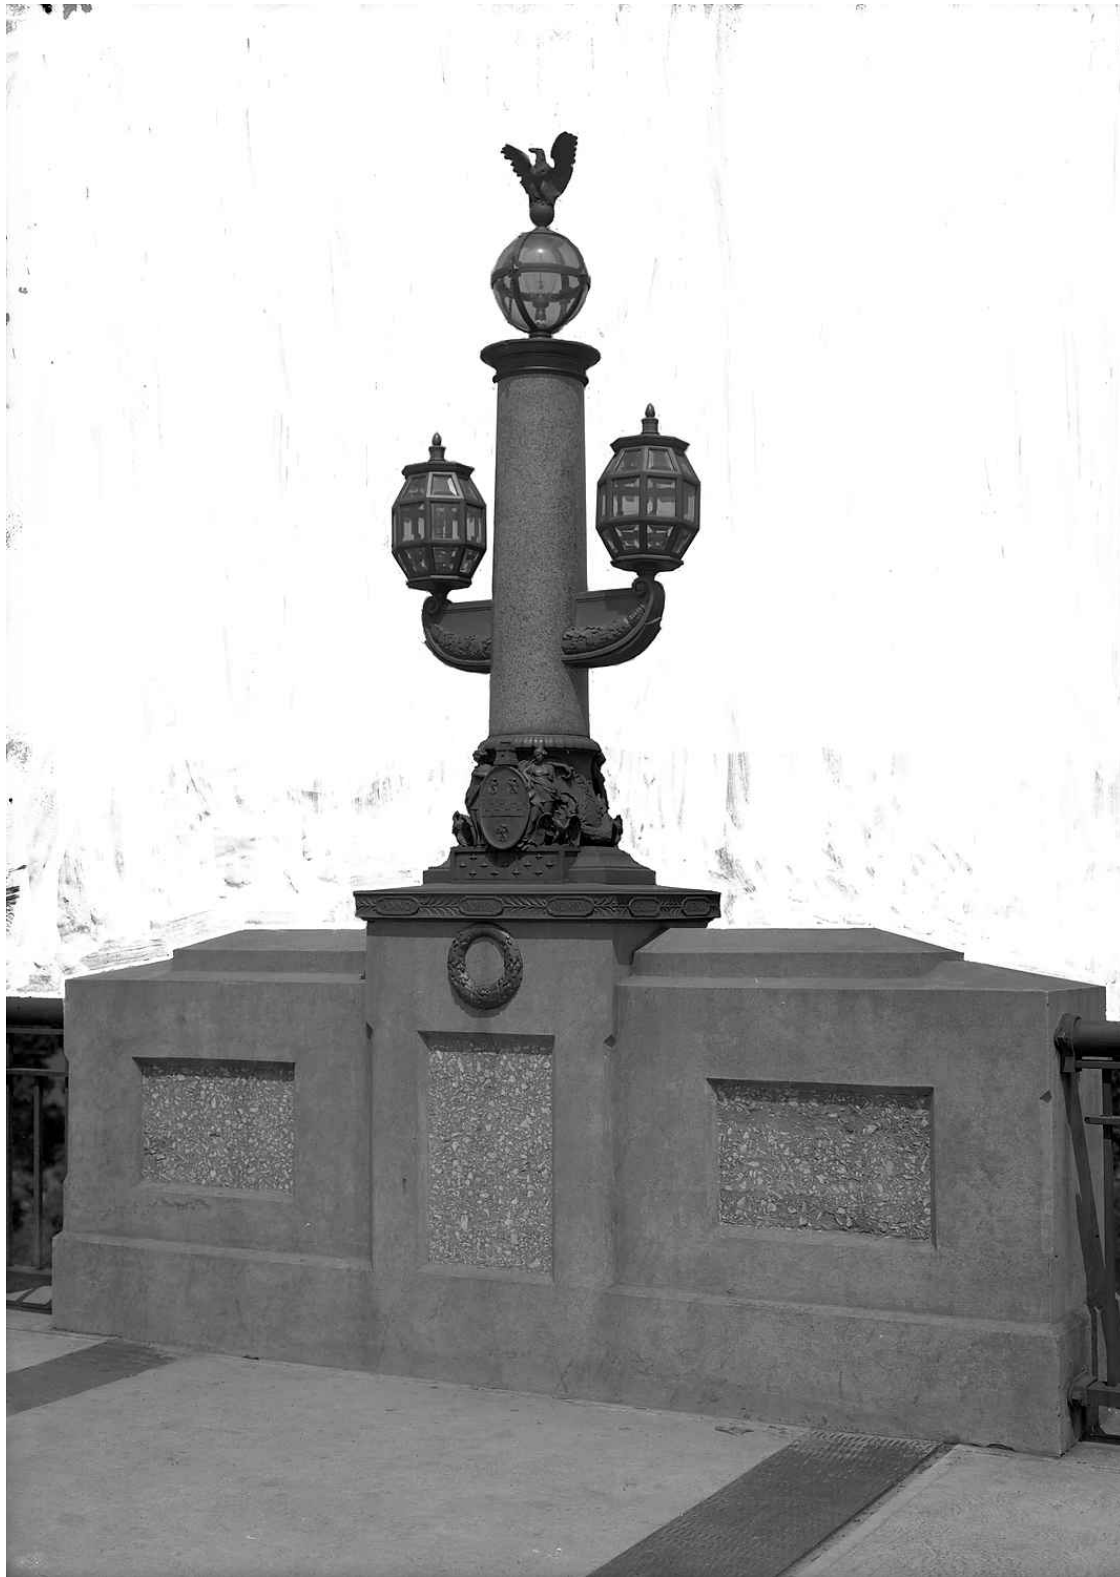
The original deck of this bridge has been replaced. As originally built, it included these ornamental lighting standards.

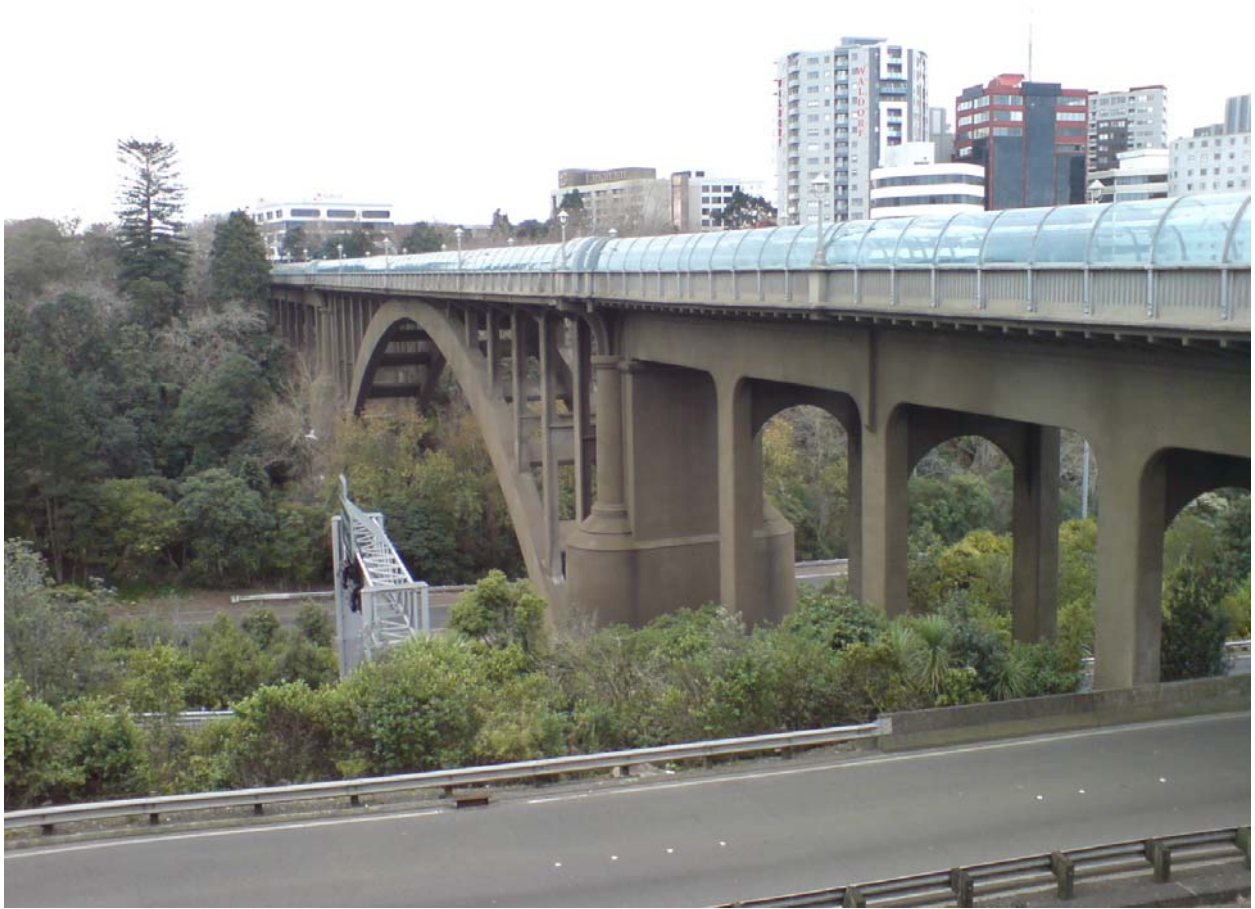
This photo shows the Grafton Bridge in New Zealand, one of only two concrete arch bridges in the world noted as being longer than the Larimer Avenue Bridge when it was built.

Crossing Washington Boulevard and the valley which the road follows, the clear span of the Larimer Avenue Bridge is shown as anywhere from 300 to 312 feet depending on what source you look at. In any case, the span was reported by multiple engineering periodicals of the period as the longest concrete arch span in the United States when it was completed in 1912. Two other concrete spans were noted as being larger at the time the Larimer Avenue Bridge was completed. One was the Grafton Bridge in Auckland, New Zealand, which had been completed only a couple years earlier in 1910. The Grafton Bridge, which remains standing today (and appears to be in good condition) features a main span of 320 feet: only a bit longer than the Larimer Avenue Bridge. The other bridge noted as longer was Ponte del Risorgimento whose 328 foot span was completed only one year earlier in 1911, crossing the River Tiber in Rome, Italy. This bridge which also remains standing today (and appears to be in good condition) has an arch with a very shallow rise, and is therefore quite different in appearance from both the Grafton and Larimer Avenue Bridges.

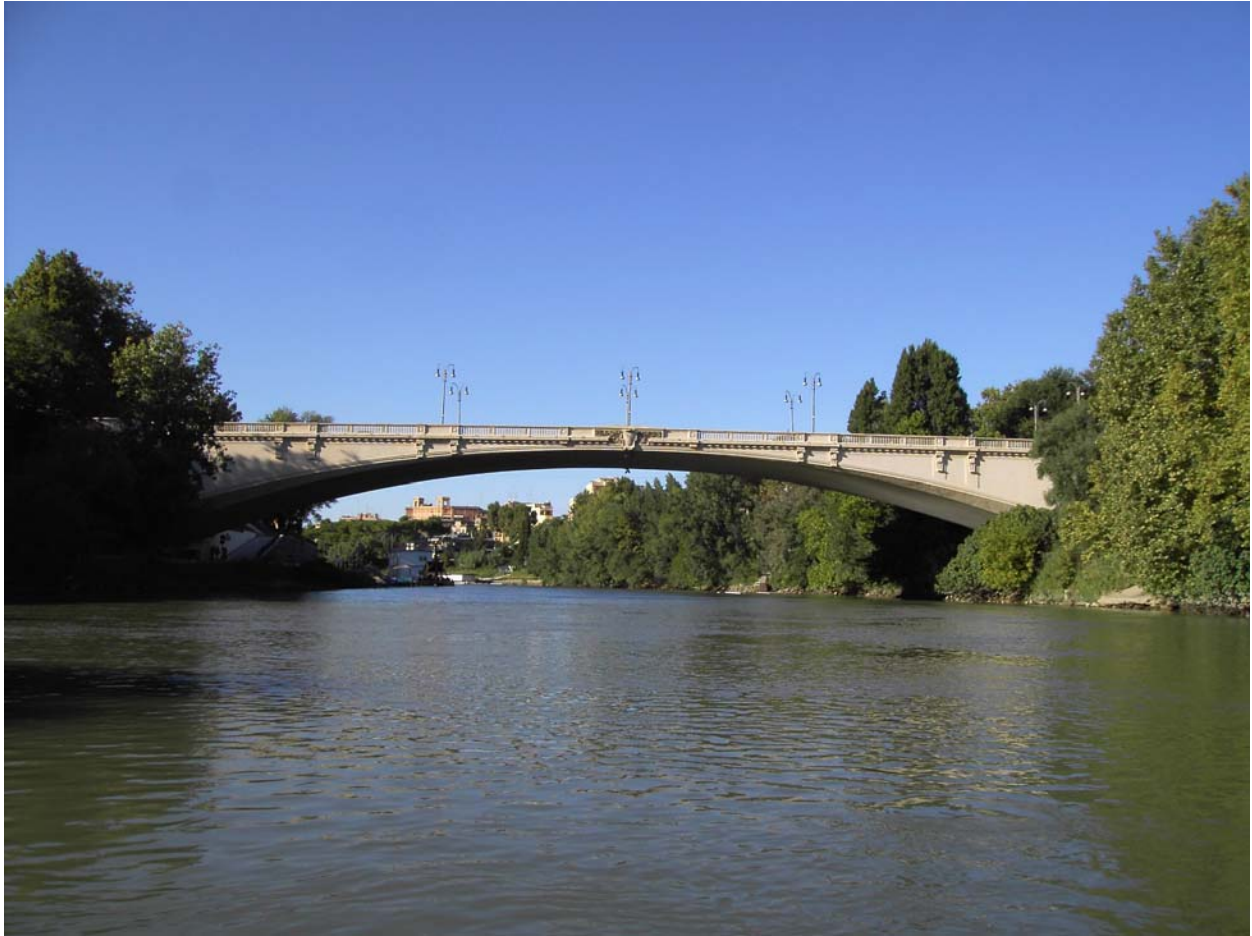
This photo shows Ponte Risorgimento in Italy, one of only two concrete arch bridges in the world noted as being longer than the Larimer Avenue Bridge when it was built. Photo By Lalupa

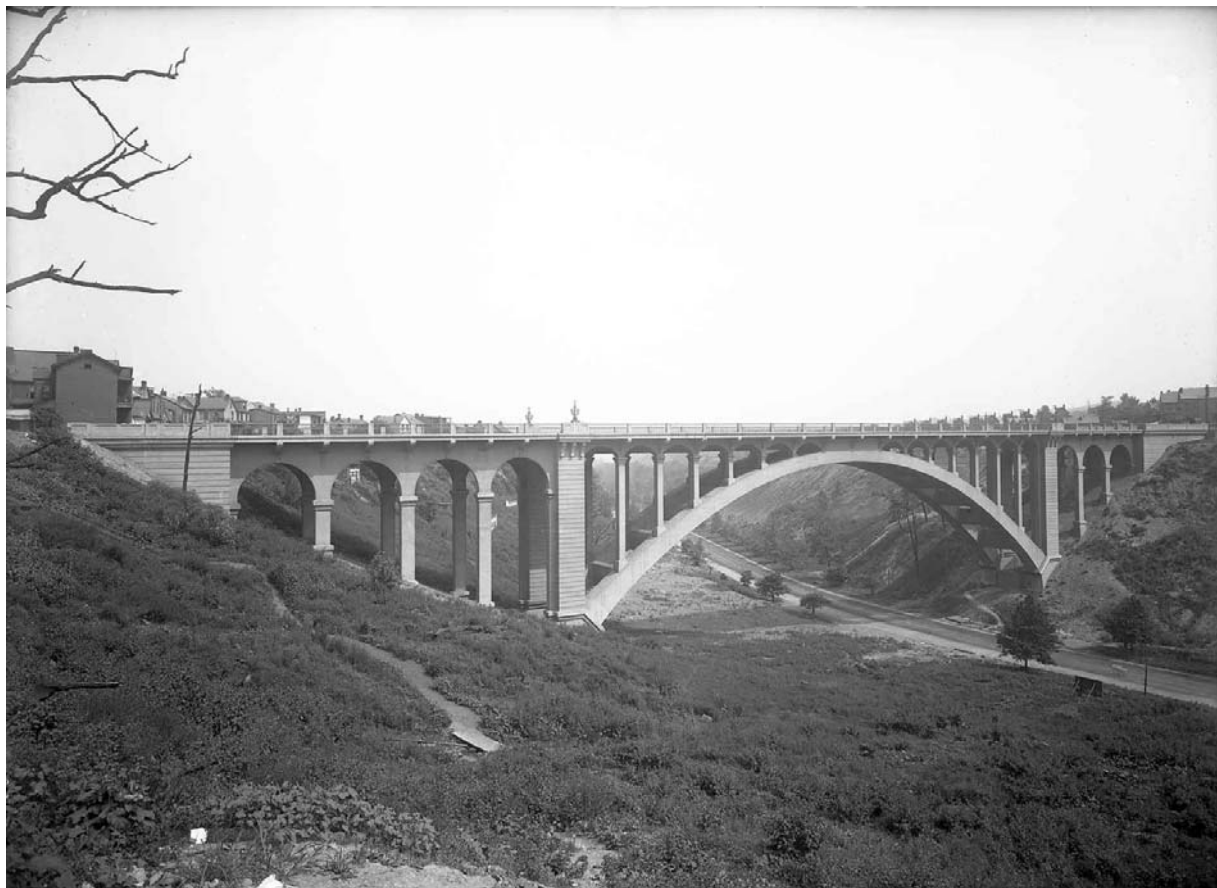
This photo shows the Larimer Avenue Bridge shortly after construction was completed.

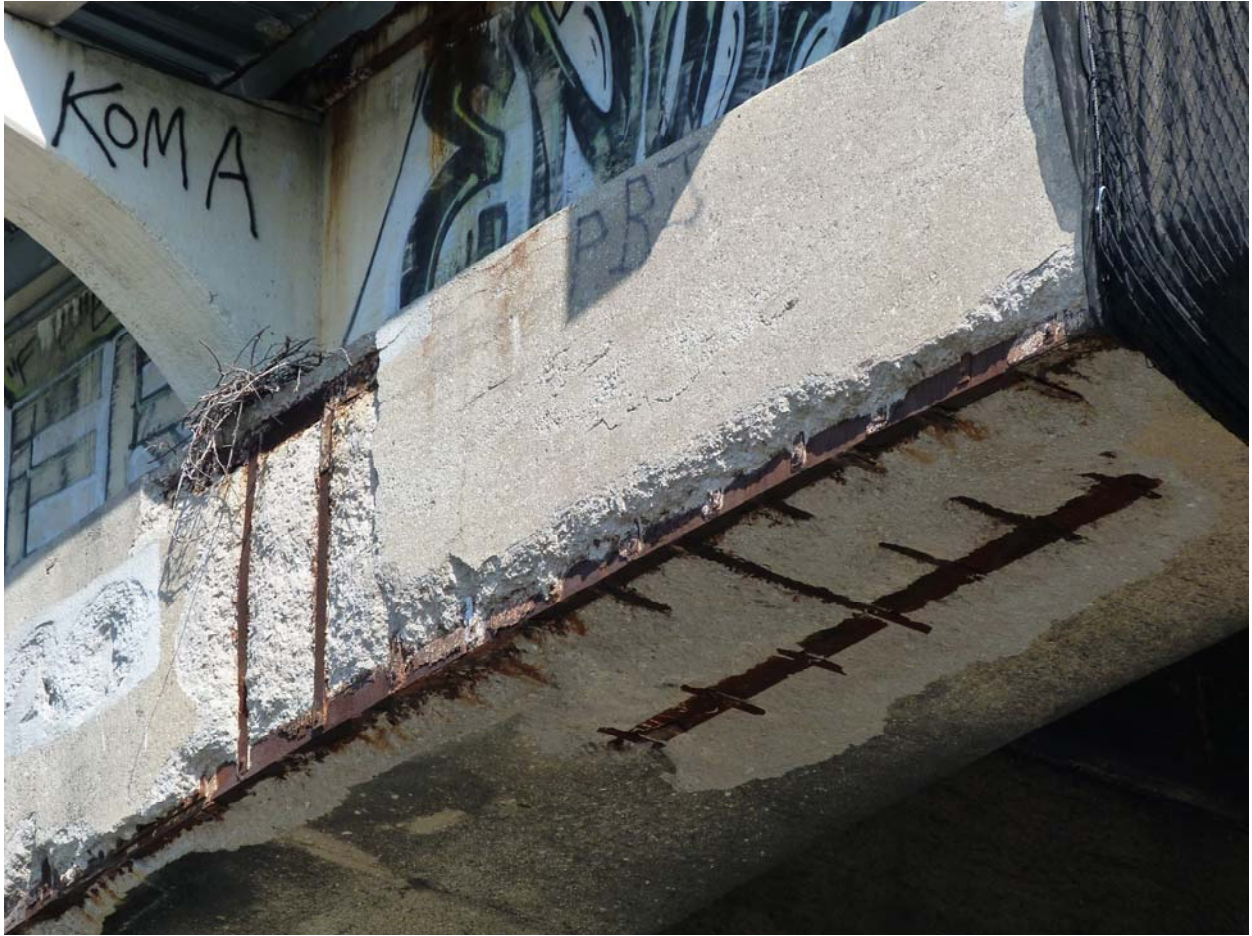
Rib- Deterioration has exposed the steel reinforcing on this section of concrete arch rib.

steel angles and bars. The angles were positioned around the perimeter of the arch rib, with repeating rows of steel bars spanning between these angles. The bars were riveted to the angles, and when the concrete was poured, all this steel was encased inside the concrete, forming the reinforced concrete arch rib. Sadly, this bridge has not been maintained and in some areas of the arch rib, the concrete has fallen away revealing this steel reinforcing. This is of course undesirable, but does offer a rare view of this unusual construction that should otherwise be hidden from view.
