Historic Bridge Foundation Facebook Archives

Focus Bridge: Lion Bridge

May 2015

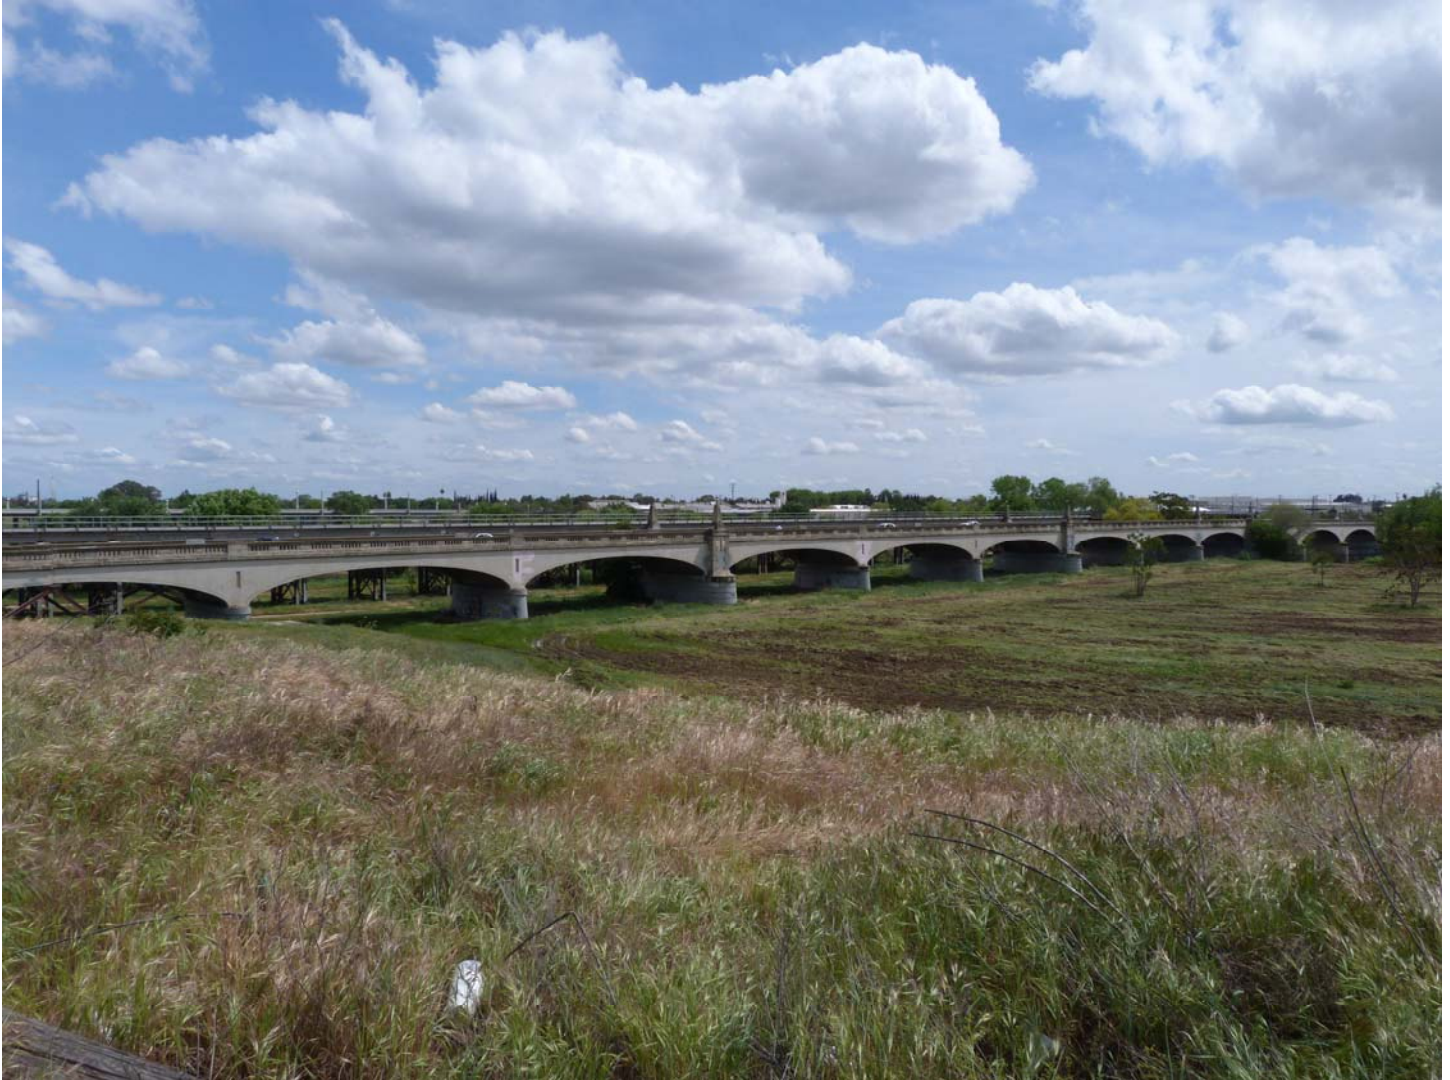
Lion Bridge, elevation view.

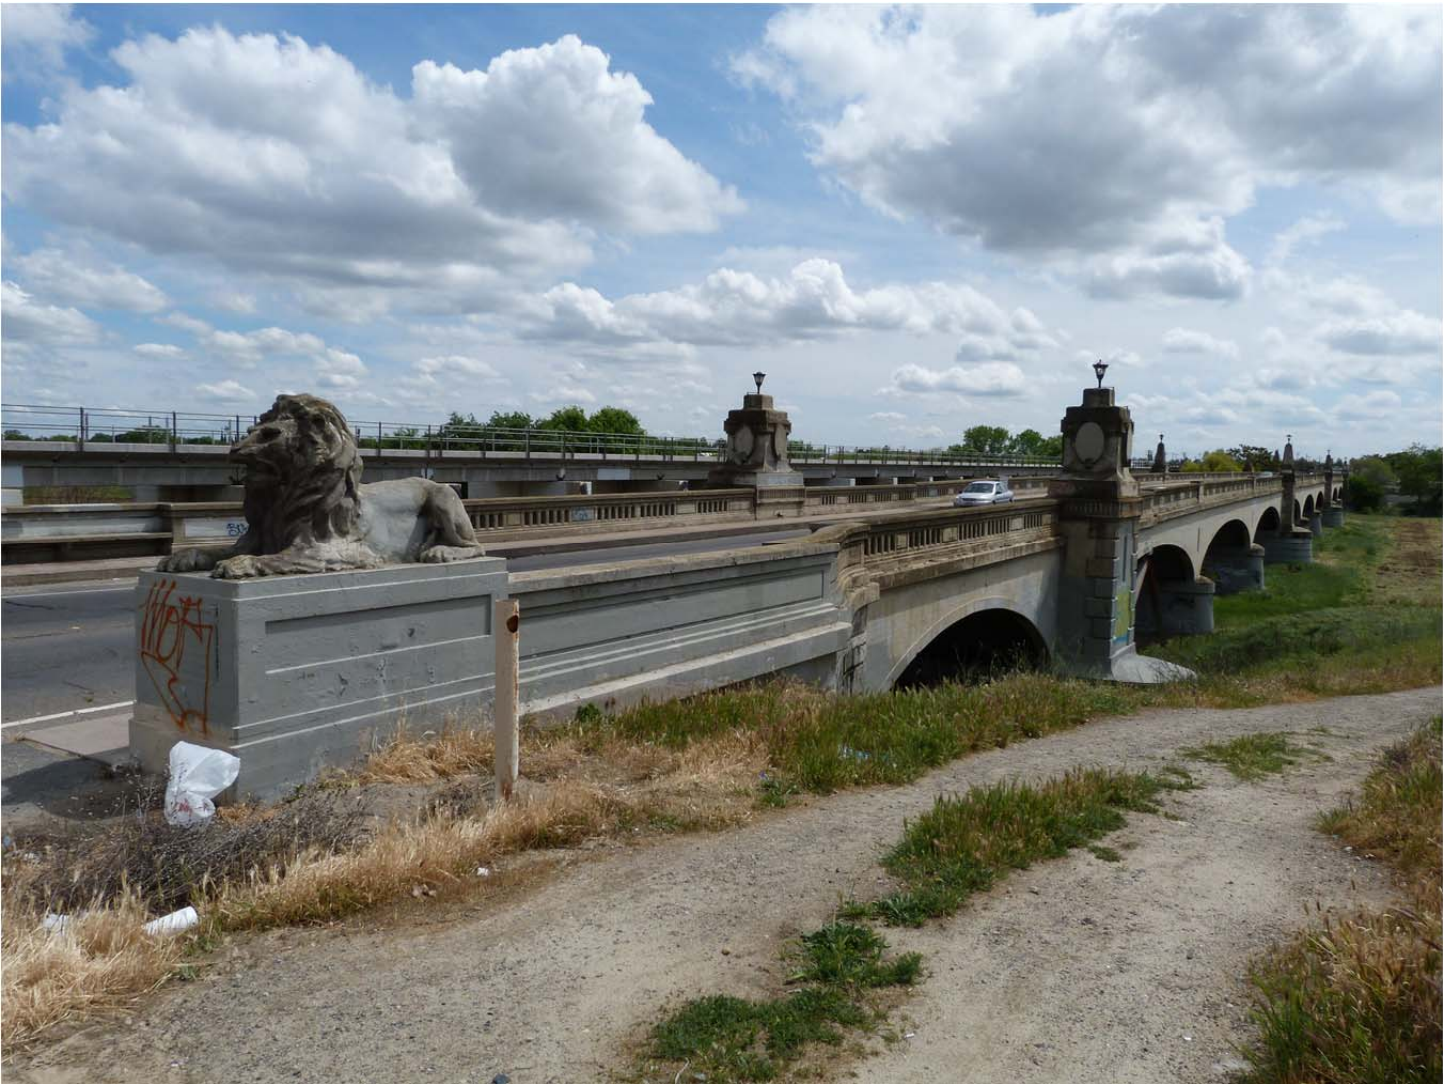
View beside the Lion Bridge

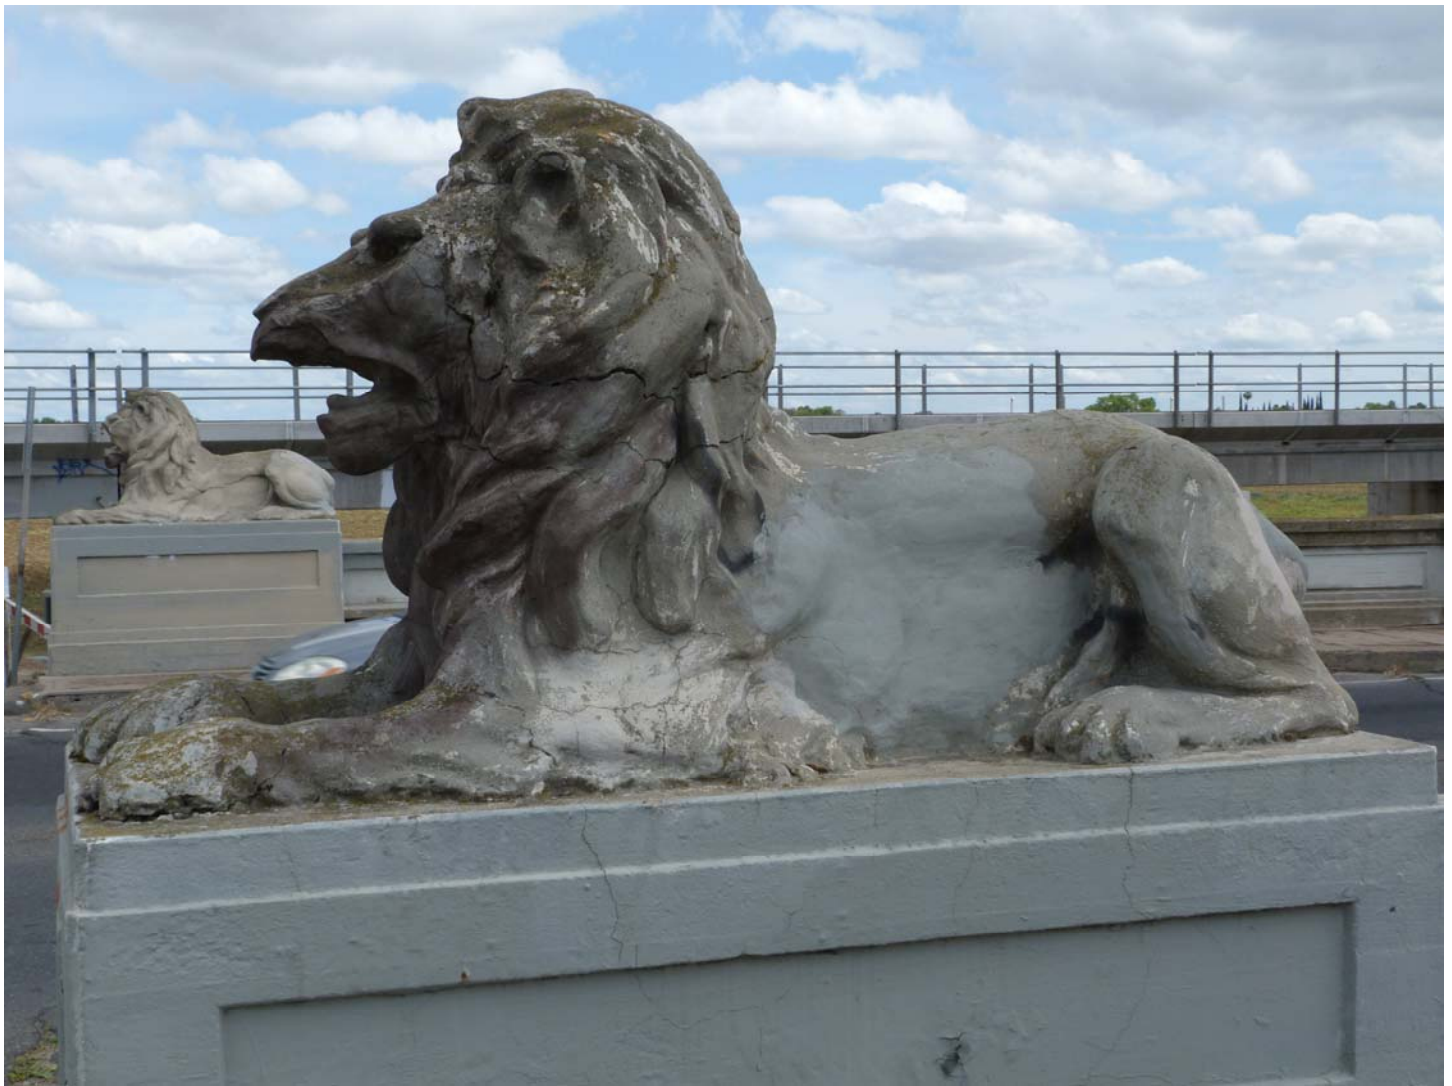
The bridge retains good historic integrity, but the bridge has structurally deteriorated. The beautiful lion sculptures are cracked and crumbling. The northernmost arch span appears to have settled, and in doing so, it has clearly revealed its cantilever construction, since the two cantilevered halves of the bridge have separated and one is slightly higher than the other now. A special metal brace has been added under this span.

View showing two of the Lion sculptures on the bridge.

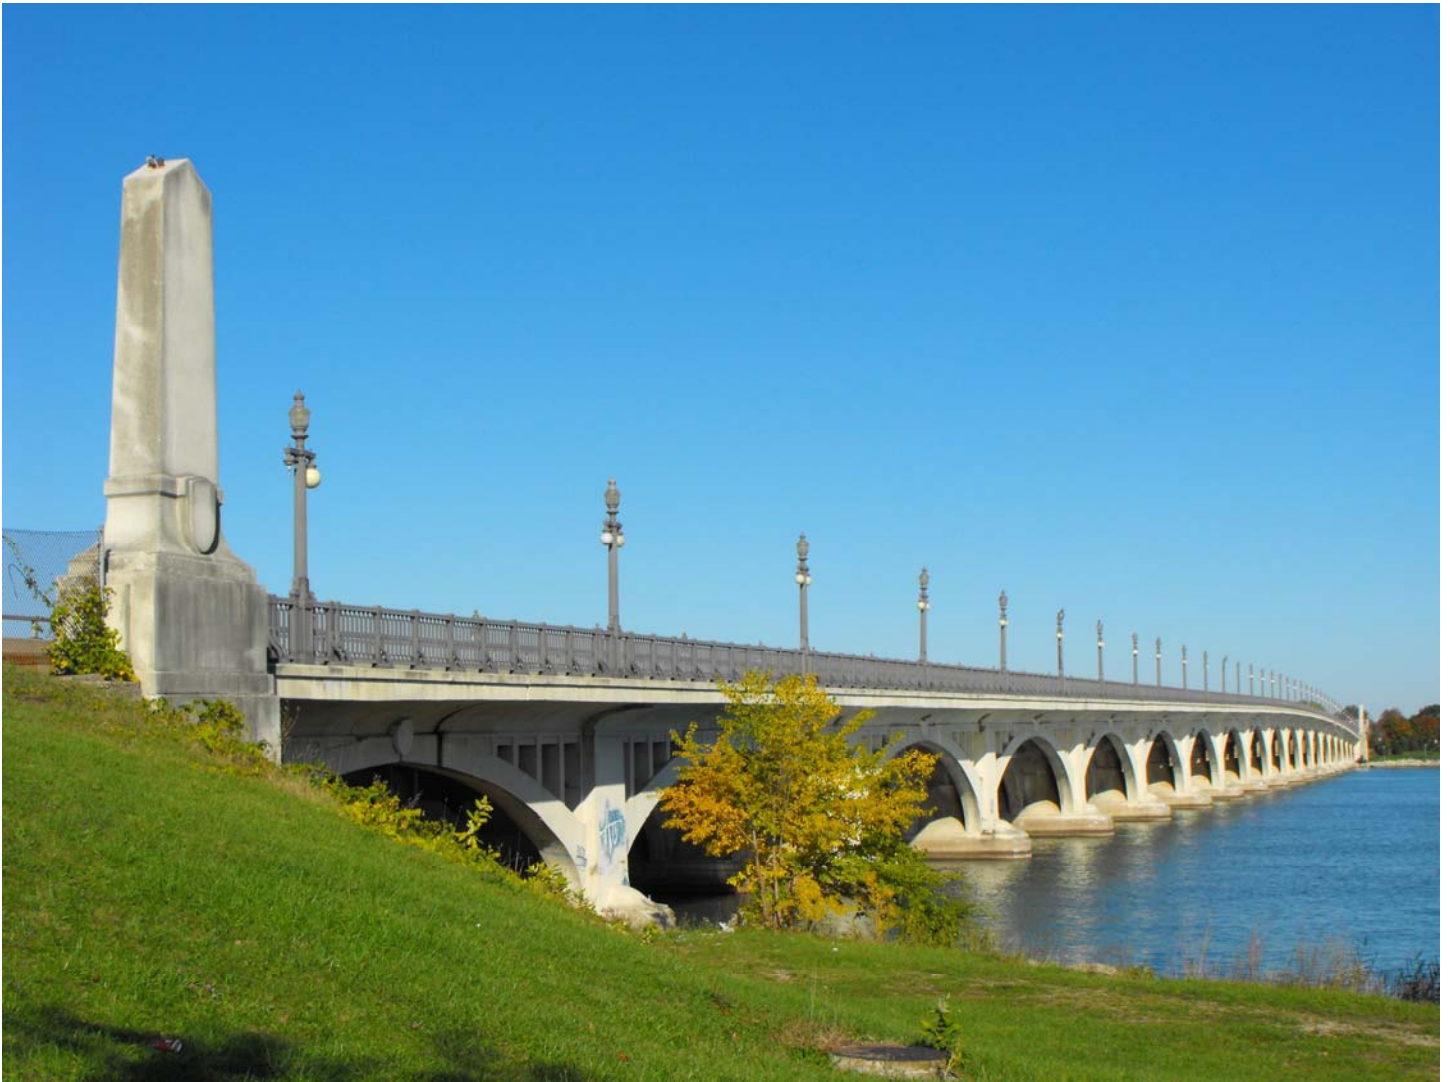
The Belle Isle Bridge in Detroit, Michigan is another large example of a concrete cantilever arch bridge, and its details make for a nice comparison to the Lion Bridge.

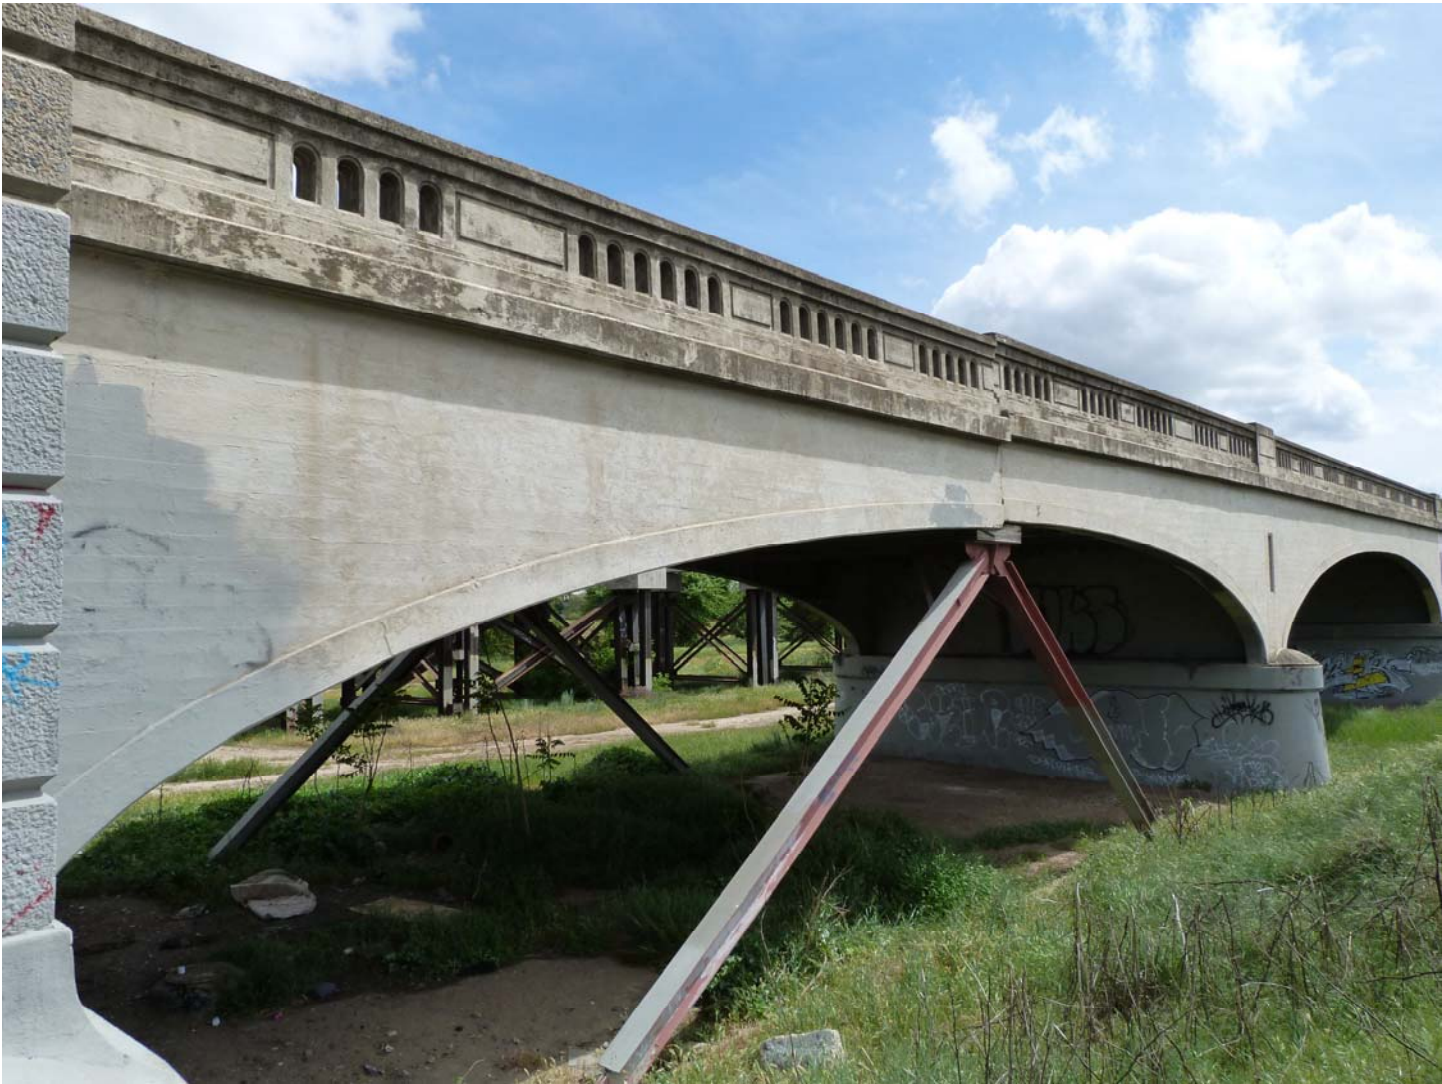
View showing the span of the Lion Bridge that has settled and been braced with steel beams.

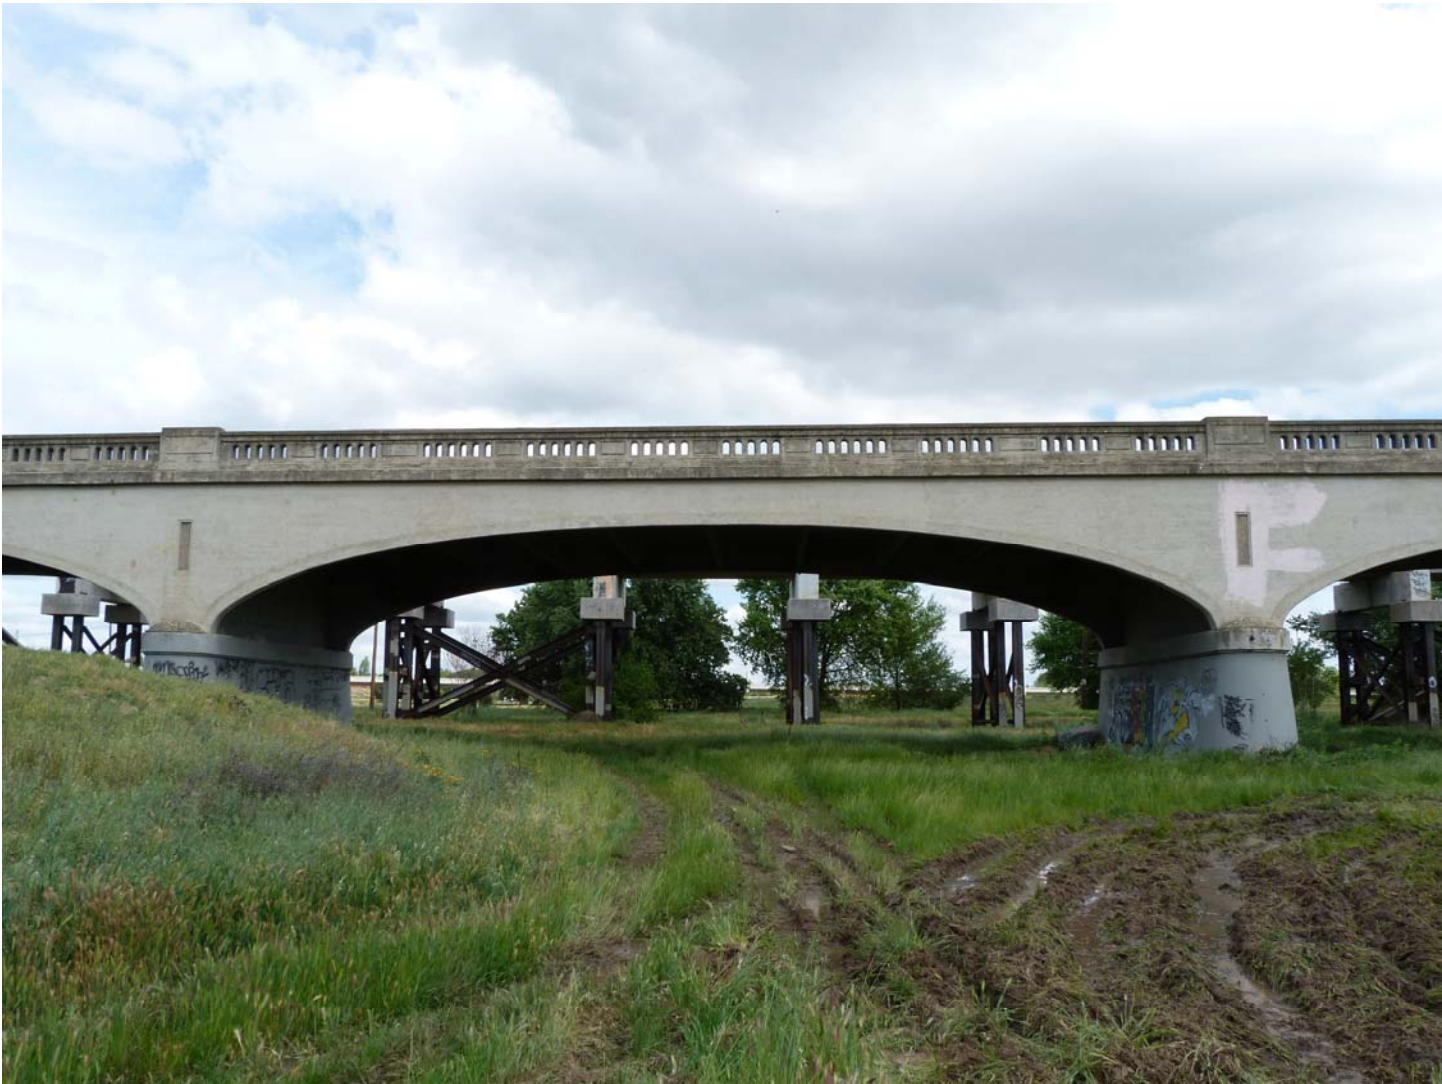
View of a typical span on the Lion Bridge.

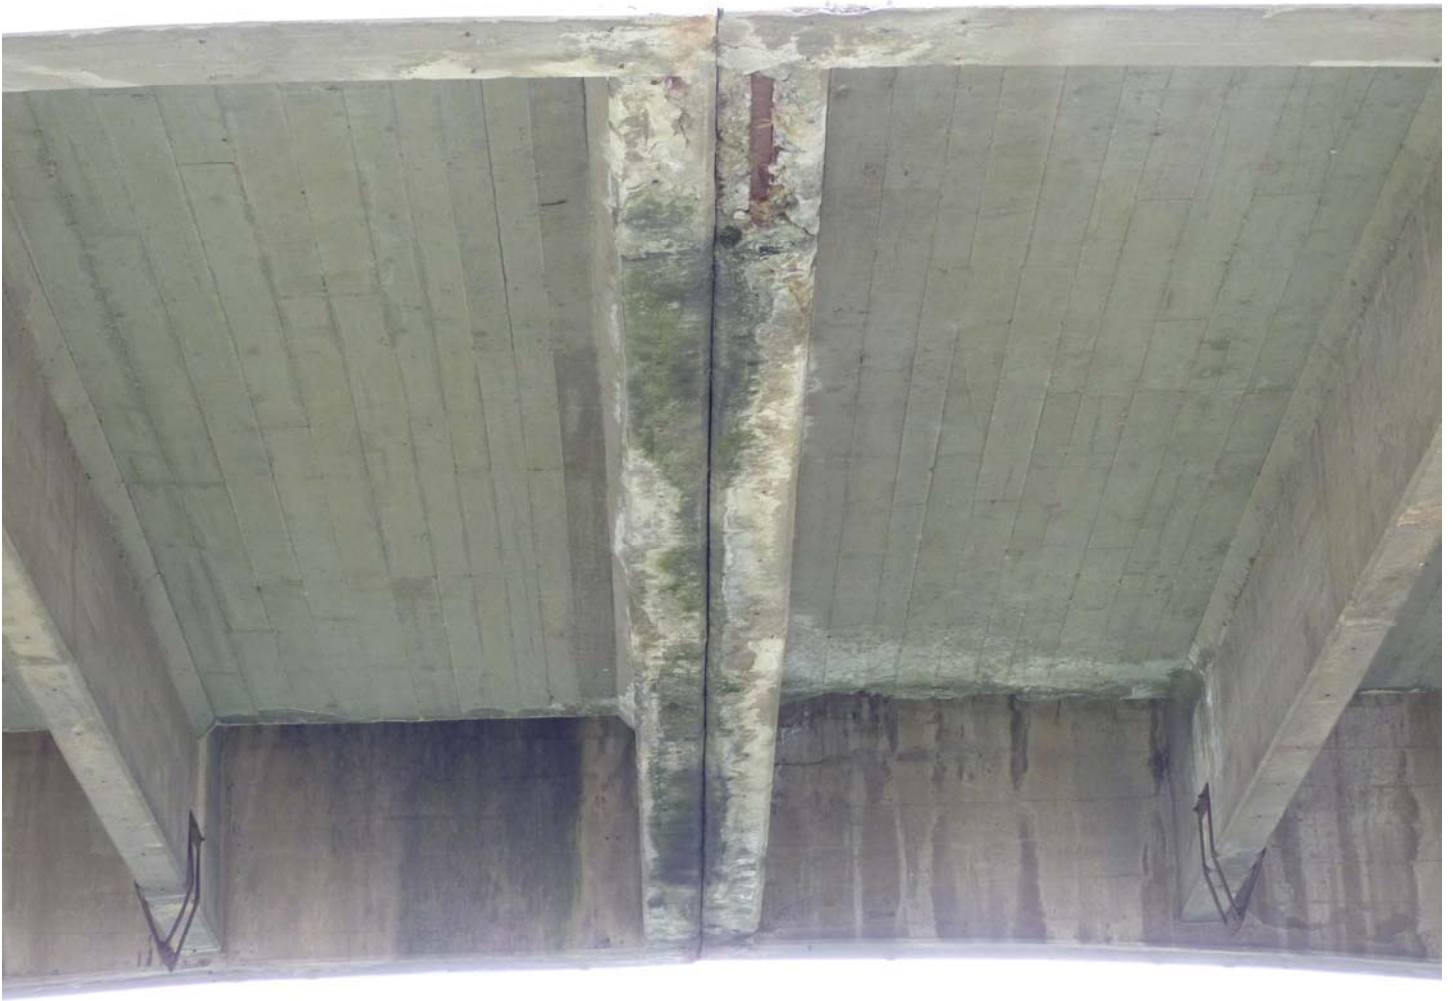
View under the deck at the center of a span on the Lion Bridge. Note the seam in the deck indicating where the two halves meet.

Usually, a concrete arch bridge (or any type of true arch) does not act like a cantilever. However, with concrete cantilever arch bridges, engineers designed the bridges in a manner where each half of an arch span functions independently on its own, as a cantilever extending from the pier or abutment. Typically, this required an internal reinforcing system more advanced than a traditional system of rebar. In the case of the Lion Bridge, reinforcement took the form of riveted steel trusses arranged in a cantilever form. These trusses were then encased in concrete. In this sense, the bridge could be thought of as a concrete encased steel cantilever truss bridge. However in the case of the Leonard and Day "canticrete" bridges, traditional rebar reinforcing rods were also added alongside the trusses before the concrete was poured to give the bridge additional strength.

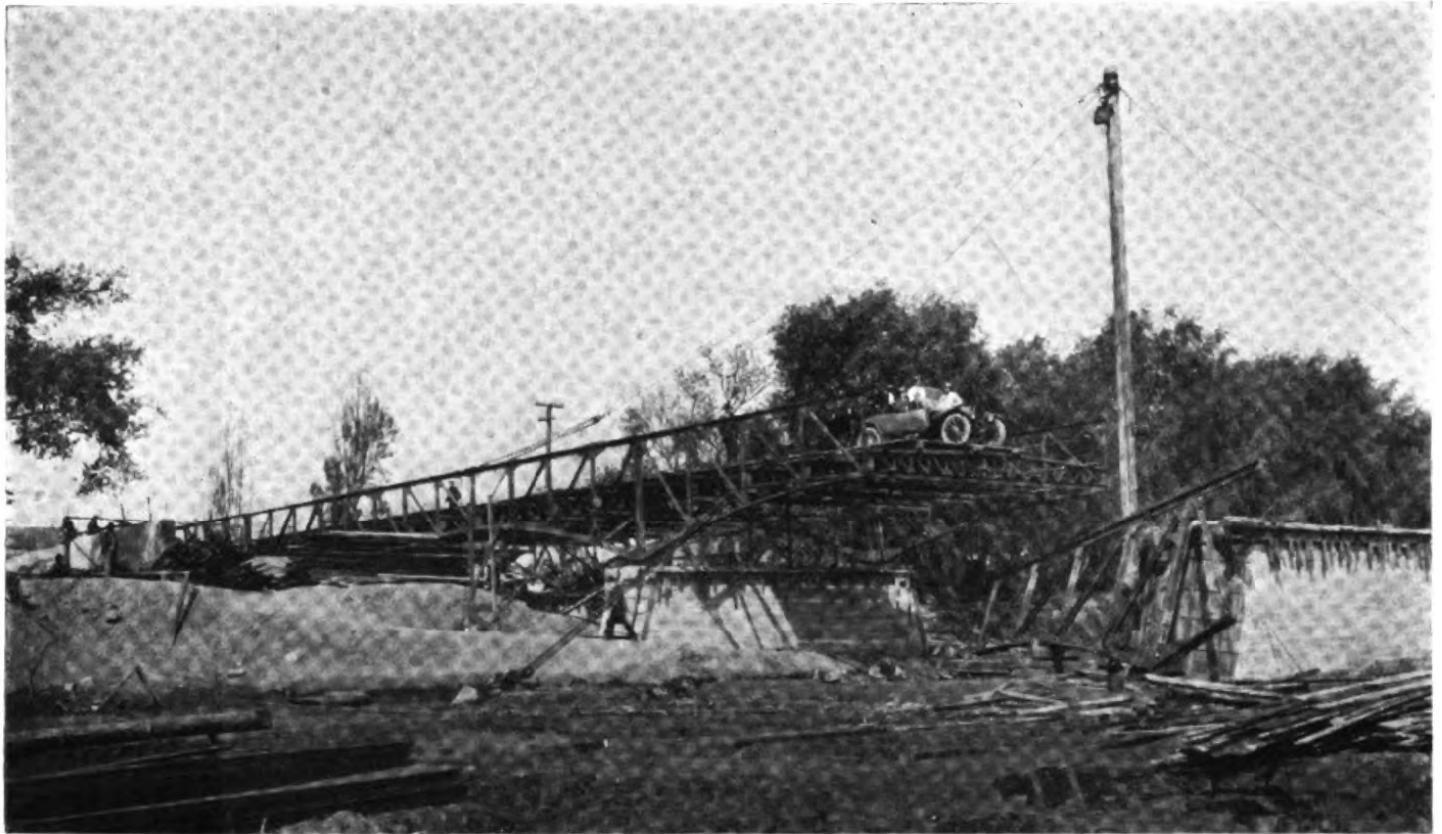
Construction Photo of Pajaro River Bridge: This Photo Shows A Canticrete Bridge With Its Trusses, Before Concrete Encasement
Source: The Architect and Engineer of California, 1919.
Digitized By Google.

This historical photo showing the construction of the Lion Bridge reveals the truss design of the internal steel reinforcing. Note how the trusses extend out from the pier and are able to support themselves without any additional aid, a demonstration of cantilever function.

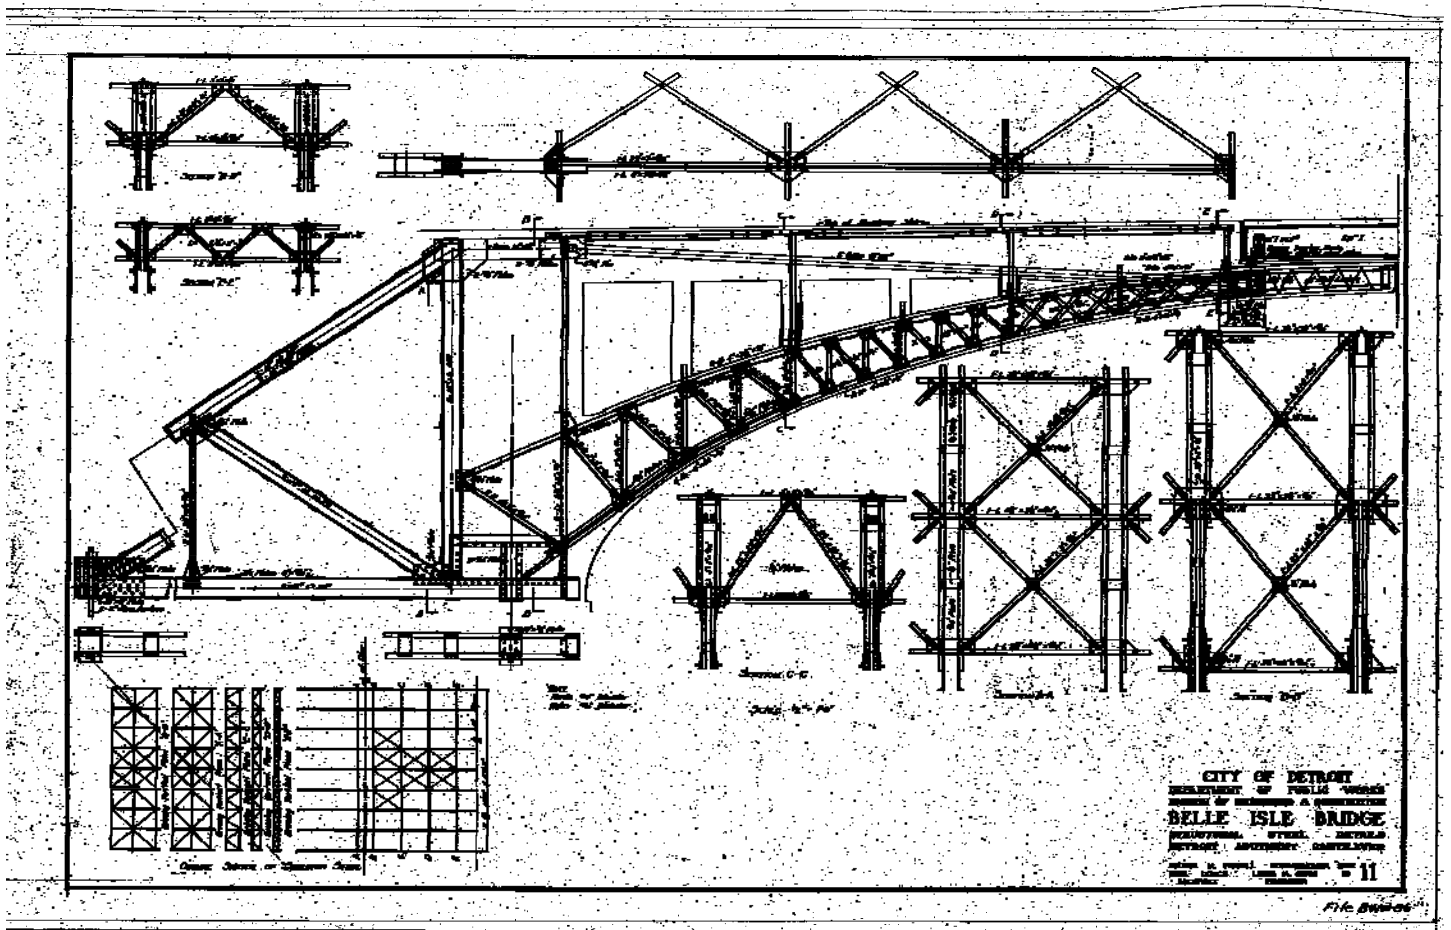
From the original construction drawings, this shows the reinforcing layout of the Belle Isle Bridge. Unlike the Lion Bridge, the Belle Isle Bridge only has trussed reinforcing in the arch ribs, with only an eyebar stay above, which enabled this bridge to feature an open spandrel design.

Cantilevered concrete arch bridges are extremely rare nationwide. Perhaps the only other large, prominent example is the Belle Isle Bridge in Detroit, Michigan. The Belle Isle Bridge makes a nice comparison to the Lion Bridge as its design differs a bit. Unlike the Lion Bridge, the Belle Isle Bridge only has trussed reinforcing

in the arch ribs, with an unusual eyebar stay system above. This design eliminated any reinforcing trusses in the spandrel wall, which also enabled the Belle Isle Bridge to feature an open spandrel design, which would not have been possible with the Lion Bridge's reinforcing layout. Unlike the Lion Bridge, the Belle Isle Bridge also includes short concrete slab segments that span over the ends of each half of the arch span at the center of the span. These slabs rest on the arches a small distance back from the actual center of the bridge. Among the most prominent and iconic landmarks of Detroit, the Belle Isle Bridge has been rehabilitated and preserved.

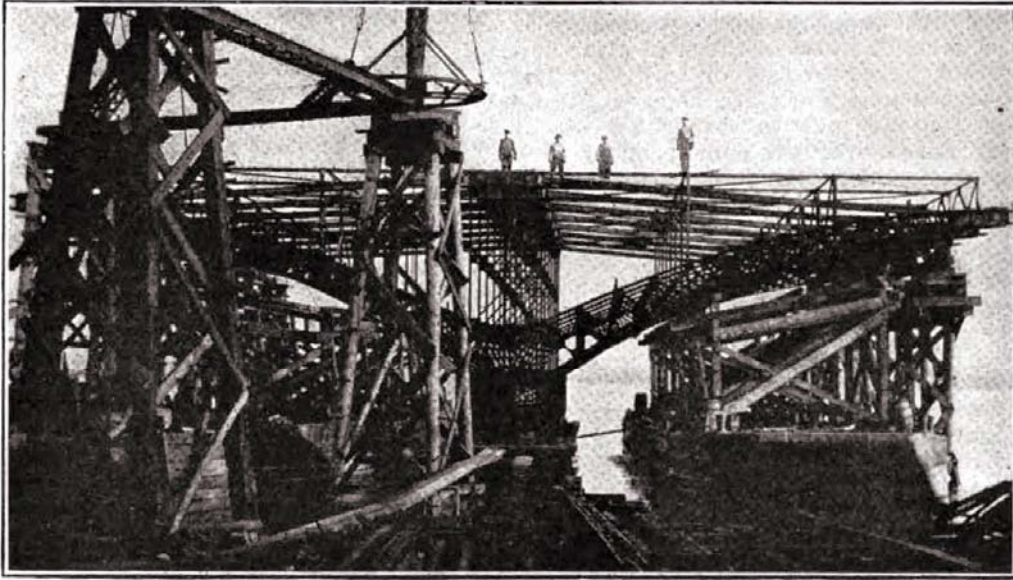
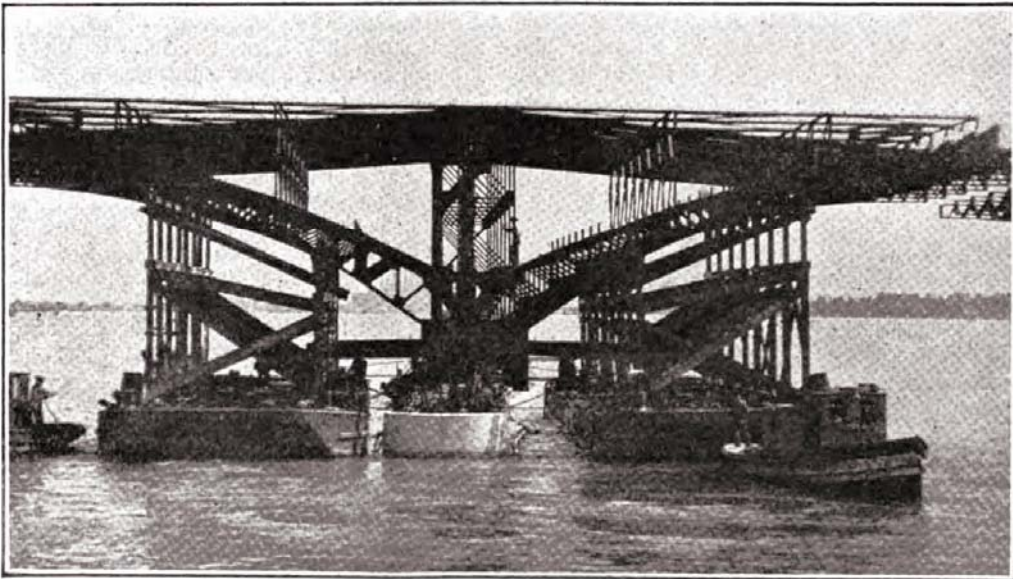
Bridge Construction Showing Interior Reinforcing

This photo shows the construction of the Belle Isle Bridge. Note the steel trussed ribs, which are supplemented by eyebars stays above.

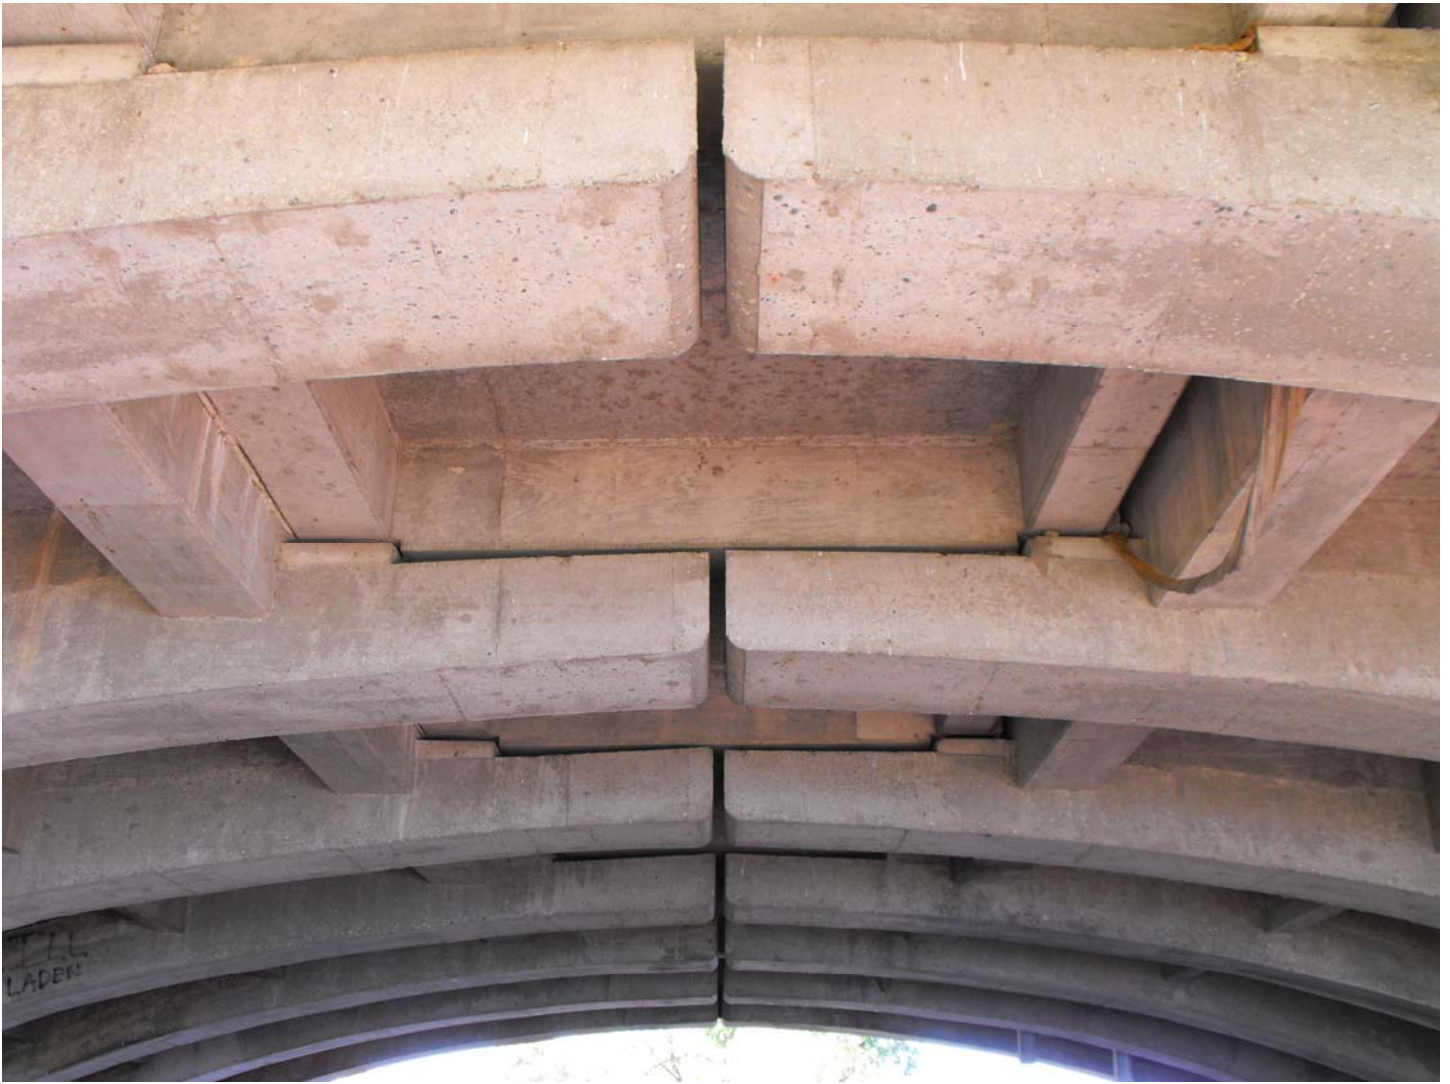
This photo shows the crown of a Belle Isle Bridge span. Note the separation between the two halves of the bridge. Unlike the Lion Bridge, the Belle Isle Bridge includes short concrete slab segments that span between each half of the arch span. These can be seen resting on the arches a small distance back from the actual center of the bridge in this photo.
