Did You Know...

... that the Edmund Pettus Bridge at Selma, Alabama, is one of the most architecturally significant bridges in Alabama? The bridge is one of the few historic bridges in America to be designated as a National Historic Landmark. The reason for this rare designation is the bridge's association with the civil rights movement, particularly Bloody Sunday on March 7, 1965, when law enforcement violently stopped marchers who were fighting for voting rights legislation. The bridge's significance in the more traditional areas of engineering and architecture is often overlooked in the shadow of this major event in American history.

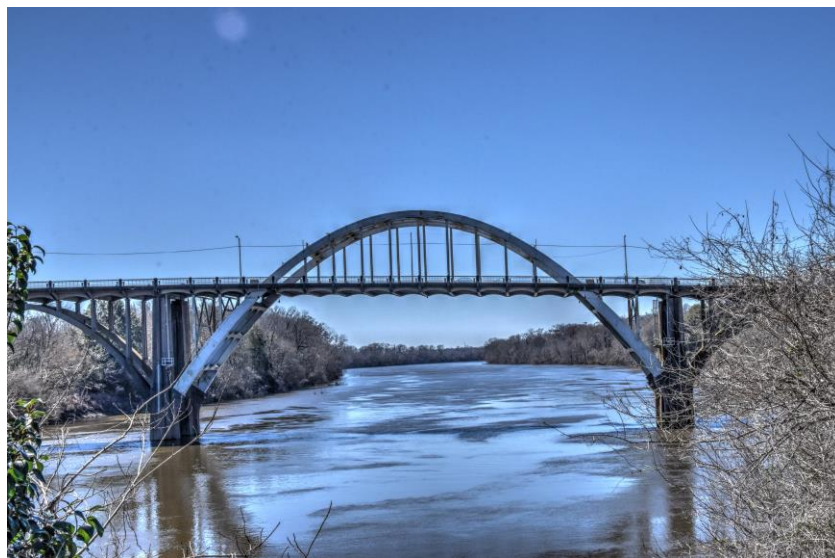
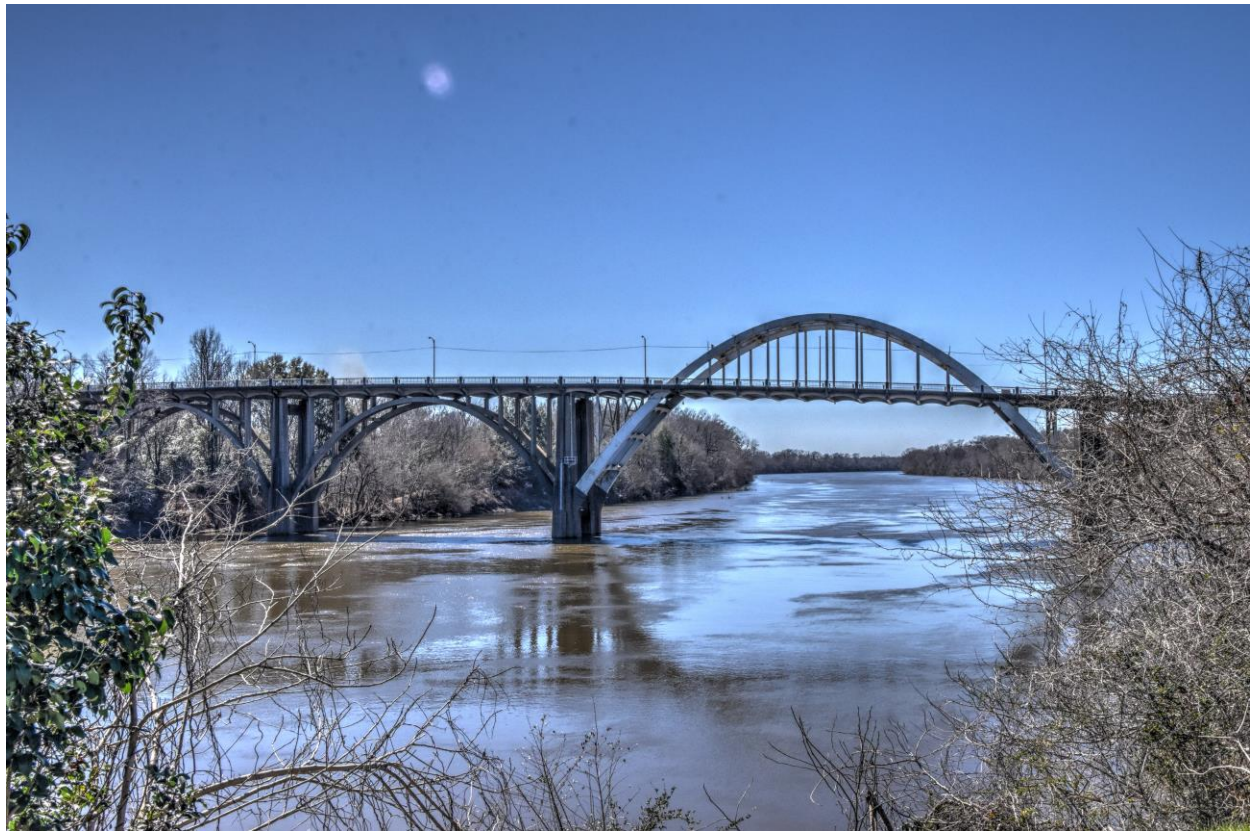
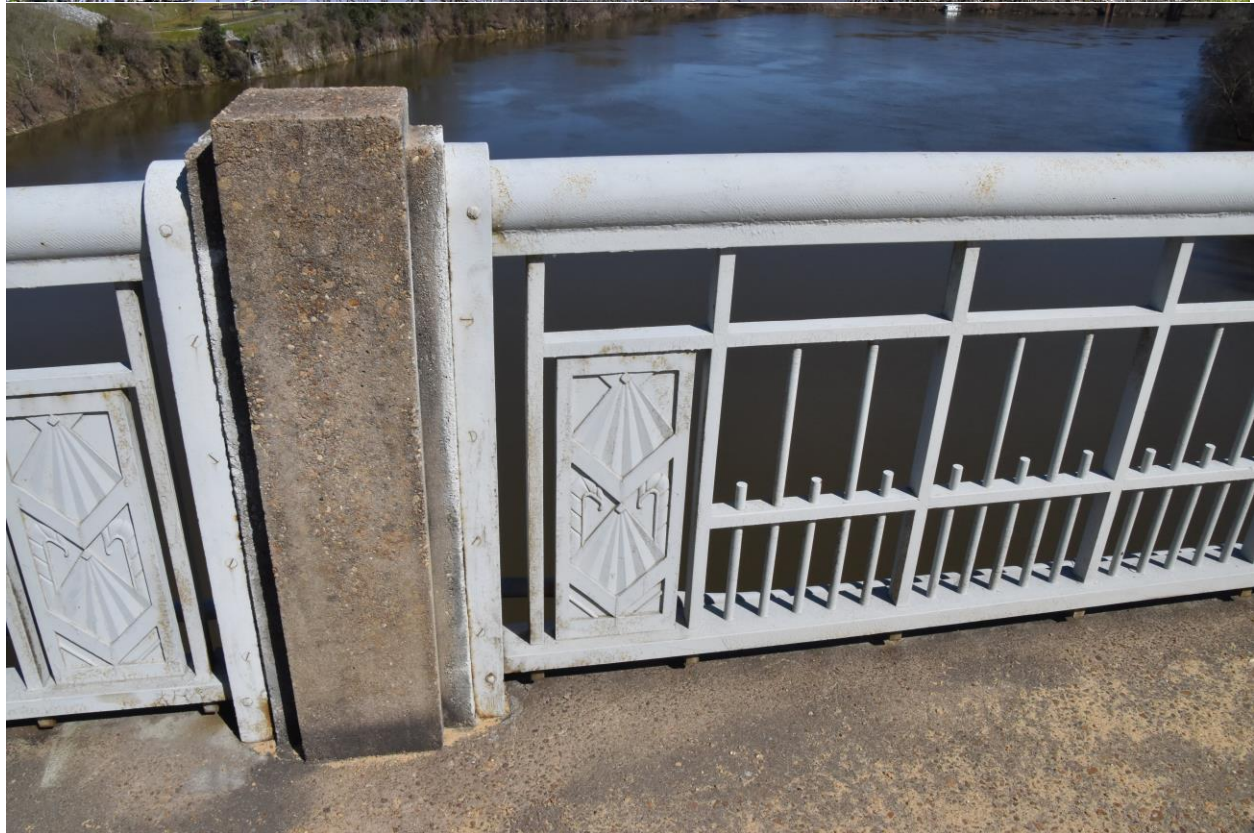
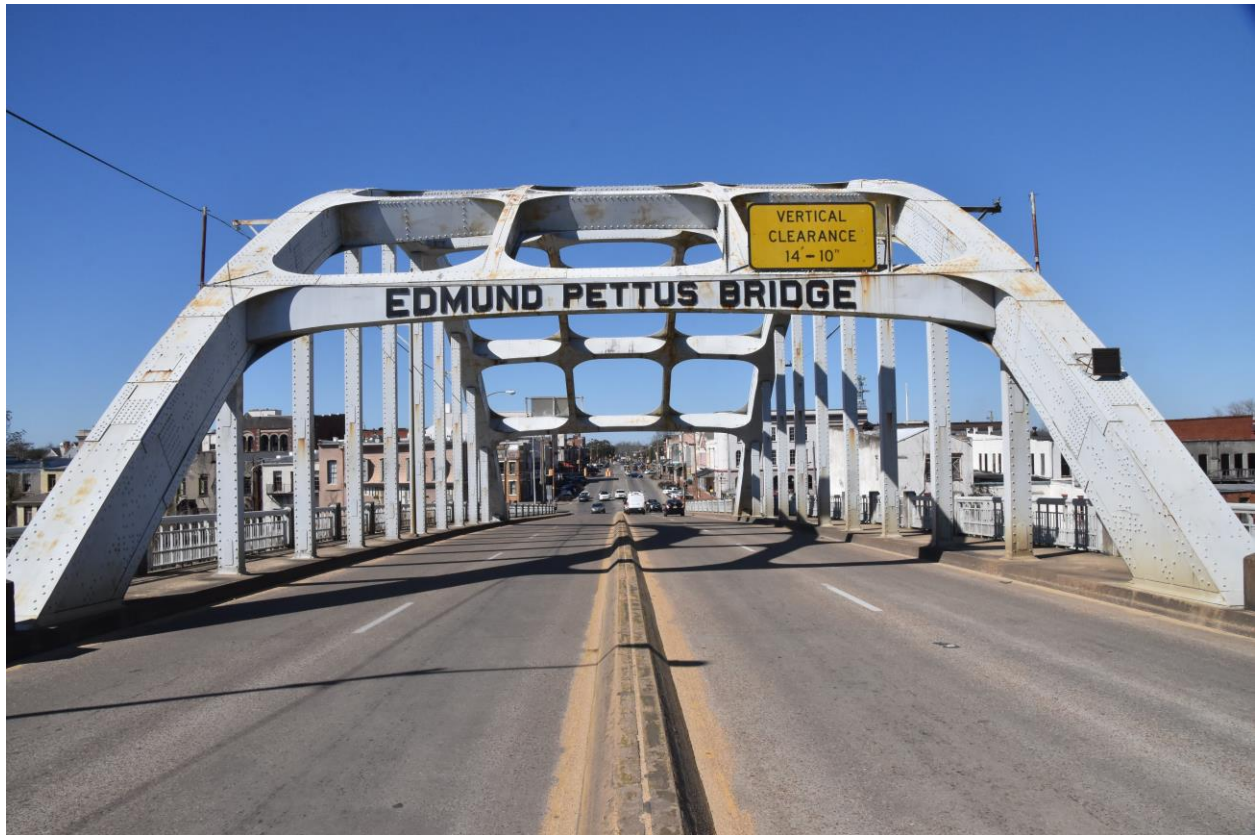
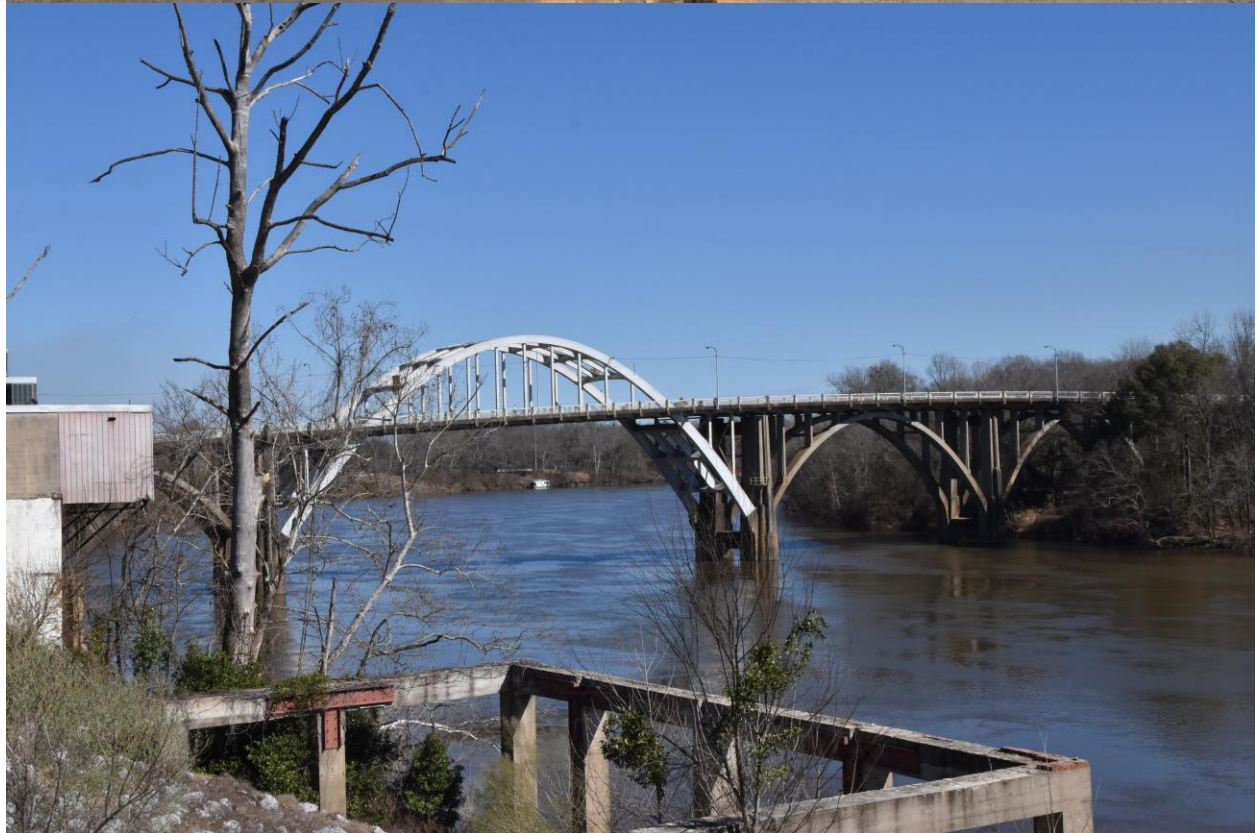
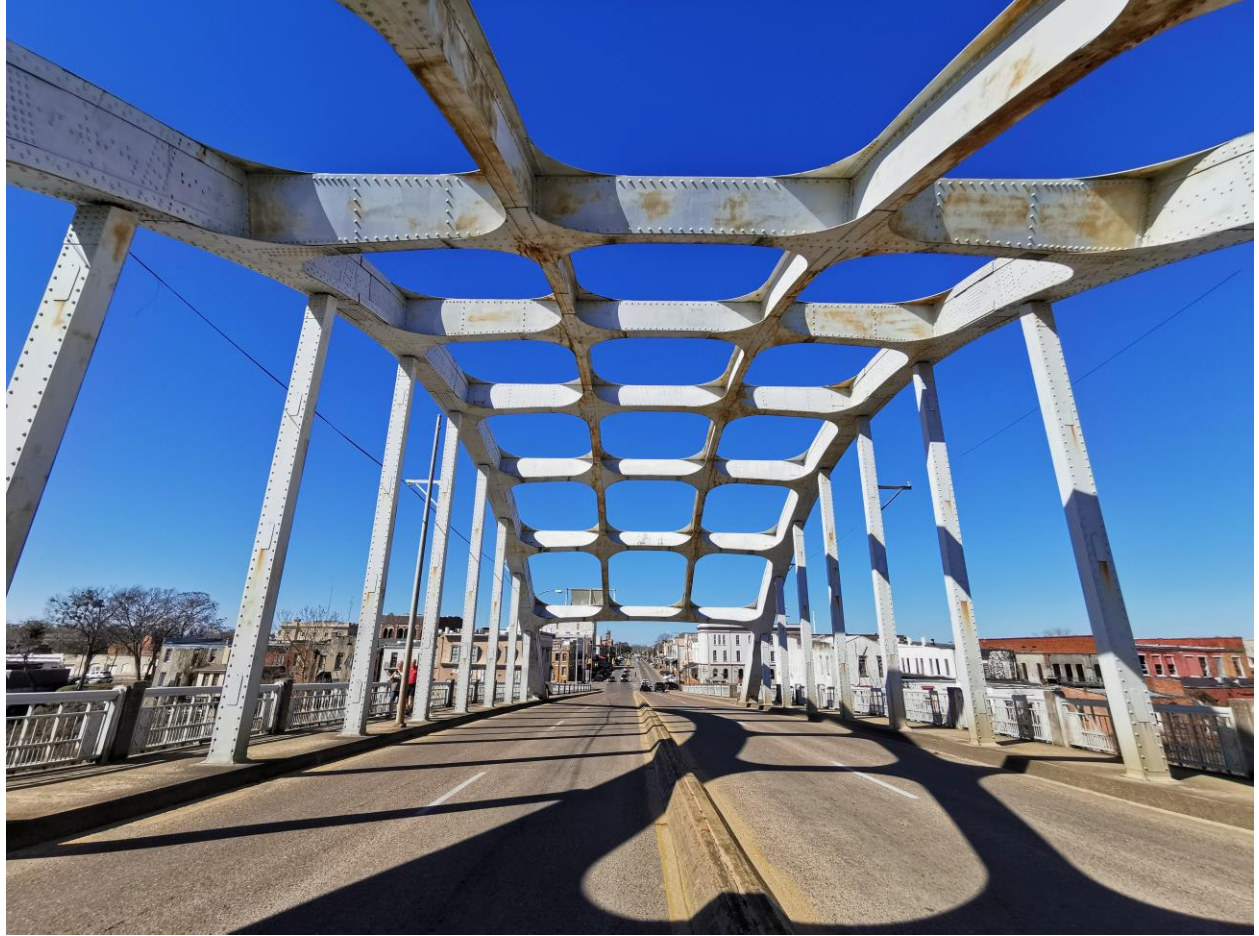
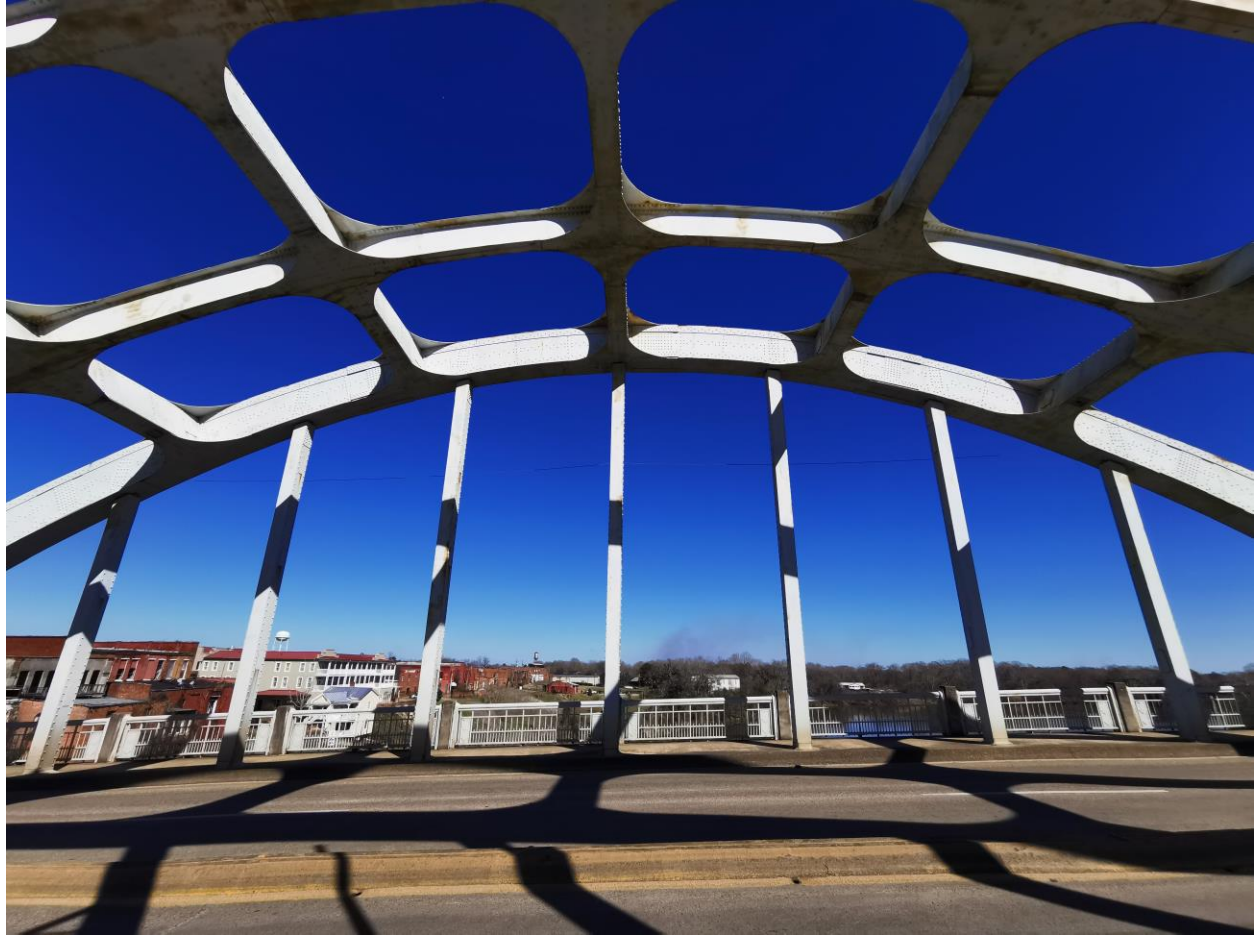
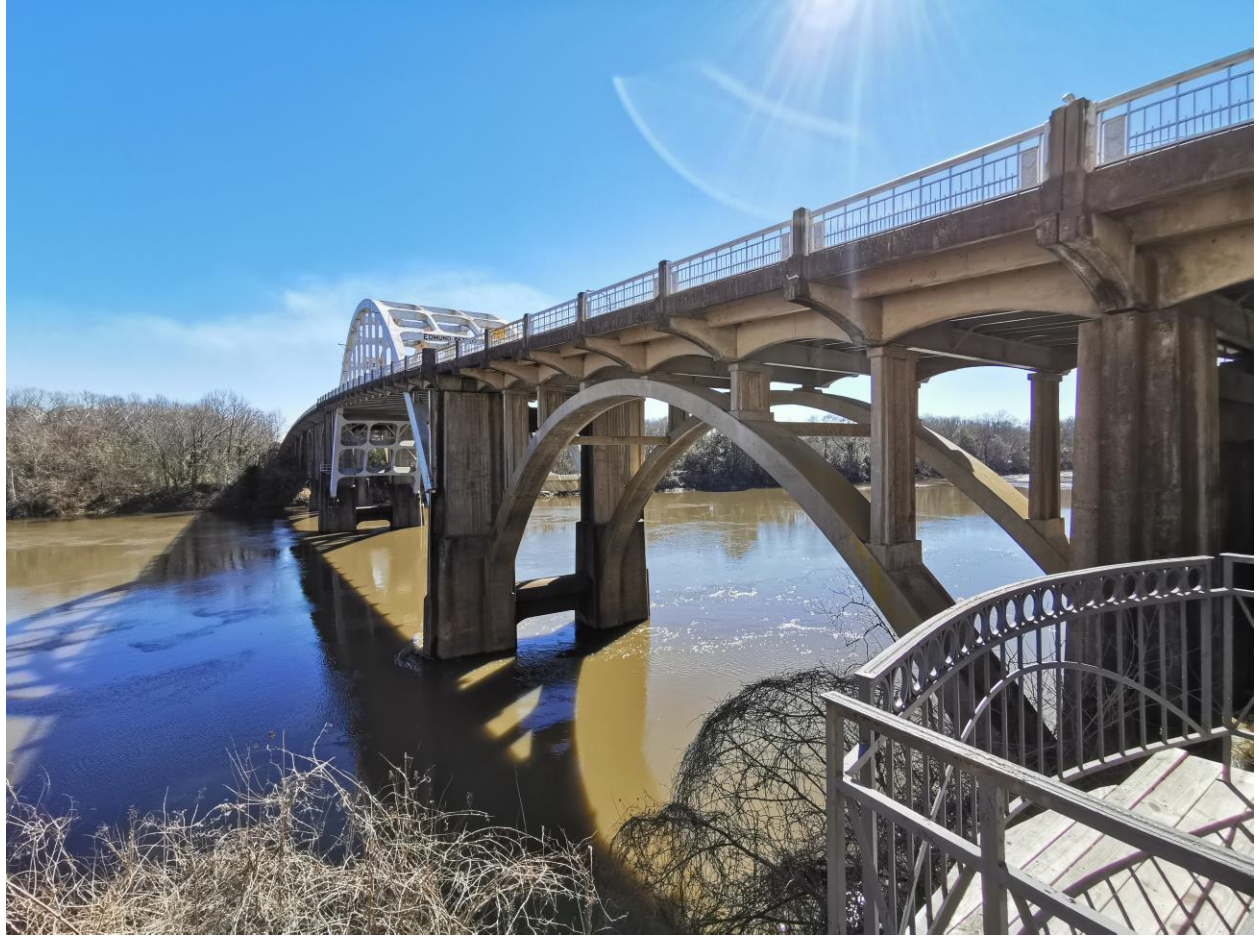
The bridge was completed in 1940s, and consists of a 250 foot steel through arch main span, which has overhead bracing. The steel arch springs from concrete piers below the deck, with arches that rise above the roadway. The bridge also features 10 concrete open spandrel deck arch approach spans, which vary in span length from 41.5 feet to 154.5 feet. The overall length of the bridge is 1,248.6 feet, and the bridge features a total deck width of 56 feet.

The bridge has a number of unique architectural features. The steel sidewalk railings are of particular interest. The panels include ornate Art Deco style plates within each panel. The top of the railing features a steel pipe that was rolled by Bethlehem Steel. The steel arch span is also noted for its striking overhead bracing design which differs from traditional period design. The bracing steel is laid out in a grid-like arrangement, with curved details at the corners where the members intersect, forming a unique overhead pattern of rounded rectangles.
