The story of the bridge

A strategic location

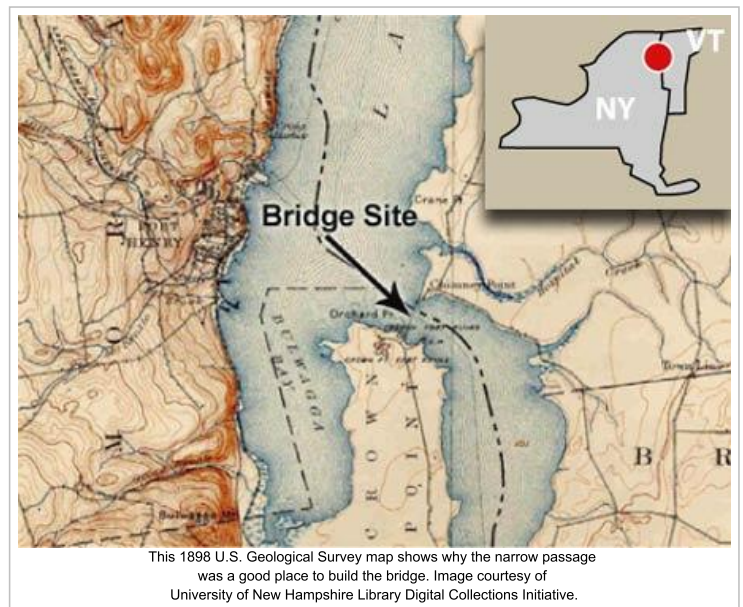
This 1898 U.S. Geological Survey map shows why the narrow passage was a good place to build the bridge. Image courtesy of University of New Hampshire Library Digital Collections Initiative.

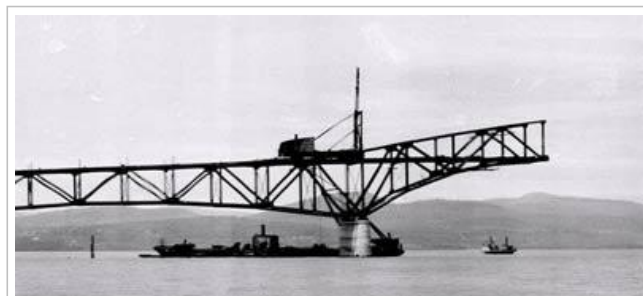
Innovative construction methods allowed the erection of cantilevered steel chords without the need for temporary supports.
Photo courtesy of Vermont State Archives.

Spofford’s approach to these design challenges was to refine the “continuous beam” or “truss” technology, already popular with railroad engineers, and which had the advantages of cost savings and more efficiently distributing stresses. The Lake Champlain Bridge was the first long highway bridge to use that continuous truss technology. Spofford advanced this technology by using a cantilever system to create a graceful transition between the approach spans, with low curving deck trusses, and the arching through truss channel span. This design not only solved the problem of a visually awkward transition where the deck truss and the through truss meet, it also reduced construction costs.

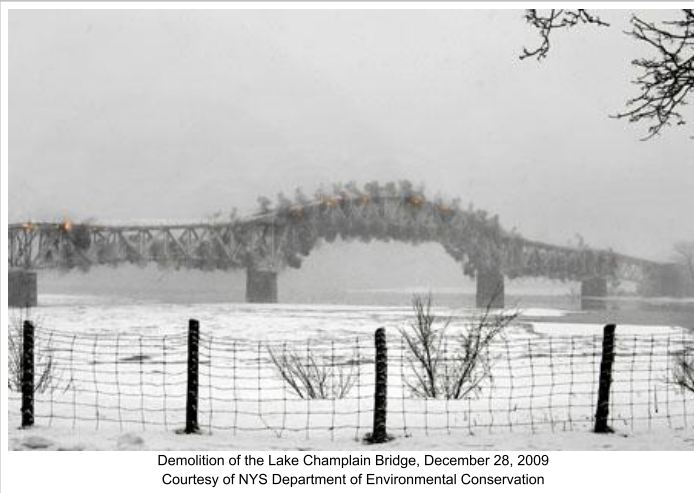
Demolition of the Lake Champlain Bridge, December 28, 2009
Courtesy of NYS Department of Environmental Conservation

Engineering evaluation showed that while short-term and long-term rehabilitation or replacement of the piers was technically possible, it could not be guaranteed as a long-term solution. Furthermore, the fragility of the bridge condition would have resulted in unacceptable danger to construction workers, and led to a decision to demolish rather than rehabilitate the bridge. The 1929 Lake Champlain Bridge was demolished by implosion on December 28, 2009.

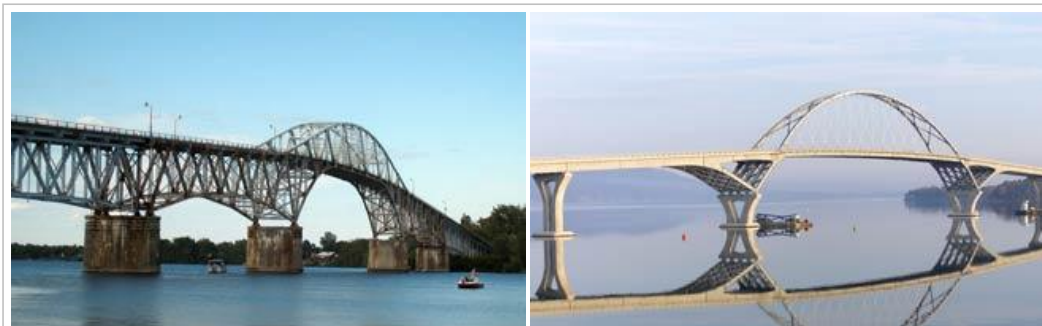
One large span, rising high above the lake's navigational channel, is a strikingly similar feature of the 1929 and 2011 Lake Champlain Bridge. Image (right) © Andy Ryan, photo courtesy of HNTB

The new Lake Champlain Bridge is a different design from the 1929 bridge. Yet, the arching form of the new design is reminiscent of the old bridge and responds to the scenic quality of the area in a similar way. Many people preferred this design because it evokes the elegance of the original bridge.
