Historic Bridge Bulletin

Volume 2, Number 3
November 2015

What is a Fracture Critical Bridge, and Why Does It Matter?

Case Study: Opie Road Bridge, New Jersey

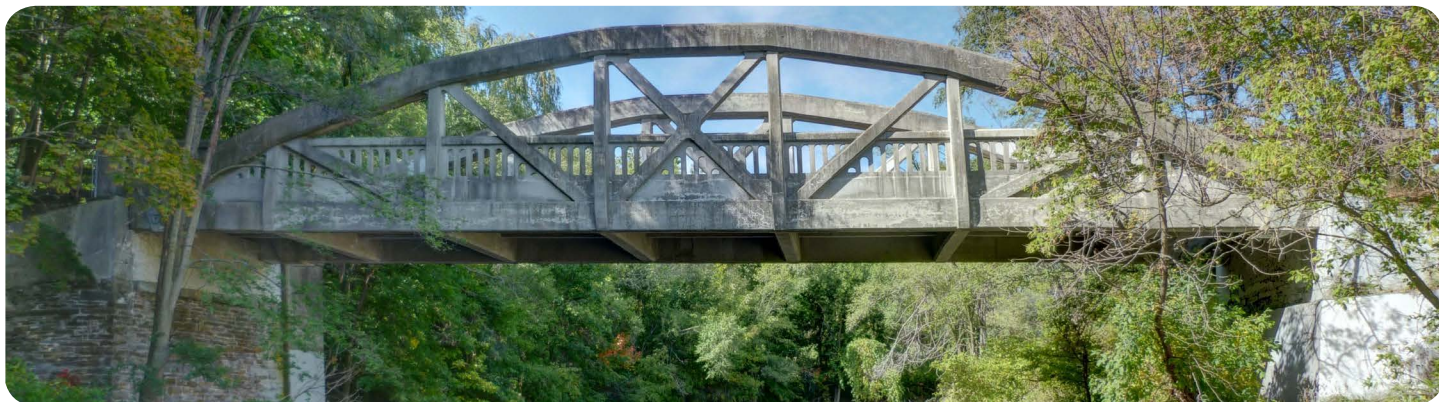
Built in 1909 to carry Middle Road over Etobicoke Creek at what is today the western border of Toronto, Ontario, this concrete bowstring truss bridge was the first in Canada. It is preserved for pedestrians. *Photo by Nathan Holth.*

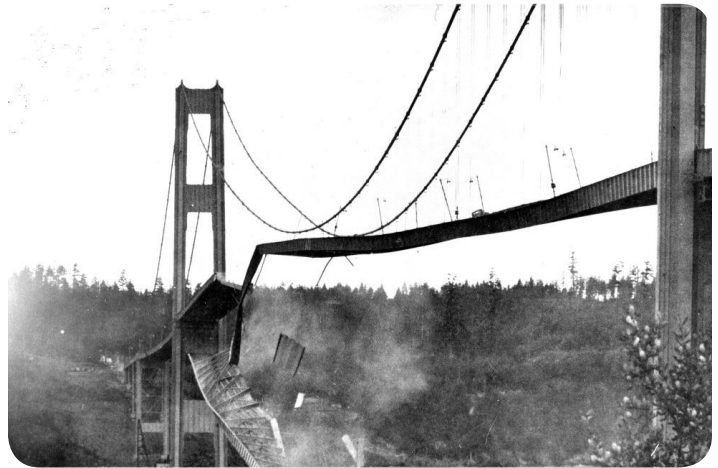
Collapse of Galloping Gertie, November 7, 1940. *Courtesy WSDOT.*

The euphoria of the moment was to be short-lived. Galloping Gertie’s oscillating deck prompted Murrow and Eldridge to install tie-down cables in a vain attempt to calm the bridge’s movements. But the problems outpaced potential remedies, and on the morning of November 7, 1940, Galloping Gertie’s center span ripped itself apart in winds clocked at just over 42 mph. Its plate girder deck created a vortex of swirling wind, contributing to its “torsional flutter,” the self-generating twisting motion that ended the bridge’s brief life. Gertie was to be the last suspension bridge designed without wind-tunnel testing to

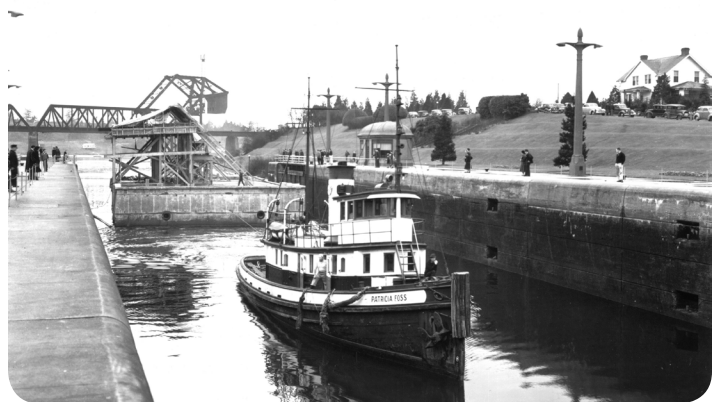
Pontoon in Ballard Locks in transit to Lake Washington, January 27, 1940. Photo by Alfred Simmer, courtesy WSDOT.

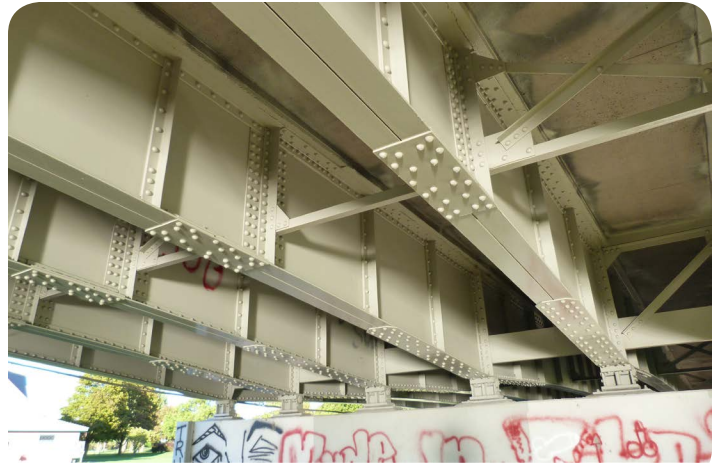
This 1938 continuous bridge's design consisting of eight parallel riveted built-up beams potentially offers all three types of redundancy. *Photo by Nathan Holth.*

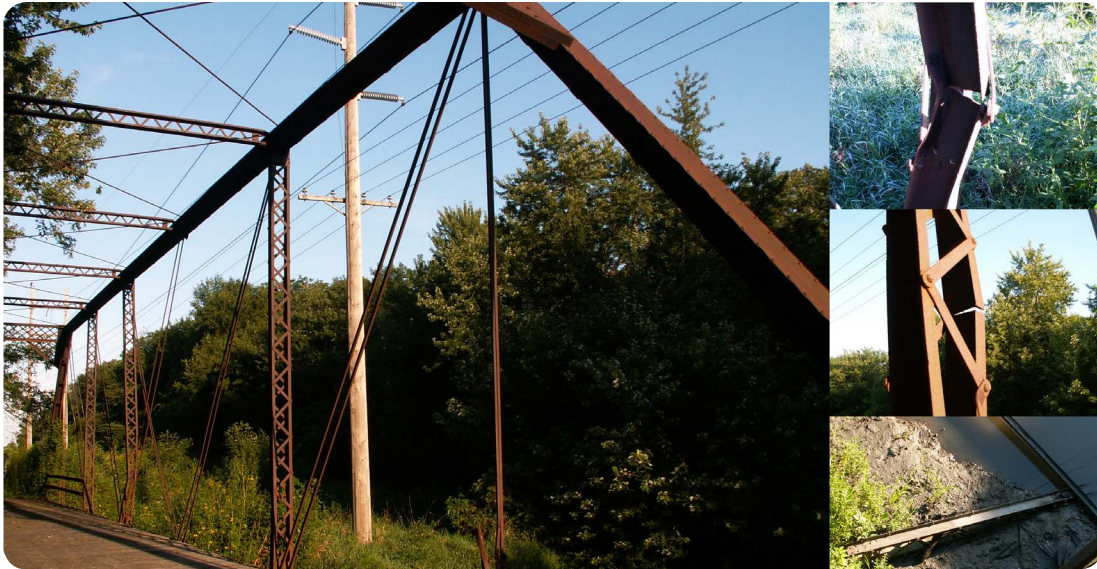
A collision severely damaged one vertical member of this pin-connected truss bridge. Another vertical was broken and fell into the river. Although this severely compromised the bridge, these members were compression members, and do not meet the definition of fracture critical members. The bridge was closed but did not collapse during this event.

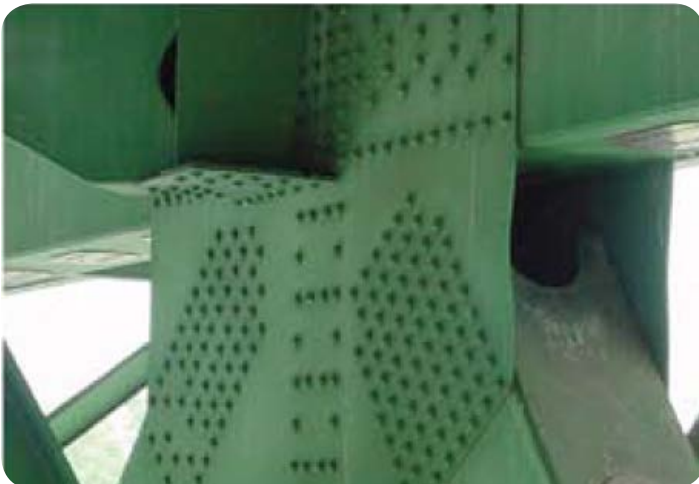
The U10 node on the I-35W Bridge. The gusset plate shown here was improperly designed, and after decades of use failed and caused the collapse of the bridge when it was subjected to a heavy load. Photo from NTSB I-35W Accident Report.

Per the official NTSB Accident Report, the I-35W Bridge collapse was initiated when a single connection failed because this connection’s gusset plate was one of several gusset plates on the bridge that were incorrectly designed when the bridge was first built. These gusset plates were not thick enough to provide the needed strength. Because this bridge was a fracture critical bridge, lacking load-path redundancy, failure of the single connection caused the collapse of the bridge as a whole.

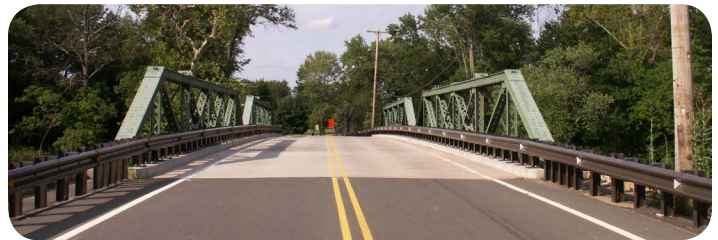
The bridge trusses and roadway after the project. *Photo by Nathan Holth.*

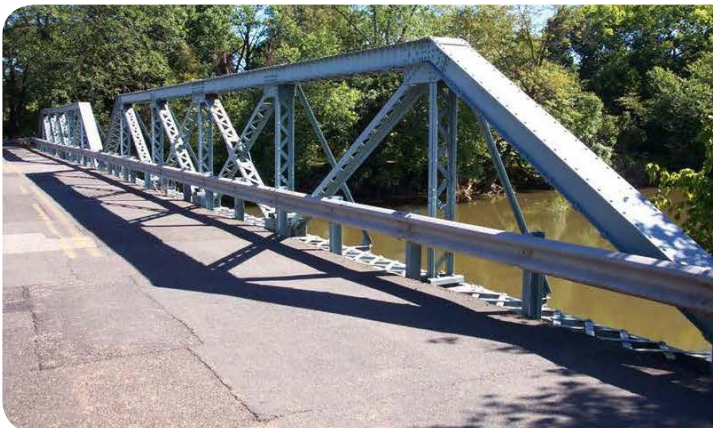
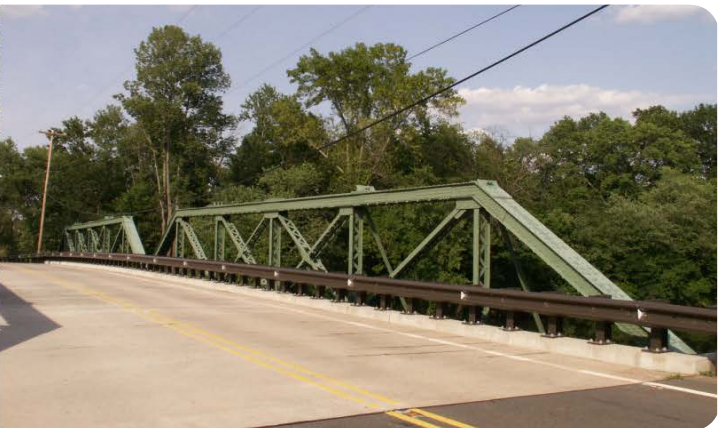
The Opie Road trusses and deck before the project (left) and after (right). *Before photo courtesy Mary Delaney Krugman Associates and after photo by Nathan Holth.*

The scope of the project was to widen the bridge's roadway from the original width of approximately 18 feet to 28 feet, while also addressing deterioration and eliminating a posted weight limit of 10 tons. As one might expect, increasing the roadway by 10 feet, while also increasing the weight limit, meant that a lot of alteration and strengthening had to take place. Indeed, an interpretive sign installed at the bridge describes the project as construction of a replacement bridge, with the new bridge utilizing refurbished trusses from the original bridge. During the project, the abutments and pier were replaced. The wider bridge required new floor beams and a new deck. The trusses from the historic bridge were strengthened by adding post-tension rods to tension members. Additionally, a number of members had plates bolted to the inside of members. Some members also had plate welded to them. The careful placement of added plate and use of button-headed bolts show an attempt to minimize the visual impact of these additions.

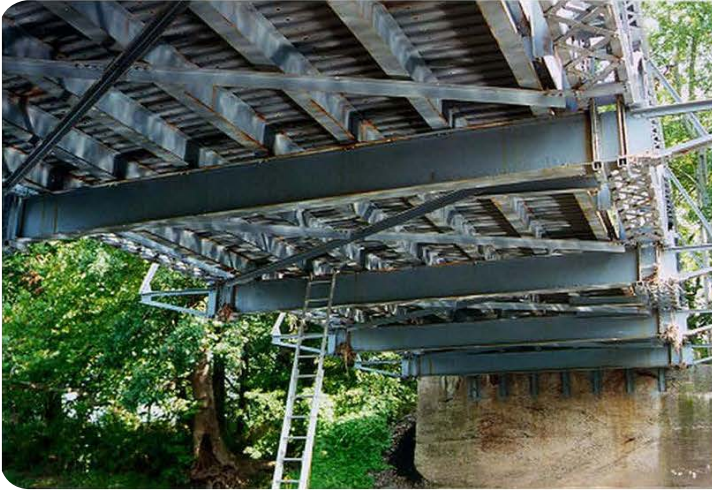
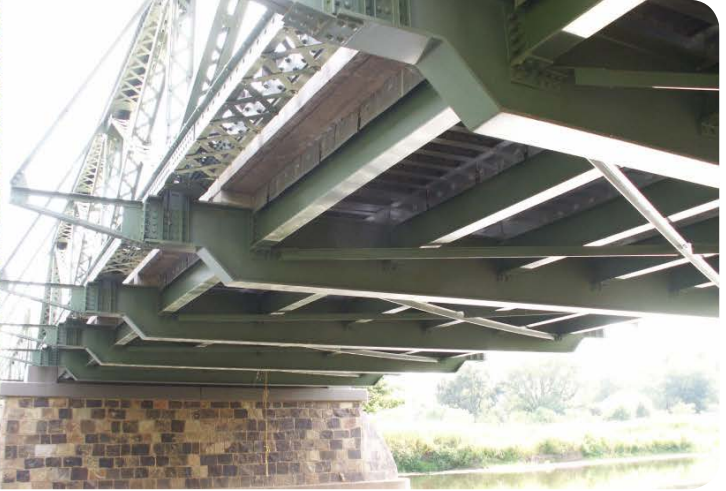
The Opie Road Bridge floor beams before the project (left) and after (right). *Before photo courtesy Mary Delaney Krugman Associates and after photo by Nathan Holth.*
