# Historic Bridge Bulletin

## Zenas King and the Bridges of New York City (Part II) King Bridge Company Projects in New York City

## Case Study: East Delhi Road Bridge

### Rehabilitating Historic Stone Arch Bridges in Western Maryland

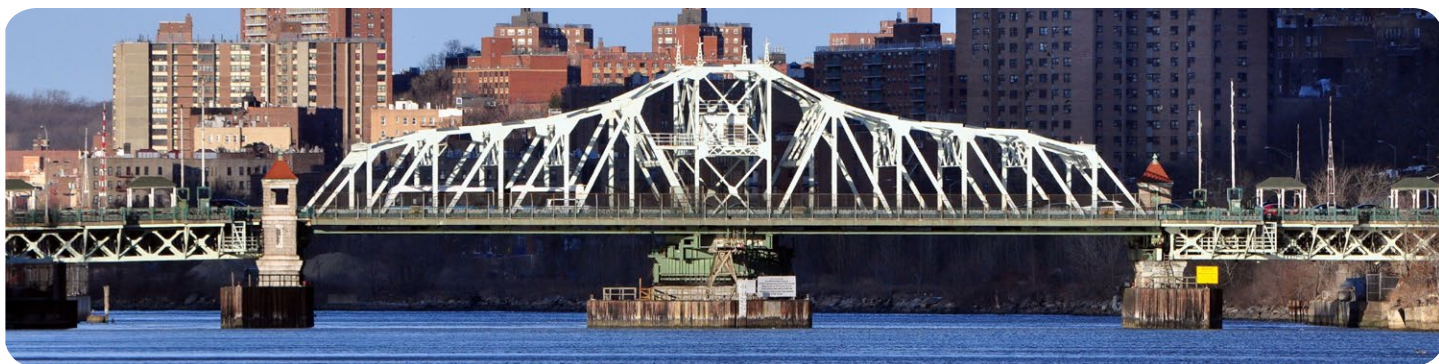
**The University Heights Bridge as it exists today.** Photo by Robert, flickr.com/photos/rbs10025/ CC BY-NC-ND 2.0.

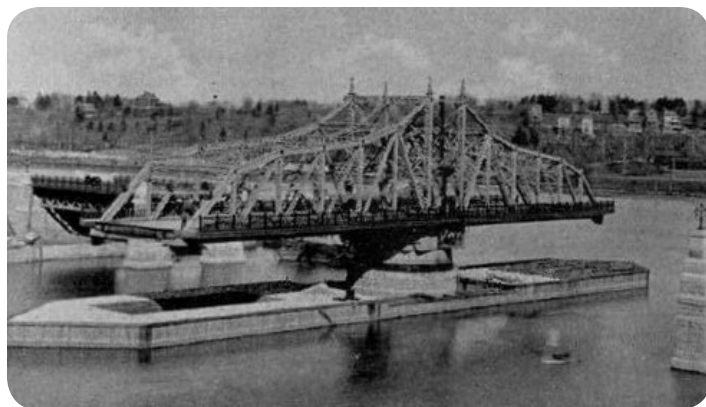
**The Broadway Bridge later became the University Heights Bridge.** Historical Photo.

instead of demolishing the bridge, the powers that be decided to float the superstructure about a mile down the Harlem River to replace the old footbridge a 207th Street and Fordham Road. It became the University Heights Bridge.

The Broadway Bridge, as it was called, was designed by Engineer Albert P. Boller. Boller, who was a consultant to the newly created New York City Department of Bridges, was responsible for the designs of many of the bridges still standing across the Harlem River, including the famous Macombs Dam Bridge. The King Bridge Company must have had good relations with Boller since both of the King bridges were built to his unique designs. When plans were made to extend the Broadway subway line into the Bronx, the Broadway Bridge had to be replaced to accommodate both rail and street traffic. But

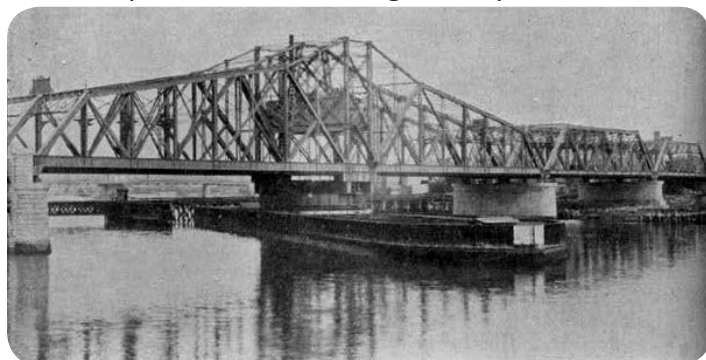
**Park Avenue Railroad Bridge.** Historical Photo.

The bridge was known as the Park Avenue Bridge and consisted of a swing span of 389 feet and four fixed trusses of lengths varying from 131 to 185 feet. The cost of the bridge was shared by New York City and the Vanderbilt interests, and was used for close to 60 years by the New York Central and New Haven Railroads as a key link to Grand Central Station.

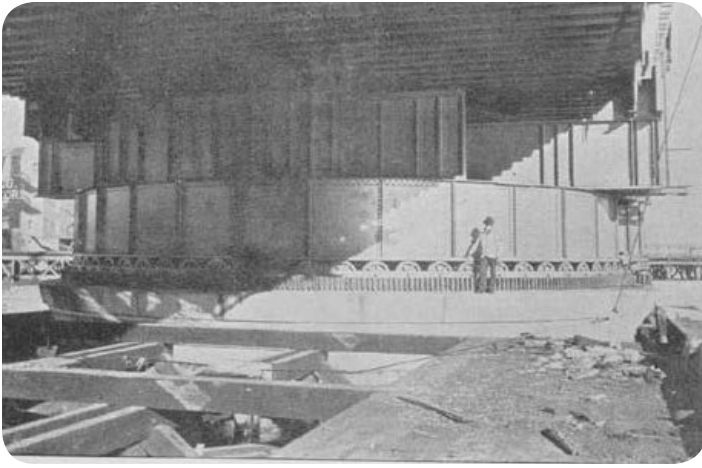
**Double-drum turntable, Park Avenue Railroad Bridge.**  
*Historical Photo.*

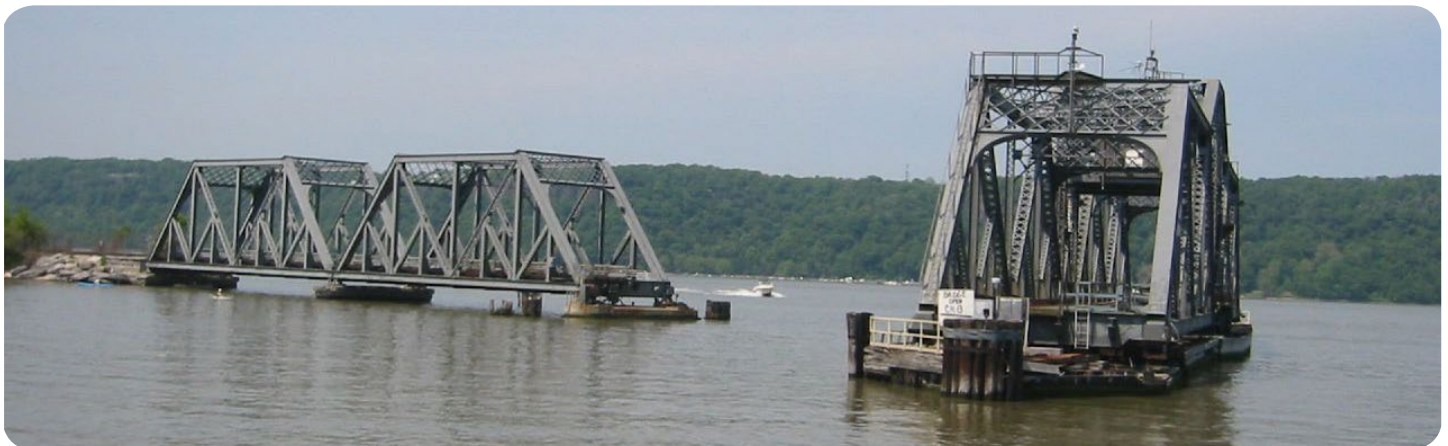
**Spuyten Duyvil Bridge in open position.** *Photo by WorldIslandInfo.com.*

To accommodate boat traffic moving from the creek into the Hudson River, the swing span has to be opened often, particularly during the warm weather months when the tour boats of the Circle Line and others make their dramatic entrance onto the Hudson through this portal.

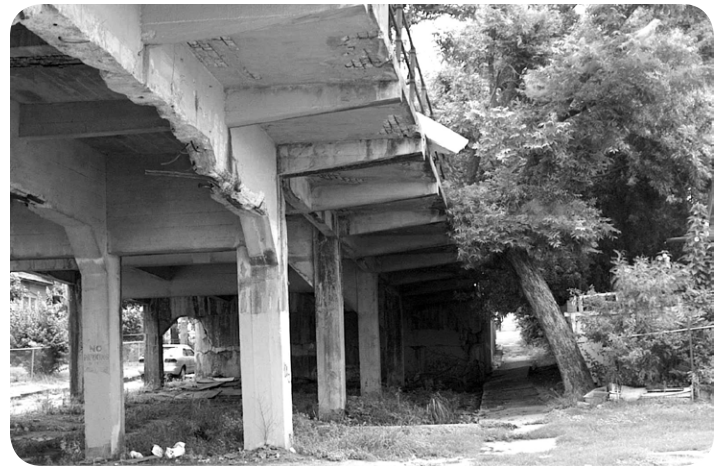
**Concrete approach spans for the Hays Street Bridge prior to rehabilitation.** Photo by Patrick Sparks.

an engineer for the project--Sparks Engineering of Round Rock, Texas. The rehabilitation involved rebuilding the bridge's two elevated concrete approaches, structurally rehabilitating and painting the truss spans, and adding lighting, landscaping, and interpretive signs. To ensure compatibility with the bridge's character, the work was carried out in accordance with the Secretary of Interior's Standards for Rehabilitation.

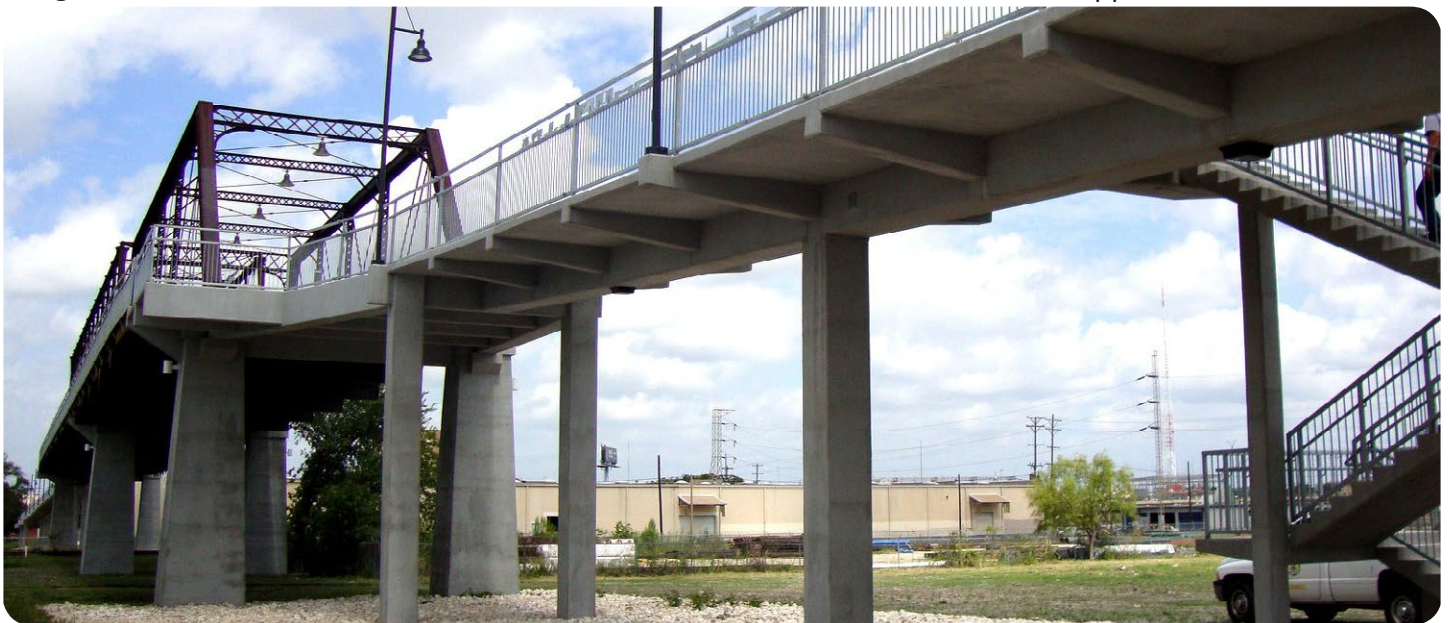
**Hays Street Bridge after rehabilitation, showing new approach spans to the right.** Photo by Patrick Sparks.

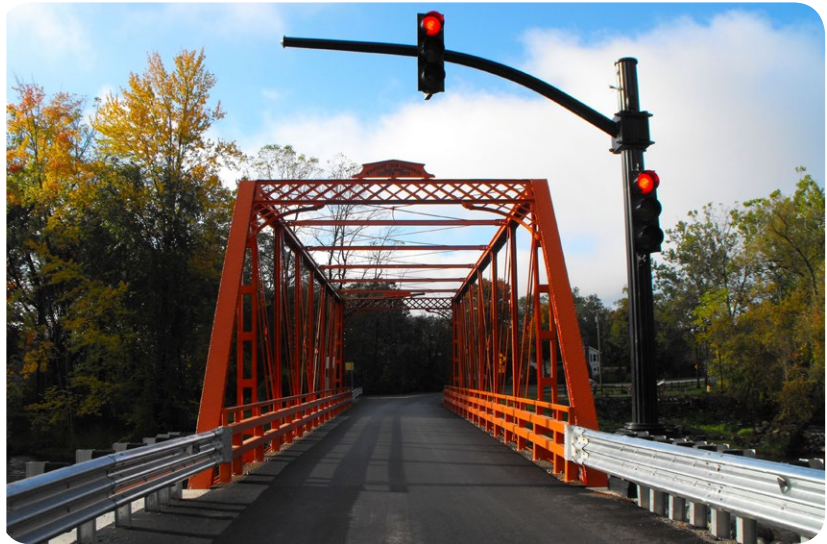
*Photo by Nathan Holth.*

- **Location:** Washtenaw County, Michigan
- **Type:** 109 foot single span, pin-connected Pratt through truss. Built ca. 1883 by Wrought Iron Bridge Company of Canton, Ohio. 16 foot (one lane) roadway.
- **Purpose of Rehabilitation:** Continued vehicular use in original location.
- **Year of Rehabilitation:** 2009
- **Details:** This closed bridge gained strong preservation support from locals. There are several aspects of the rehabilitation that are noteworthy.

The original railing had been removed and replaced with a guiderail mounted to the trusses. This was removed and replaced with a steel tube guiderail mounted on the deck rather than the trusses, which better protects the historic trusses from damage. Only one of the two identical builder plaques remained on the bridge. Two replica plaques were cast from the original and put on the bridge, while the original plaque was placed into storage. This solution protects the original plaque from damage or theft and it can serve as a pattern for additional replicas if needed.

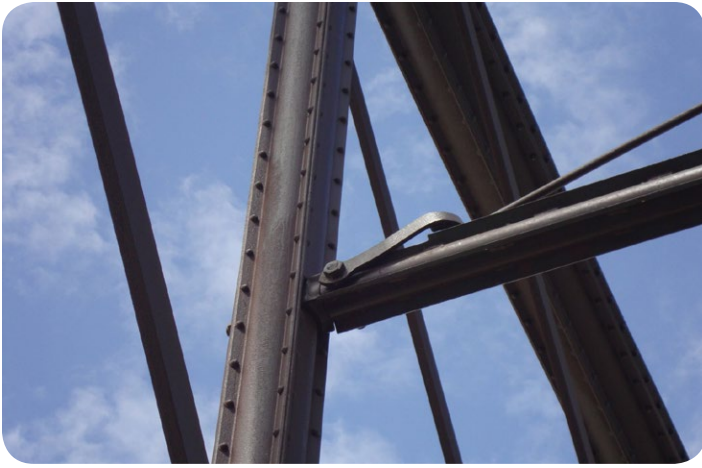
**Phoenix columns on the Hays Street Bridge.** *Photo by Patrick Sparks.*

One span was a 130 ft. long Pratt truss and the other (and more historically significant) was a 225 ft. long Whipple truss built by the Phoenix Bridge Company of Pennsylvania. The spans were easily dismantled and moved to San Antonio because the joints were connected with large removable laminated steel pins. The spans were widened from their original 16 ft. width to 25 ft. to carry vehicular traffic, which in 1919 was mostly wagons.

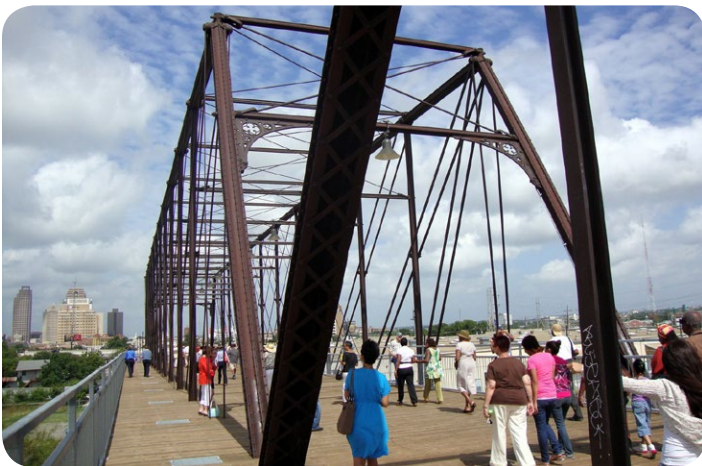
**The Hays Street Bridge after rehabilitation was completed and the bridge opened to pedestrians.** *Photo by Patrick Sparks.*

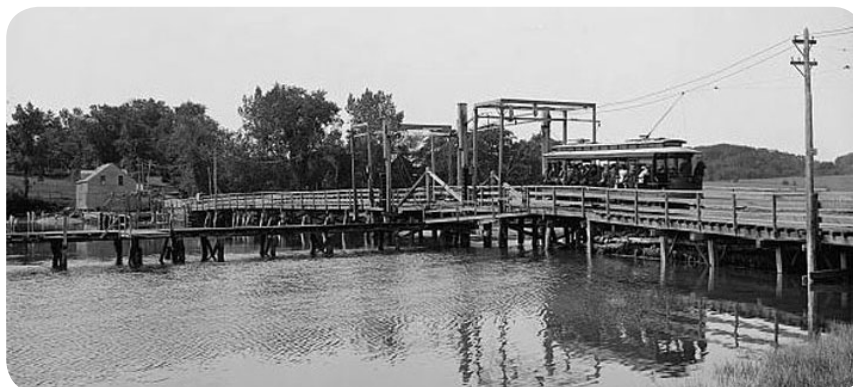
**Sewalls Bridge before reconstruction. Historical Photo.**

replacement, but Maine made funds available only for a concrete or steel structure. A battle developed between the preservationists, who wanted the new bridge to retain the historic structure of the original, and the moderns, who want a steel structure and the state subsidy. The preservationists prevailed, not through appeals to history but by hiring a bridge

builder who showed how a wood replica would actually be less expensive, and that the money that would otherwise have gone to bondholders could pay for maintenance of the wood structure. With the aid of press coverage, preservationists convinced the governor to take the subsidy anyway. All was well with the replacement replica bridge until an inebriated driver plunged his truck off it in 2011. Reconstruction was needed and this time no one objected to a replica of Sewall's original design. The Maine Department of Transportation completed it in 2013 with modern materials and the addition of diagonal piles to better resist the tide-driven winter ice.

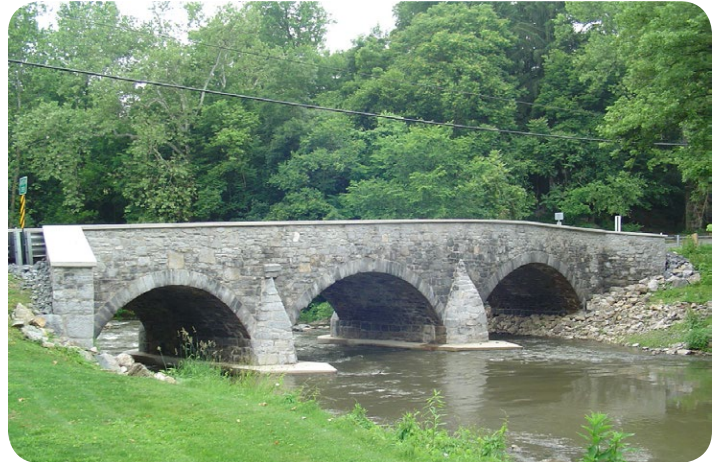
**Built in 1833 by George Weaver, the East Oak Ridge Drive bridge over Antietam Creek boasts a unique design of three arches that grow progressively larger as they cross the creek toward the west, carrying the roadway from low ground to high ground. Weaver's design also combined both rounded and pyramidal piers on the downstream side of the structure, unique only to this bridge. Photo by Washington County, Maryland.**

The East Oak Ridge Drive bridge lies within a community and therefore carries heavier daily traffic. Because the structure's walls were failing, it was rehabilitated under an accelerated schedule and was later honored with an award by the County Engineers Association of Maryland.

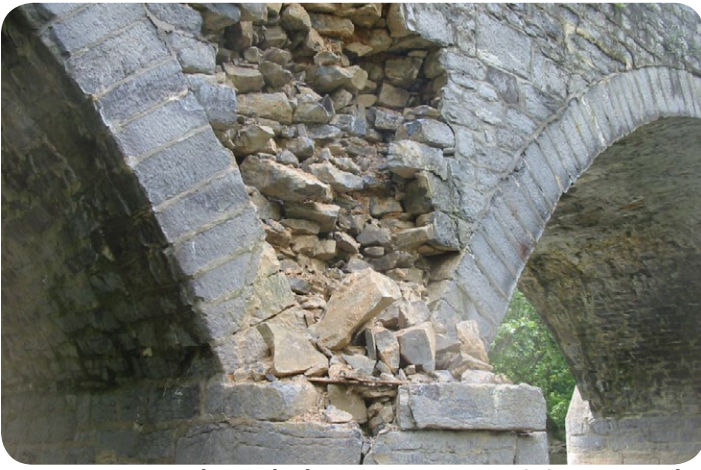
**Water seepage through the open masonry joints caused the failure of the pier nose and spandrel wall.** Photo by Washington County, Maryland.

The first step for these rehabilitations was to inspect the bridge for condition and damage. In addition to missing or fallen stones, engineers routinely found some level of water seepage through the fill material, causing the walls to bulge. Damage ranged from very minor to extreme, creating the potential for structural failure.

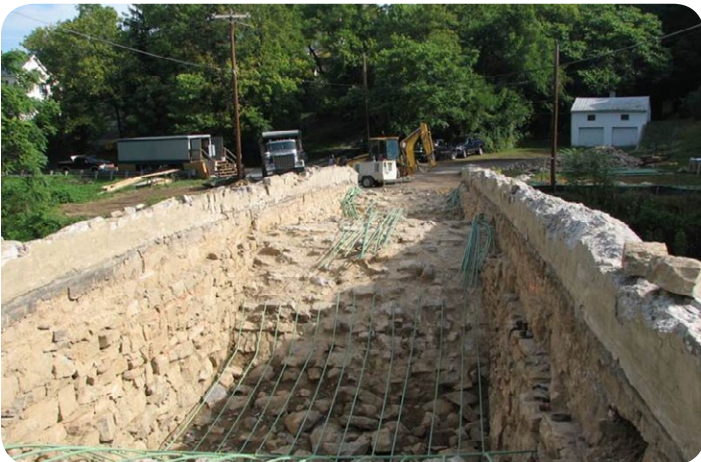
**Contractors removed soil and gravel fill in layers using a balanced sequence to expose the arches. Bottom layer of reinforcing is shown being placed prior to the addition of lightweight concrete.** Photo by KCI Technologies Inc.

After precautionary shoring was constructed under the arches, the soil and gravel was removed over each span in layers using a symmetrical sequence that allowed the bridge to remain standing on its own throughout the reconstruction. The soil and gravel is not considered a character defining element

of the historic structure. Crews then reversed the process, adding light-weight, reinforced concrete that approximated the characteristics of the soil fill in two-foot high lifts until it reached the roadway surface elevation.

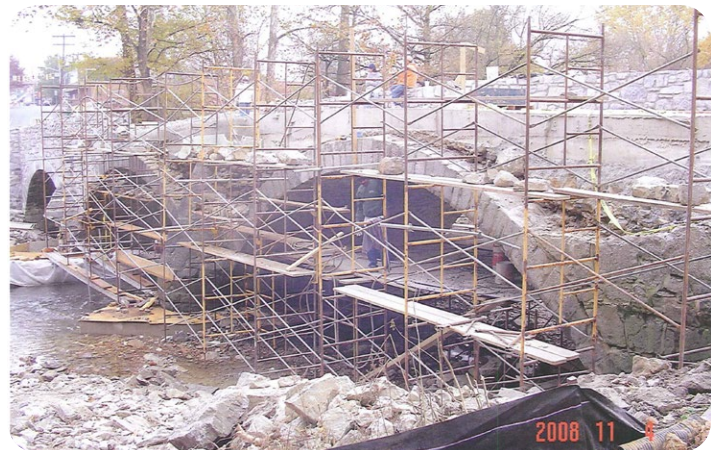
**Stream diversions and scaffolding helped contractors replace stones near their original position and repoint all masonry joints.** Photo by Washington County, Maryland.

any areas that were bulging or displaced. Stones were removed in an orderly fashion so they could be placed close to their original location, maintaining the historic integrity of the structure. For pier noses, individual stones were numbered to ensure their exact placement. Local quarries were identified to replace missing stones if the existing masonry could not be found in the stream below. The entire structure was then repointed to replicate the original masonry mortar color and joint finish type.

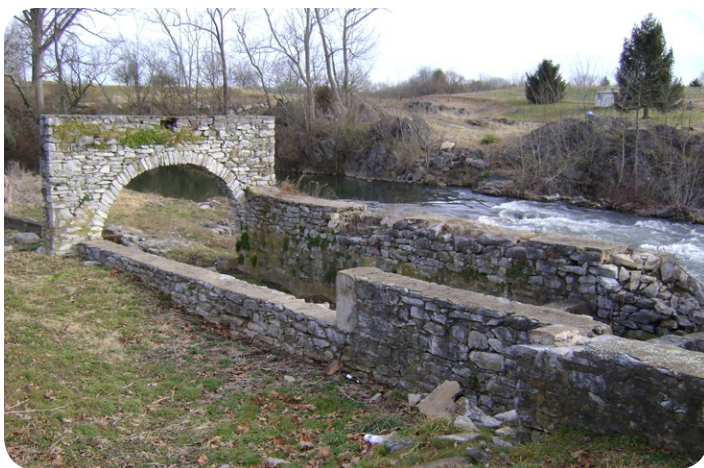
**Plans for the Rose's Mill Bridge on Garis Shop Road include rehabilitating the adjacent historic mill race structure.** Photo by Washington County, Maryland.

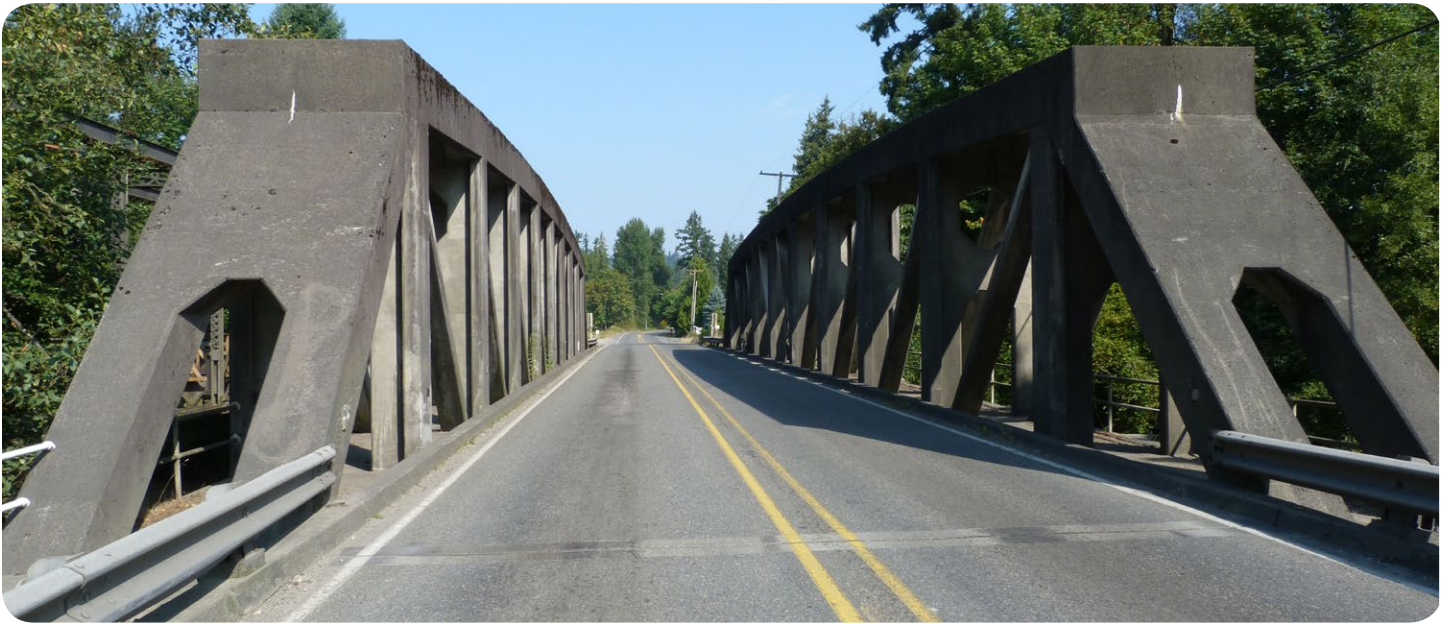
The McMillin Bridge in Pierce County, Washington. This bridge had been threatened with replacement and demolition as the Washington State Department of Transportation (WSDOT) planned a project to construct a new bridge and then demolish the historic bridge. The Historic Bridge Foundation, along with many other preservation-minded organizations, participated as a consulting party in the Section 106 Review for this bridge. The process took several years, and has today resulted in WSDOT agreeing to leave the historic McMillin Bridge standing, and its replacement will be constructed on a new alignment. *Photo by Nathan Holth.*
