## **Historic Bridge Foundation Facebook Archives**

### **Did You Know... That Florida has a cast and wrought iron swing bridge?**

**December 2014**

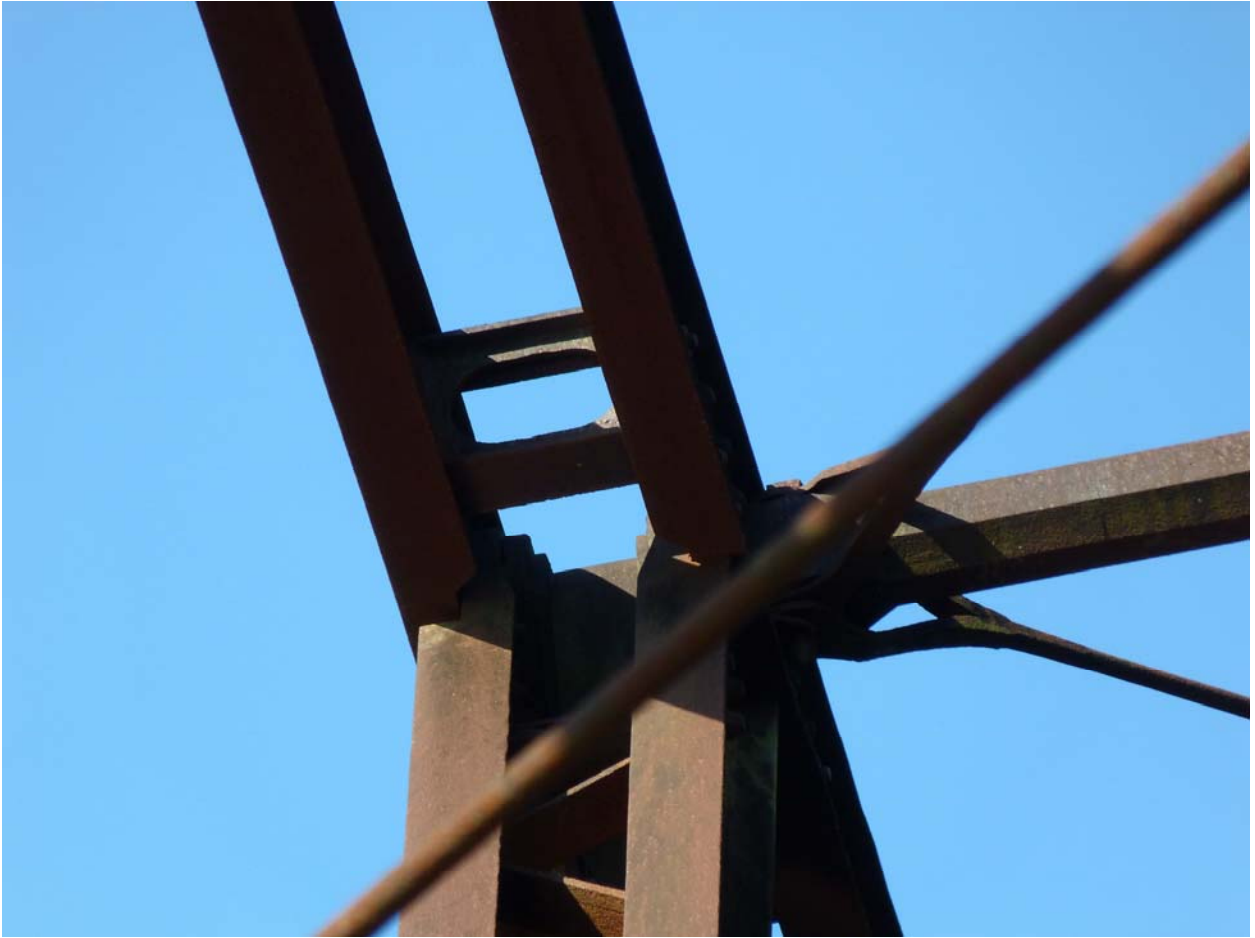
Looking up at the upper chord of the bridge.

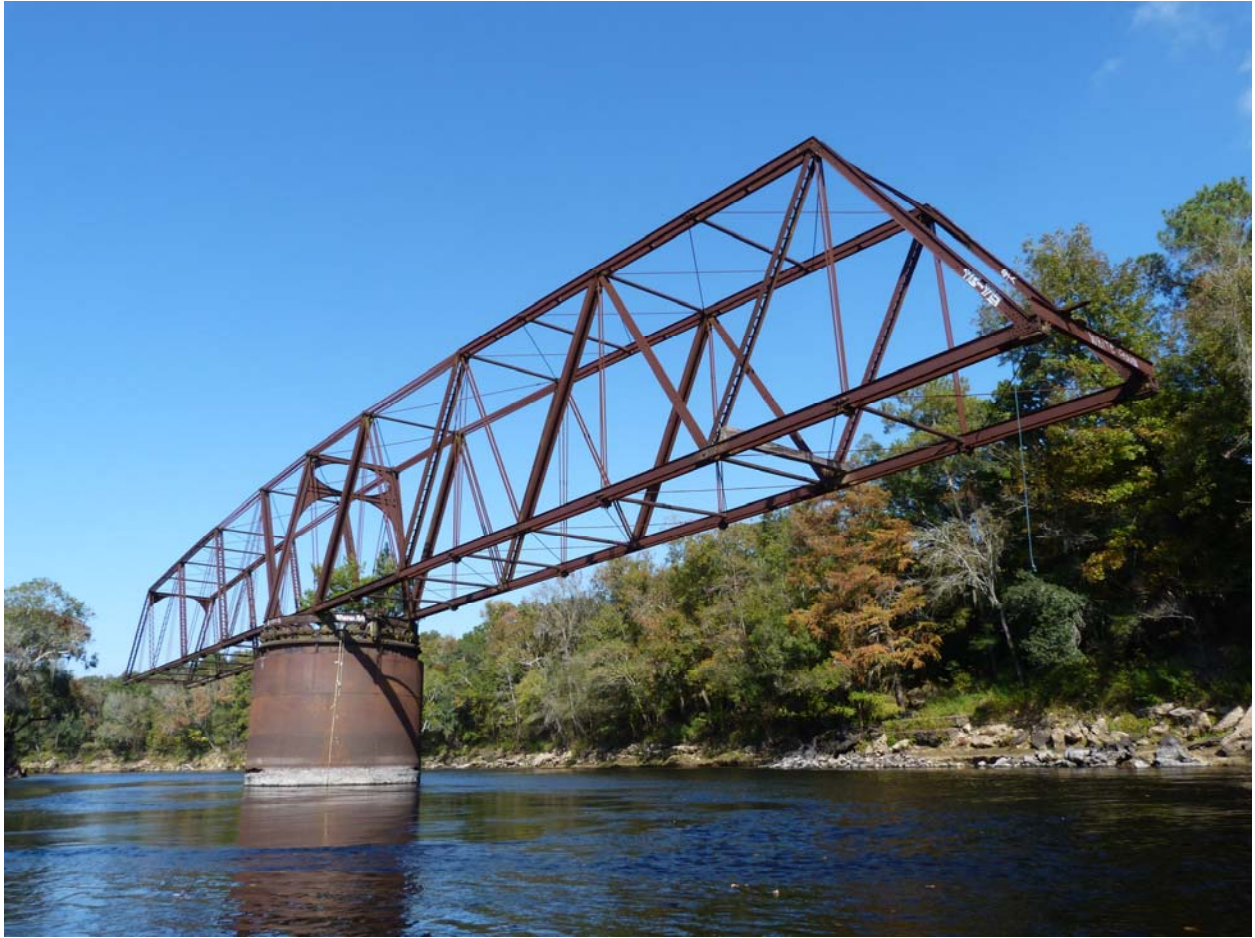
The bridge is a pin-connected Warren through truss, with a symmetrical rim-bearing swing design. It rests on a riveted steel caisson that appears to be filled with concrete and is deteriorating near the water level. While the truss webs of this bridge are composed of wrought iron members only, transverse struts that run between the upper chords and lower chords of the bridge are cast iron beams. Cast iron blocks are found between the upper lower chord channels. On the lower chord, these blocks also act as guides for the vertical members, which at each panel point consist of three rods. Lateral bracing

Overview of bridge.

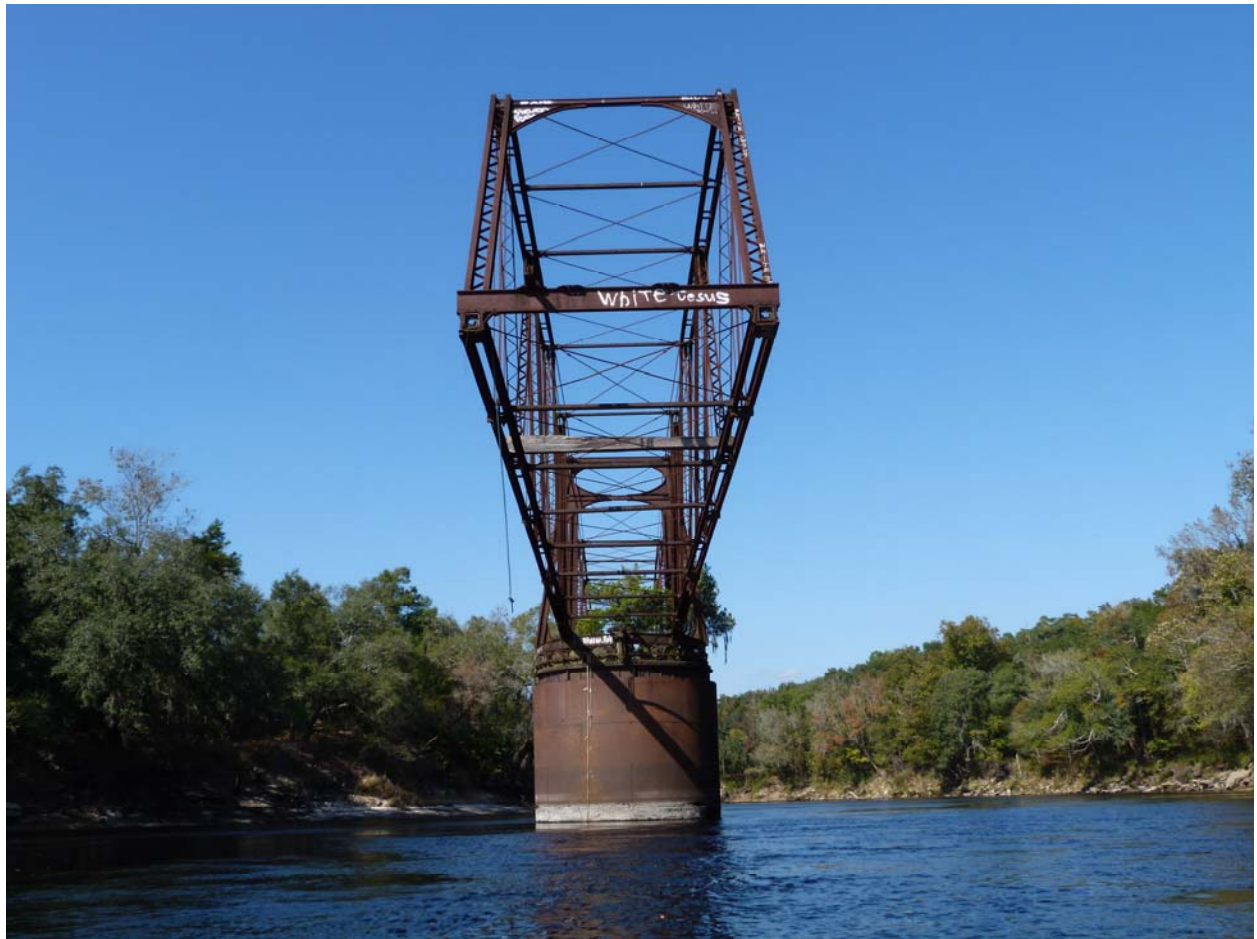
Looking up at the portal of the bridge. — in [Mayo, Florida](#).

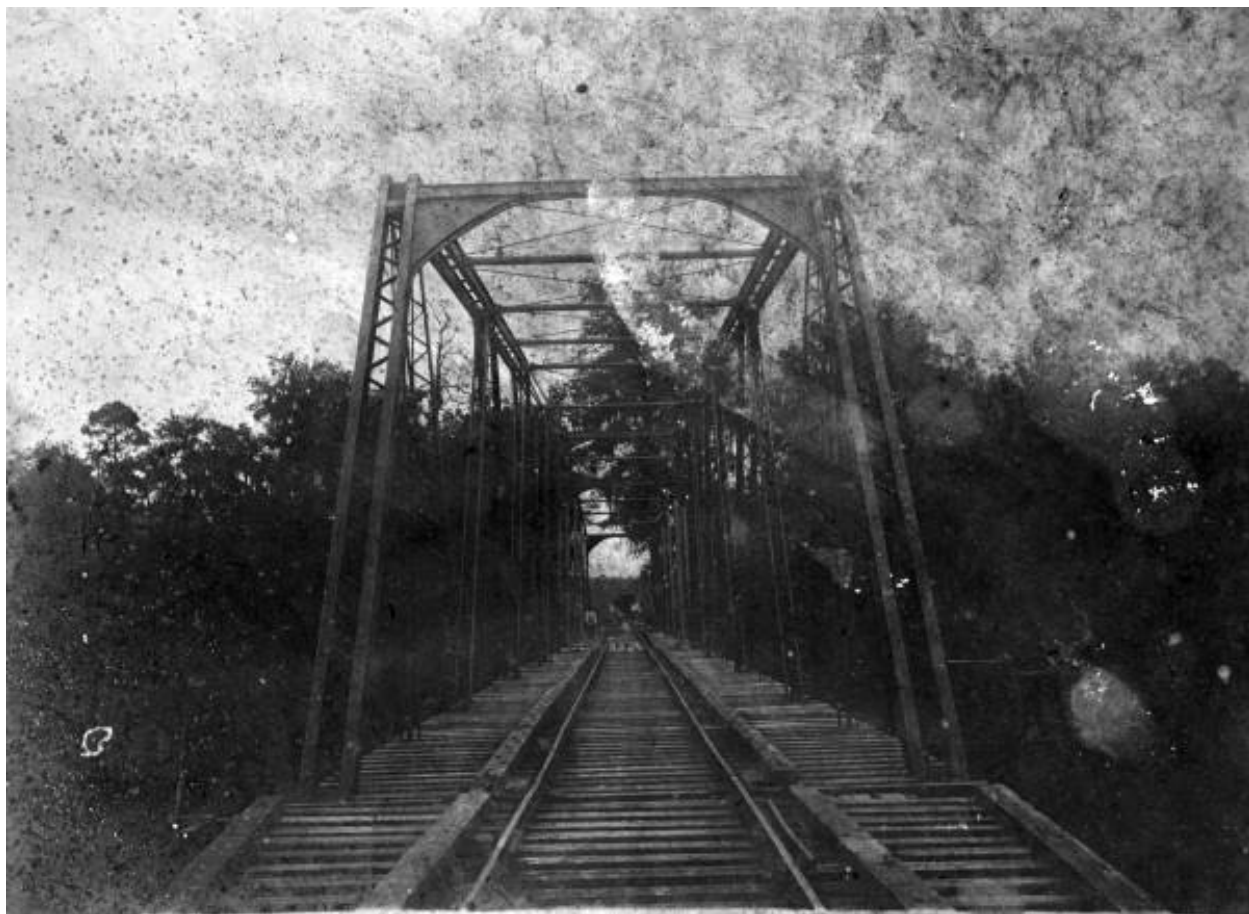
**Historical Photo of Bridge. Source: State Archives of Florida, Florida Memory, <http://floridamemory.com/items/show/138093>**

This historical photo shows the bridge when it still had a deck on it.

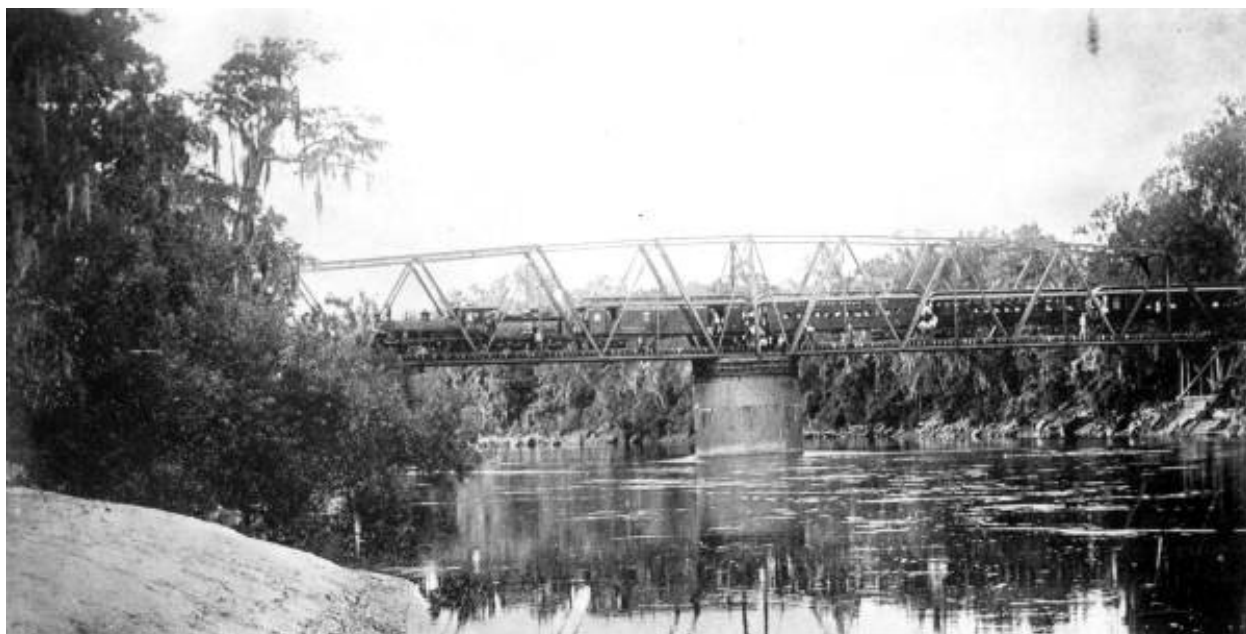
**Historical Photo of Bridge. State Archives of Florida,  
Florida Memory, <http://floridamemory.com/items/show/35323>**

This historical photo shows the bridge in the closed position with a train on it.
