Historic Bridge Bulletin

Volume 6, Number 1
March 2019

Saving Ozark's Historic Riverside Bridge

Rehabilitating the Split Rock Stone Arch Bridge

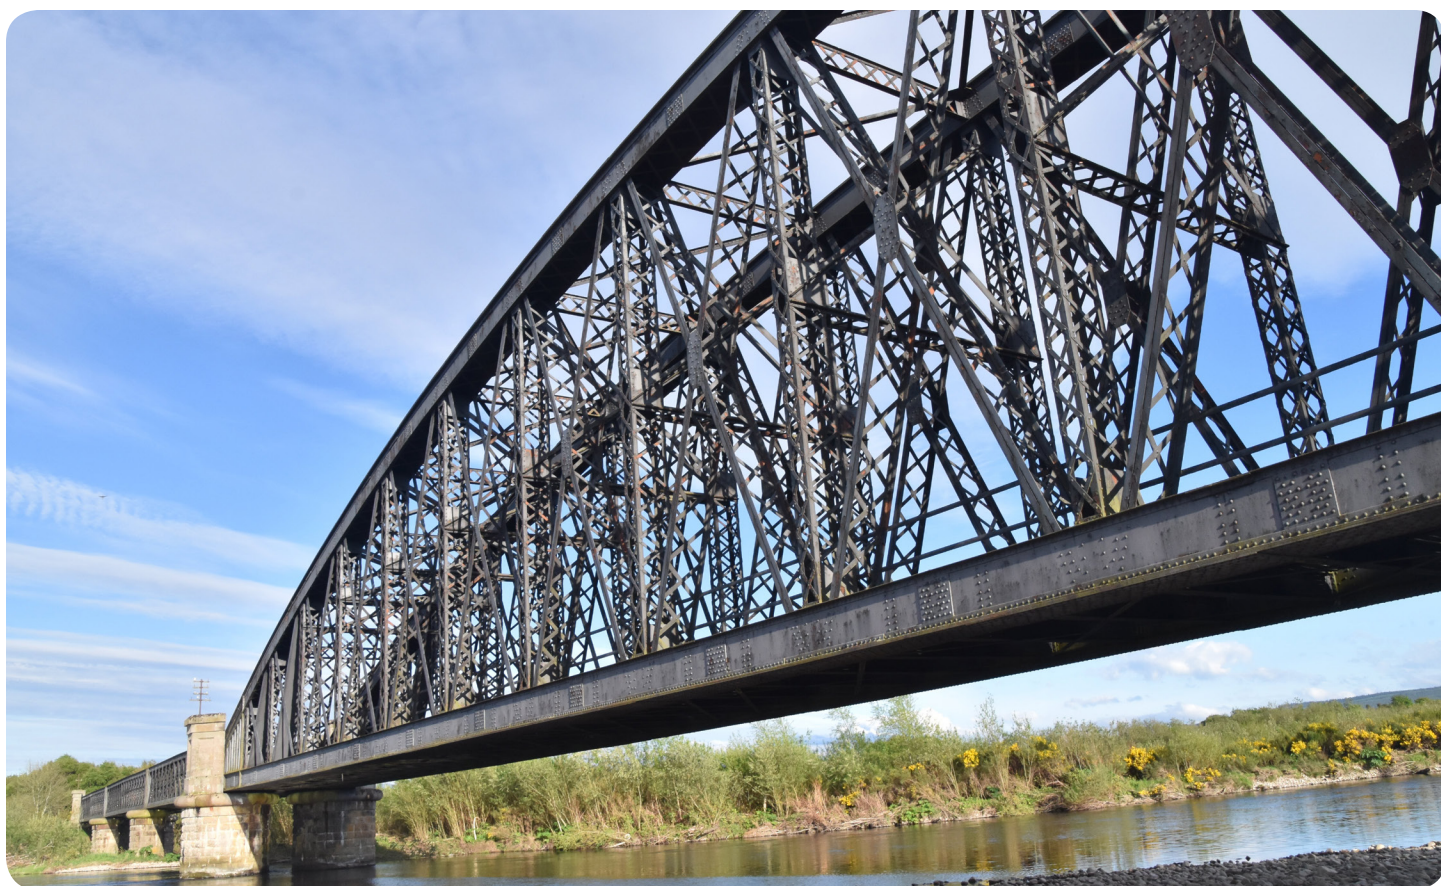
The Spey Viaduct in Garmouth, Scotland, was built in 1885 and features an impressive 350 foot main span. The former railway bridge has been converted for pedestrian use on a trail system. *Photo by Nathan Holth.*

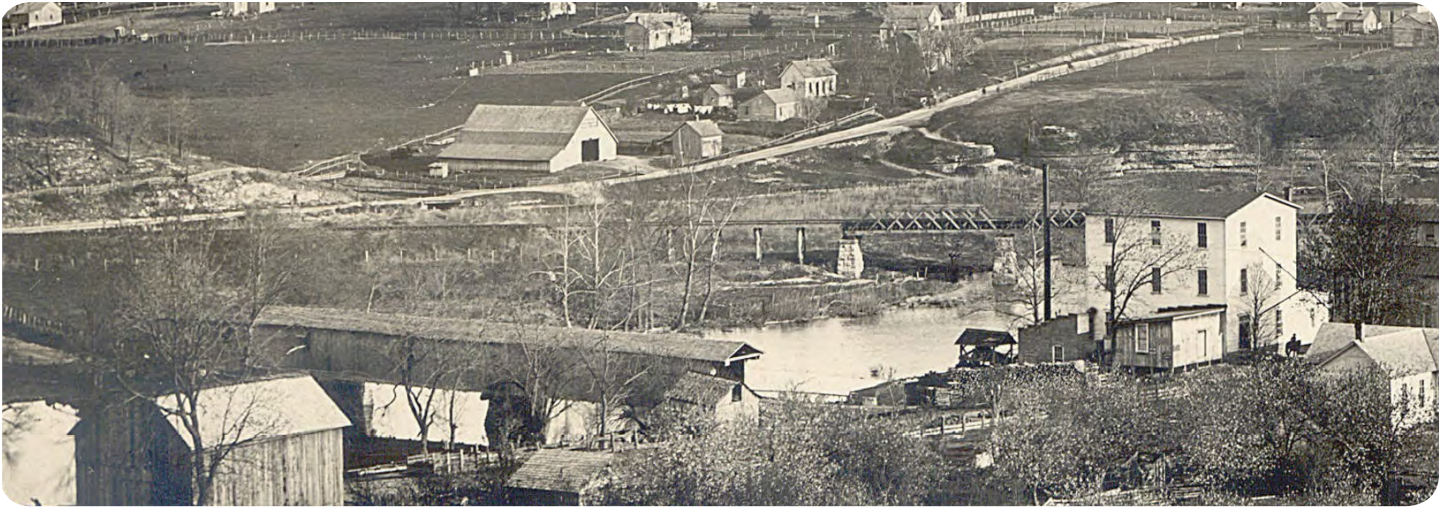
This historical photo of the Ozark Mill area shows the ca. 1865 covered bridge in the foreground, and a railroad bridge in the background. The covered bridge was replaced by a pin-connected metal truss bridge in 1909.

The two truss spans of the bridge were originally constructed in a nearby location over Finley Creek in 1909 by the Canton Bridge Company of Canton, Ohio, on what is today West McCracken Street next to the Ozark Mill. The 1909 bridge replaced a former ca. 1865 wooden covered bridge at the location, which had been destroyed by flooding. The cost of the new bridge was \$3,648.00. The location of this bridge proved to be a popular crossing, which saw increased traffic in a short period of time. In 1922, the Missouri State Highway Department decided to route US-65 along McCracken Street. A larger, heavy-duty bridge was needed for a US highway, and thus after just only a decade of service, the pin-connected truss bridge found itself being replaced. The 1922 highway bridge built by the department (which remains in

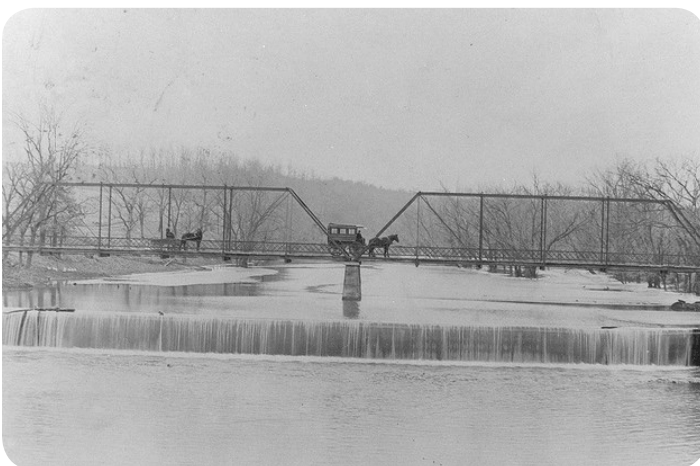
A historical elevation photo of the pin-connected truss bridge at Ozark Mill.

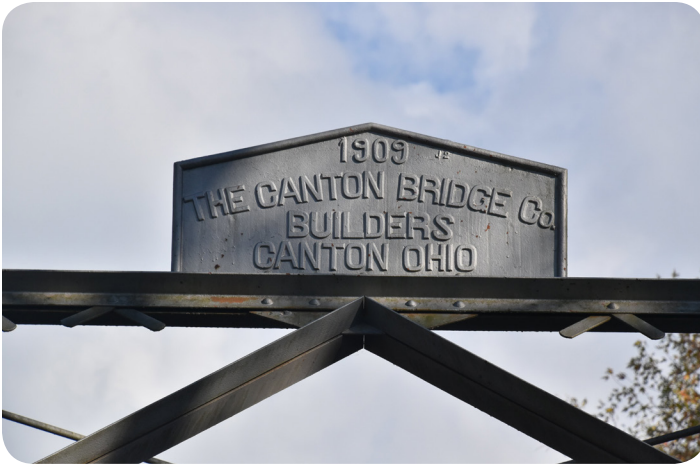
The builder plaque on the Riverside Bridge. *Photo by Nathan Holth.*

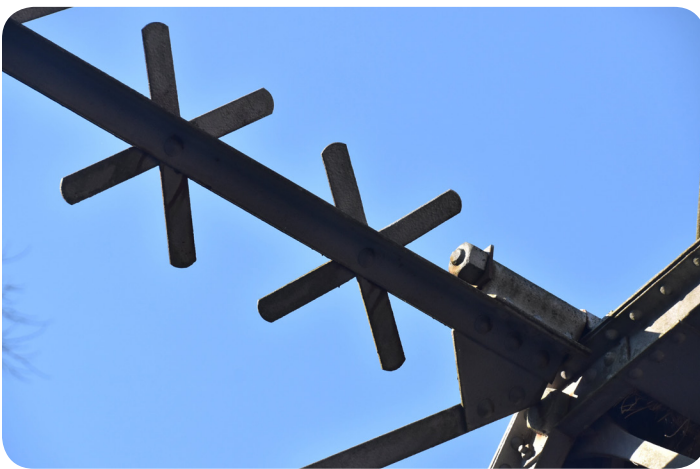
The portal bracing of the Riverside Bridge, which includes distinctive lacing bar frills and the unusual pin connection to the truss are common features of bridges built by the Canton Bridge Company. *Photo by Nathan Holth.*

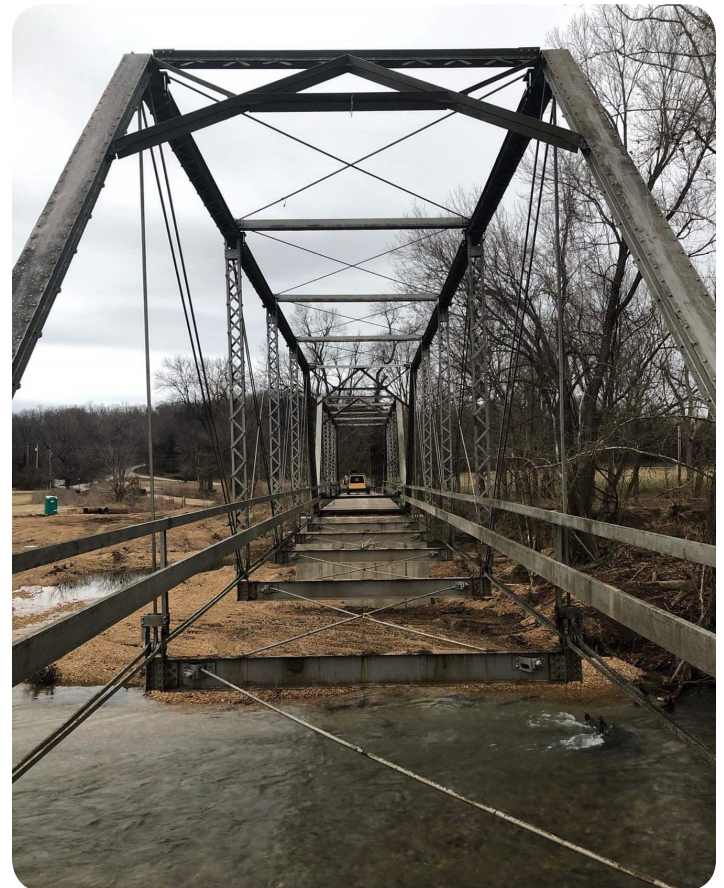
The start of the Riverside Bridge relocation project is shown here, with the deck of the bridge removed. *Photo by Daniel Shortt.*

As of the writing of this article, the Riverside Bridge has been lifted off its substructure and dismantled. The bridge will now be repaired and eventually erected on a new substructure at the Ozark Mill site.

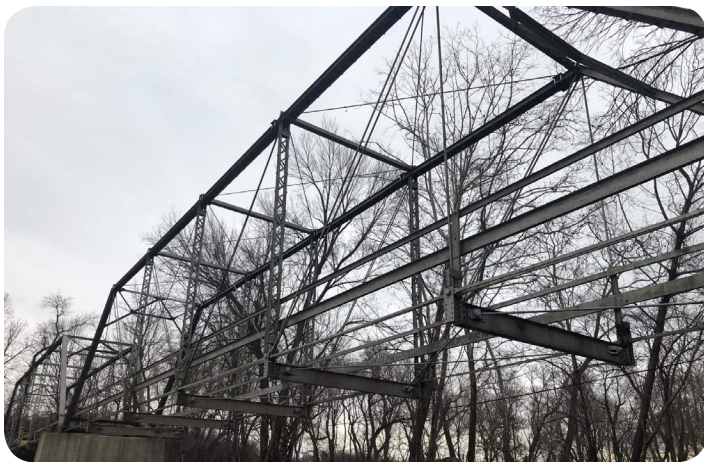
Looking up at the Riverside Bridge, with the deck removed in preparation for its relocation. Photo by Daniel Shortt.

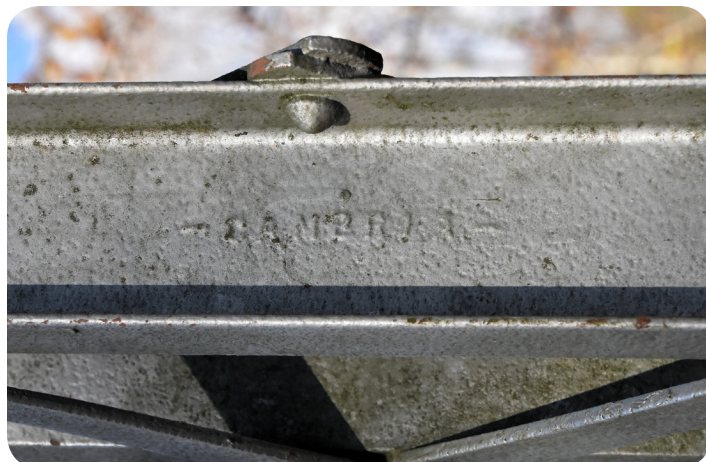
At least some of the steel on the bridge was rolled by Cambria Iron Company as shown by the name Cambria on this vertical member channel. Photo by Nathan Holth.

material, which is also a record of the craftsmen who fabricated it. The Riverside Bridge displays these features clearly because of the lack of alteration to the original material and design of the truss. Features including rivets, built-up beams with v-lacing, loop-forged eyebars, and rolled American Standard Beam I-beams are all examples of historic metal fabrication methods and designs. These features have not been seen in bridge design for decades.

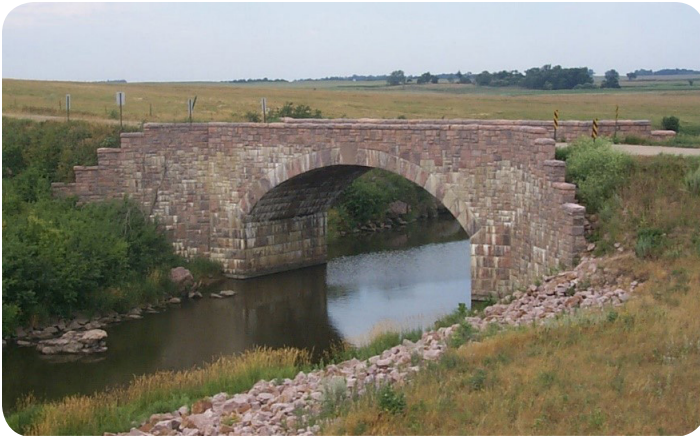
East elevation of the Split Rock Bridge. Heavy efflorescence can be seen on the arch barrel and abutment wall. Photo by Gemini Research.

Once we confirmed the bridge did not need to be strengthened as part of the rehabilitation, we looked at addressing its deficiencies. The bridge abutments, wingwalls, and underside of the arch showed significant signs of water infiltration, resulting in major efflorescence. The mortar joints are also cracked and missing in places and the arch has loose stones.

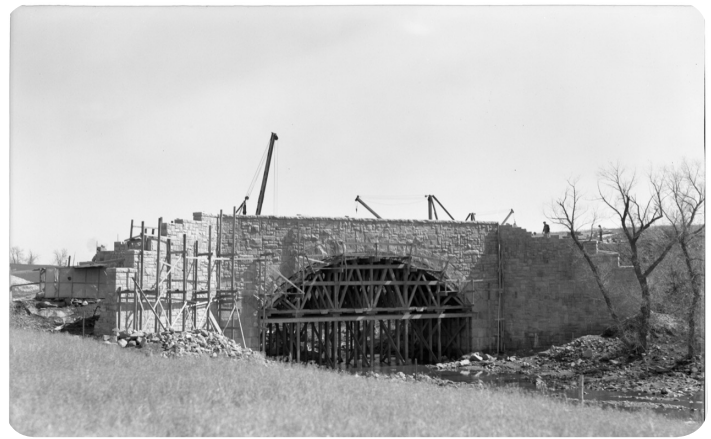
Construction of the Split Rock Bridge. Photo from Minnesota Historical Society.

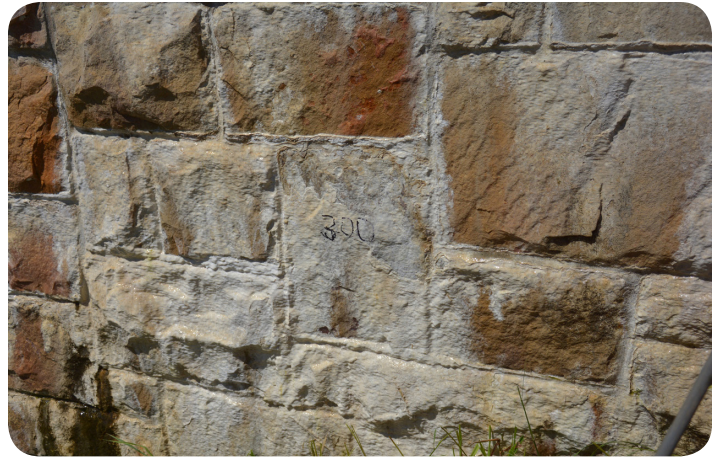
Condition of stone and mortar joint after washing the stone with 300 psi water pressure. *Photo by Gemini Research.*

cleaning methods didn't work. We also found the typical water pressure range between 300 and 500 psi did not work. Knowing that the bridge will be completely repointed and the quartzite stone is an extremely hard metamorphic rock, the testers increased the water pressure incrementally by 300 psi. The results found a tip with zero-degree fan, 2100 psi pressure, applied for 1.5 minutes slowly knocked off the efflorescence with some pitting to the mortar joints and no damage to the stone. We also tried 2500 psi and saw similar results as using a pressure of 2100 psi. Because we wanted the gentlest method, our specifications state to use a pressure up to 2100 psi.

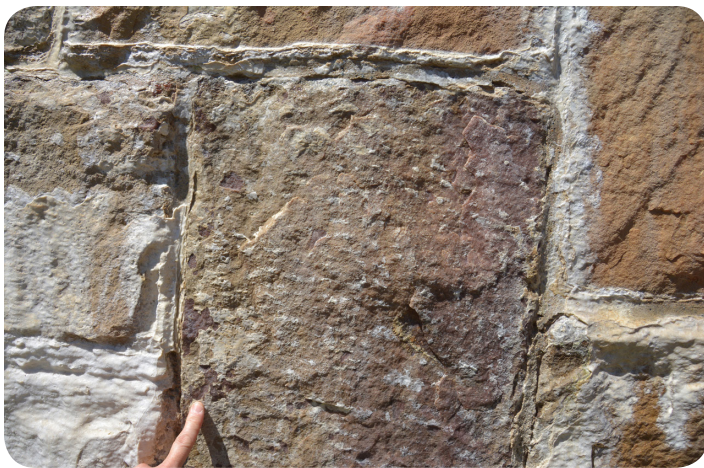
Condition of stone and mortar joint after washing the stone with 2100 psi water pressure. Photo by Gemini Research.

Dry and wet cleaning techniques were tested on the bridge stone to remove the efflorescence. The strength of the stone was impressive. Cleaning with water pressures as high as 2500 psi did not damage the stone.

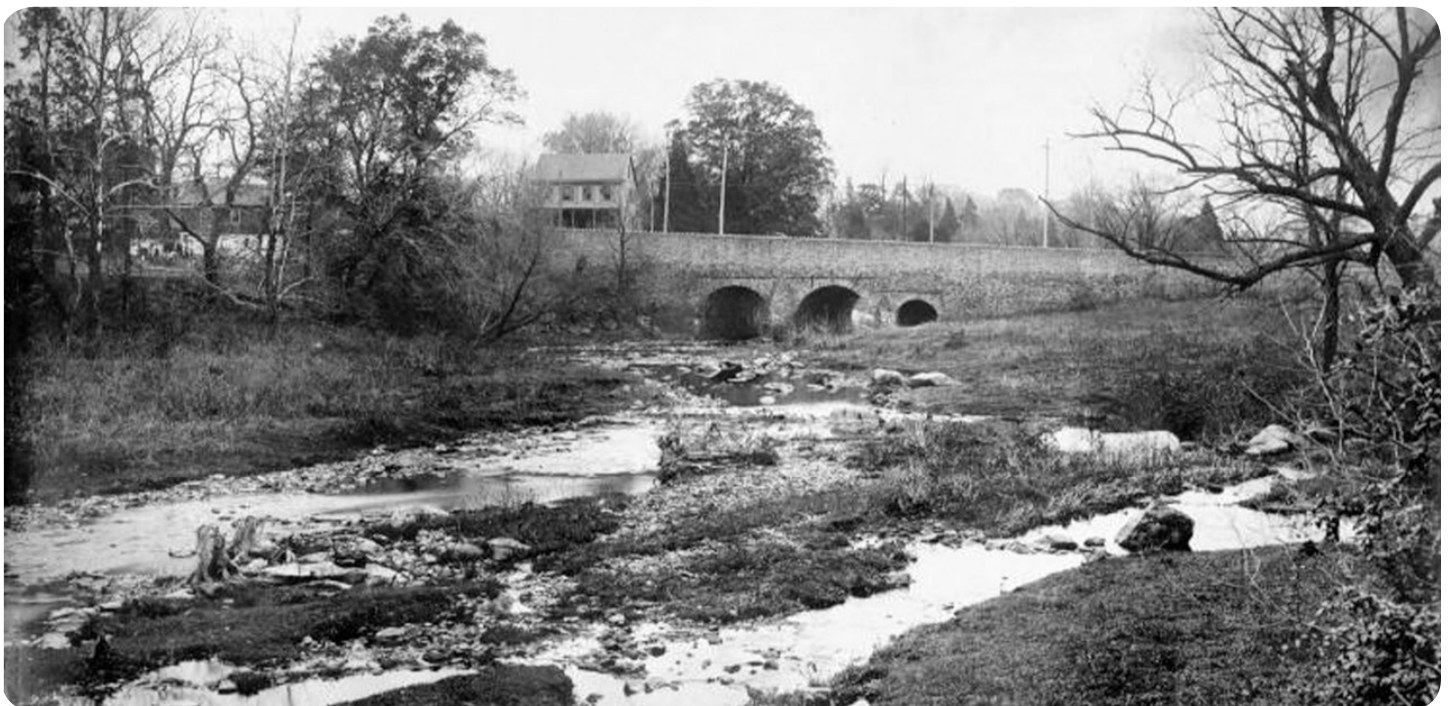
Frankford Avenue Bridge, Circa 1900.

The Frankford Avenue Bridge was built along what was originally a Native American trail that was later incorporated into the King's Highway. The King's Highway became a regularly traveled route between Philadelphia and Frankford by 1725 and extended to Boston by the end of the eighteenth century. The King's Highway ultimately connected the colonies

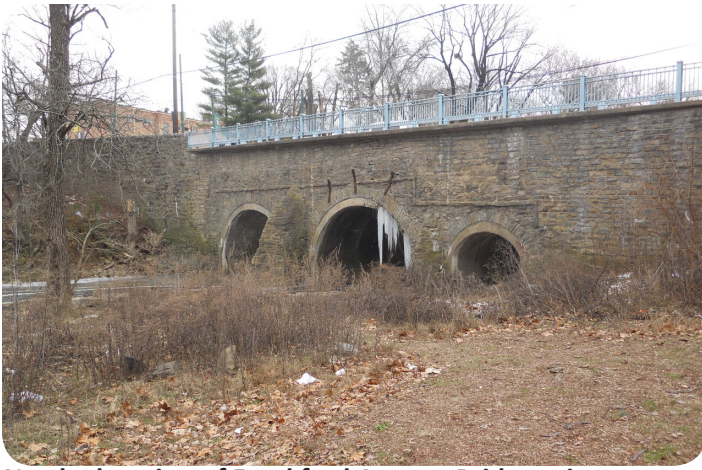
North elevation of Frankford Avenue Bridge prior to rehabilitation.

from New England to the Carolinas. The bridge has two 25-foot spans and one 12-foot-9-inch span for a total length of 73 feet. In 1803, the Frankford and Bristol Turnpike Company paved across the Frankford Avenue Bridge as part of a toll road that extended from Philadelphia to Morrisville, Pennsylvania. Due to phenomenal population growth extending into northern Philadelphia, the bridge was widened in 1893 to accommodate a trolley line.

The 1893 widening of the bridge included increasing the out-to-out width from 22 feet to 44 feet by widening the bridge to the south, raising the roadway profile, rebuilding the parapet walls with crenellated caps, and widening the culvert over the mill race. In the twentieth century, the crenellated parapets were removed from over the creek and replaced with overhanging sidewalks with decorative pedestrian railings, and reinforced concrete arch

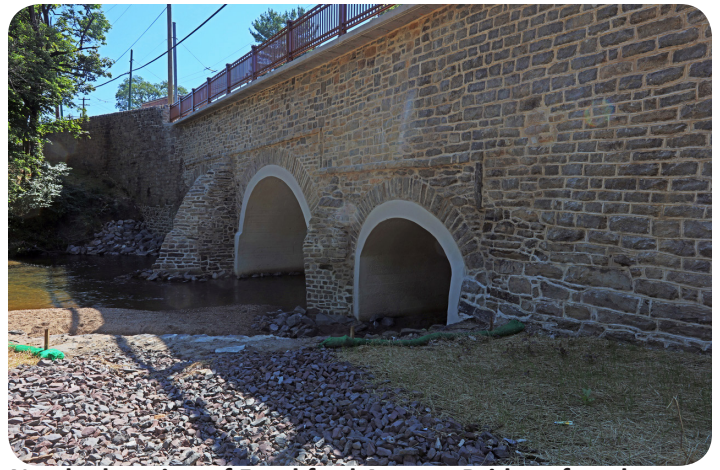
North elevation of Frankford Avenue Bridge after the 2018 rehabilitation.

The recently completed rehabilitation program scope of work included in-kind reconstruction of the spandrel walls and wingwalls, in particular the north spandrel wall that exhibited bulging and the portions of the wall that sustained collision damage. The architectural features that were present on the bridge prior to rebuilding were maintained. Cleaning, repairing and repointing of the stone masonry occurred throughout. The earth fill between the two spandrel walls and beneath the roadway was replaced with lightweight concrete fill. The sidewalks were reconstructed in-kind and a new crashworthy roadway barrier was installed between the sidewalk and the roadway. The new roadway barrier is mounted to 12-inch thick reinforced concrete moment slabs that sit on top of the lightweight concrete fill. The existing decorative pedestrian railing was salvaged, repaired, painted brown and reinstalled on the new sidewalk overhangs. The concrete arch liners were repaired and coated with a sealant. Scour protection measures (rock) were placed around the abutments and piers. Extensive utility work was conducted during the bridge rehabilitation, which included relocating several utility lines to the center of the roadway, where gravel fill was placed instead of lightweight concrete fill, allowing for future access by the utility companies. Roadway work included milling and resurfacing the approaches, approach sidewalk replacement, and inlet repair. A bituminous overlay was placed from curb to curb. The scope of work for the adjacent culvert included stone masonry cleaning

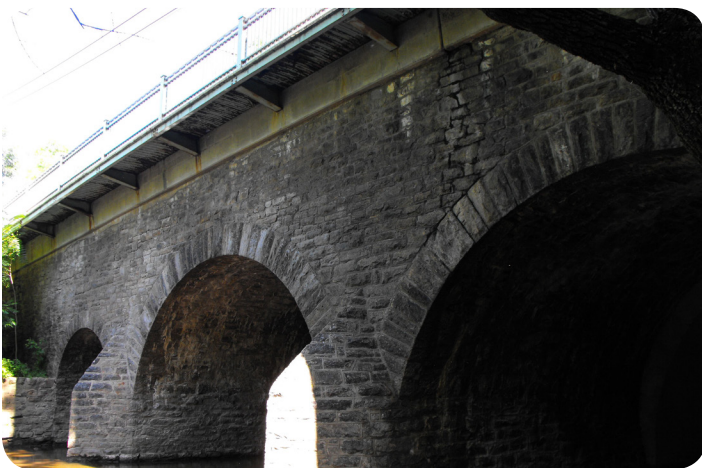
South elevation of Frankford Avenue Bridge prior to rehabilitation. Photo by Nathan Holth.

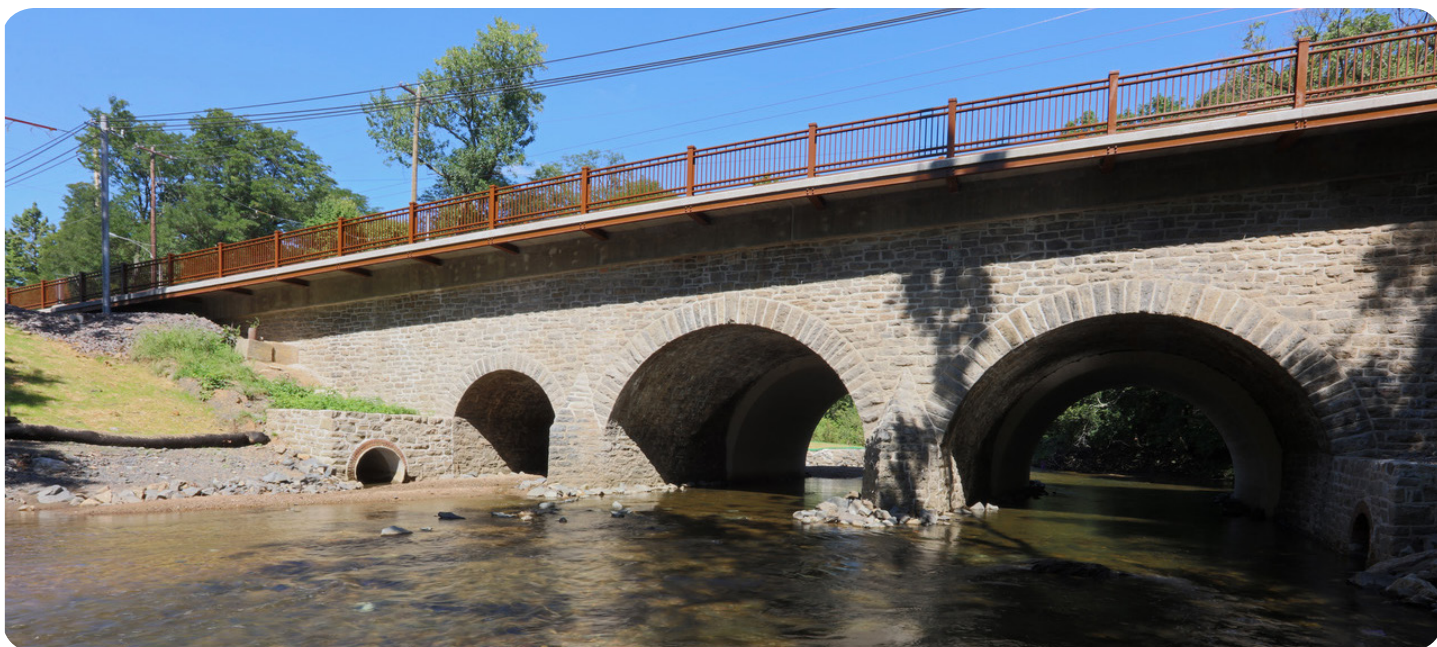
South elevation of Frankford Avenue Bridge after the 2018 rehabilitation.

and repointing and in-kind reconstruction of a portion of the wall end that sustained collision damage.
