Historic Bridge Foundation Facebook Archives

Did You Know: Mill Scale on Bridges

April 2018

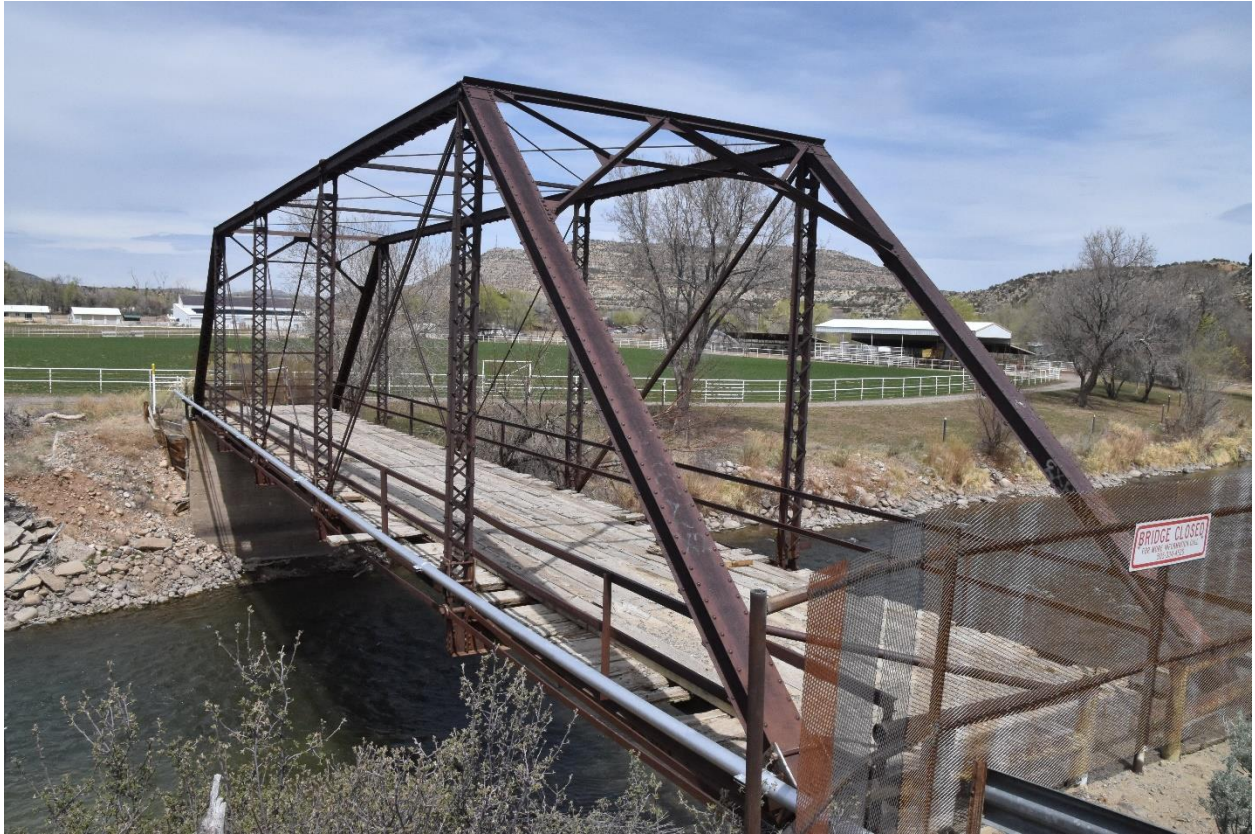
View beside bridge at southwest quadrant facing northeast.

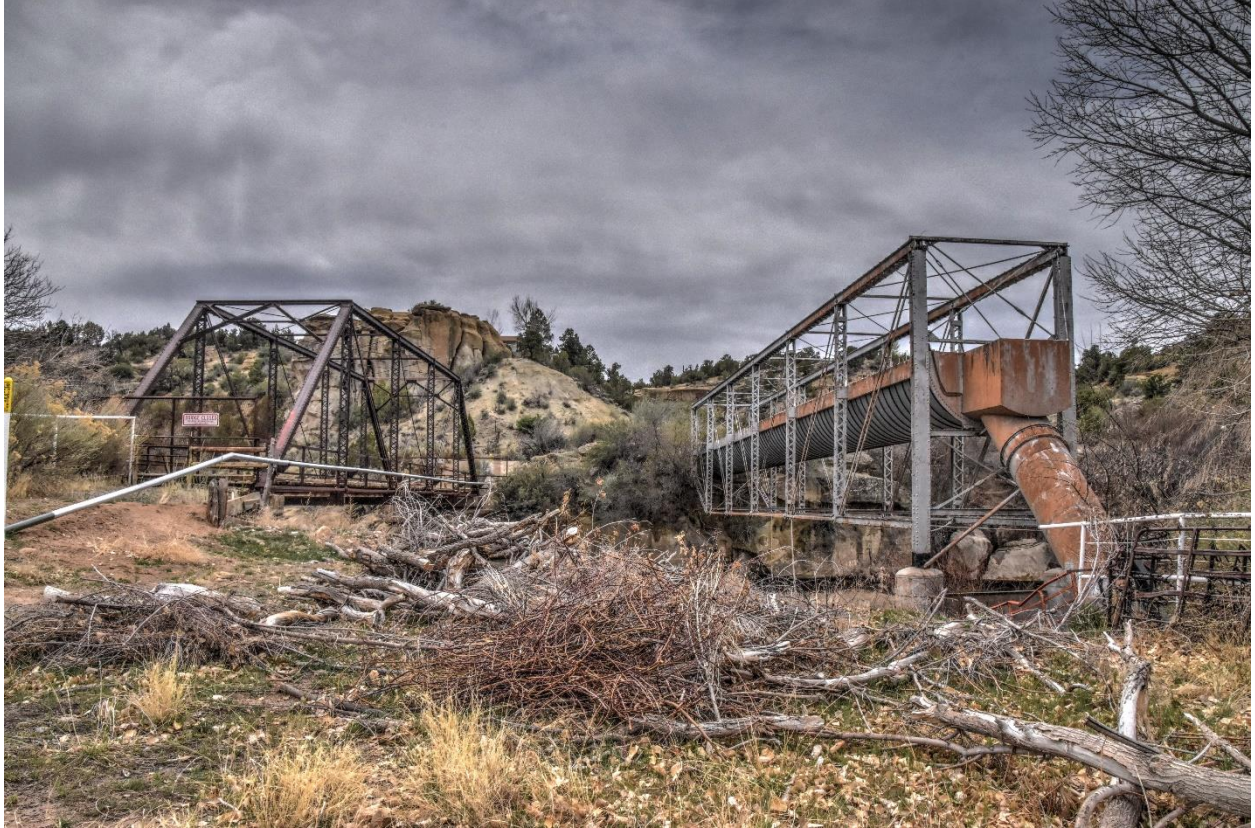
General view looking south. Cedar Hill Bridge pictured to the left, with the flume shown to the right.

Immediately west and parallel to the bridge is an irrigation flume which carries water over the Animas River. This flume structure is a pin-connected truss composed of members that are similar to those used in the highway bridge, but it has a significantly different overall configuration and appearance because it was purposely designed to serve as a flume. The flume itself is quite unusual and may have individual historic significance. It also compliments the architectural appearance of the highway truss bridge.

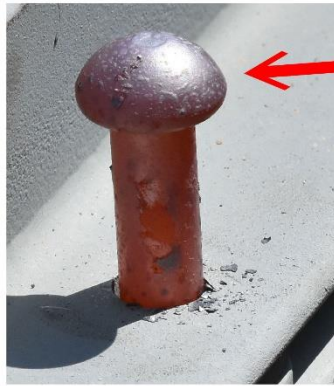
Hot rivet with intact mill scale prior to driving.

Mill scale falling off of rivet being driven.

...That under the right conditions, mill scale—the bluish-black flaky surface consisting of mixed iron oxides that forms during the hot rolling process at a steel mill and also forms when rivets are heated in a forge prior to being driven—can survive on a metal truss bridge for over 100 years? The Cedar Hill Bridge, which carries Road 2380 over the Animas River in San Juan County, New Mexico, is an example. The single span bridge is approximately 100 feet in length, consisting of a five panel pin-connected Pratt through truss. The bridge is historically significant as a rare surviving example of its type in New Mexico, as well as the entire Mountain States region of America. The bridge is also significant for its lack of alteration, and even more so for its very remarkable lack of deterioration in its steel.

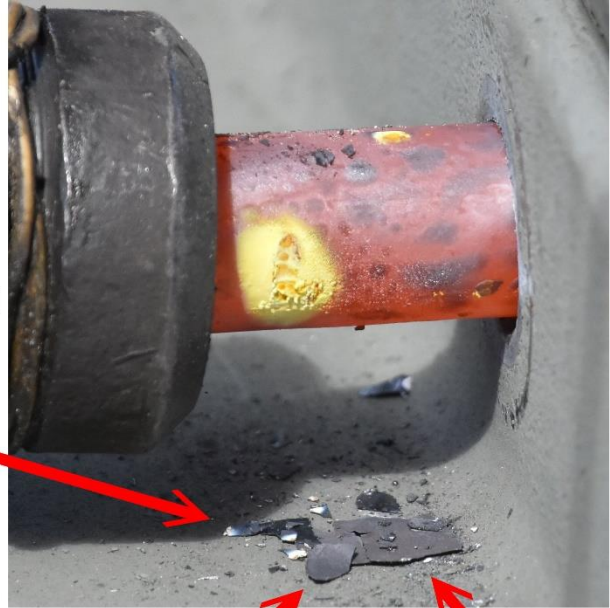
Mill scale that has fallen off newly driven rivets.

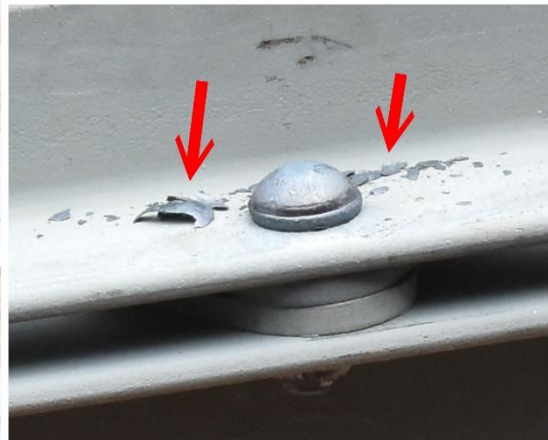
This photo of rivets being driven on another bridge illustrates the formation of mill scale after the rivet has been heated.

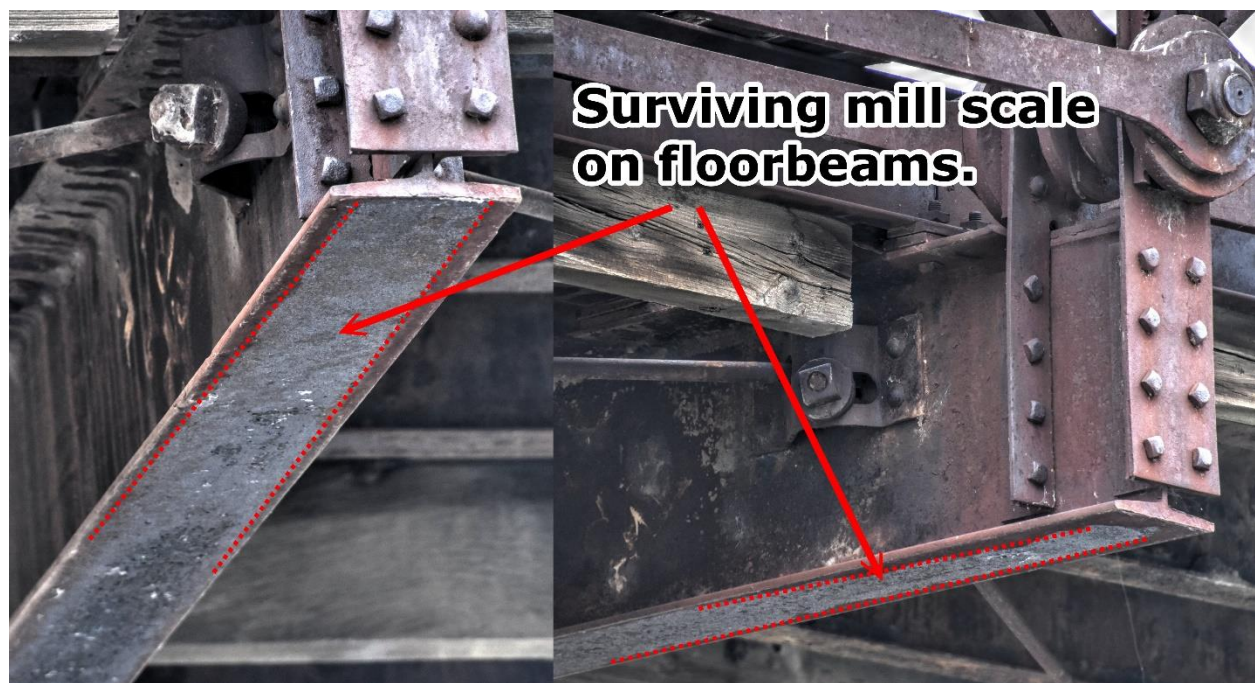
Surviving mill scale on the Cedar Hill Bridge.

The truss structure of the Cedar Hill Bridge is remarkable for the lack of rust-related deterioration of its steel materials. This may be due to the dry climate of the region, which has greatly limited the bridge's exposure to moisture and rain, and the bridge's location on a rural road where corrosive winter deicing salts and chemicals likely have never been in use. Nearly all the steel on the bridge could only be described as "like new." It appears that the bridge was never painted, indicating that this bridge has avoided deterioration by virtue of its location and material properties alone. Moreover, it appears that when the bridge was erected, mill scale survived on the bridge, and, in a number of areas, this mill scale remains in place and visible today. Typically, if a bridge was erected over 100 years ago and it had mill scale on it when erected, one would expect that time and weather would have removed all traces of it by today, which is what makes the Cedar Hill Bridge remarkable. Its unusual lack of deterioration also manifests itself in the sharp edges of all the steel on the bridge which have not worn down, and the easily legible steel mill name on the channels. The floorbeams of this bridge even have surviving hand-painted part and job numbers on them which appear to date to the original fabrication and erection of the bridge.

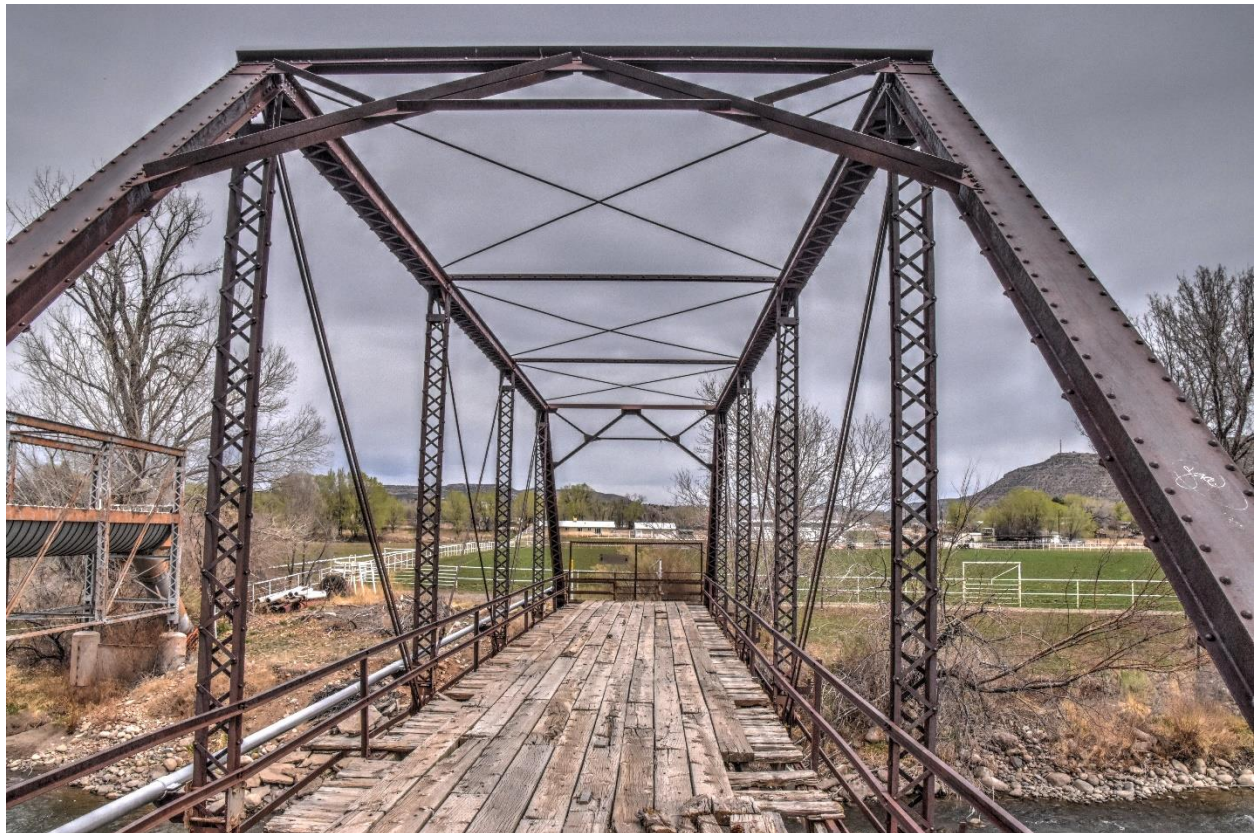
Portal view of bridge facing north.

The superstructure and deck of the Cedar Hill Bridge is composed of the following details: end posts and upper chord: back-to-back channels with cover plate and v-lacing; verticals: back-to-back channels with v-lacing on each side; bottom chord: up-set eyebars; diagonal members: up-set eyebars; counters: loop-forged rods with turnbuckles; portal bracing: traditional a-frame design composed of angle; upper and lower lateral bracing: threaded rod; sway bracing: paired angles; floorbeams: rolled American Standard beams; deck stringers: six rows of rolled American Standard beams, plus two fascia channels; deck: timber; railing: two channels mounted to truss vertical members. The bridge has riveted pin plates, which also function as hangers that are bolted to the floorbeams. The truss displays a historical technique used in fabrication shops to produce cutouts of small sections of steel, such as the ends of vertical member channel flanges to make room for eyebar heads. Rather than use a cutting torch or other modern equipment, a series of small holes would be successively drilled in a row to cut the section of material. The use of this technique is readily recognizable by the sawtooth appearance of the area that was cut. The bridge sits on a concrete substructure. The northern end of the bridge has a simple concrete abutment which extends down to the river. A large horizontal crack in this abutment appears to indicate that the abutment was constructed in two concrete pours. The south abutment in contrast is a short section of concrete which rests upon a large rock outcrop along the river.

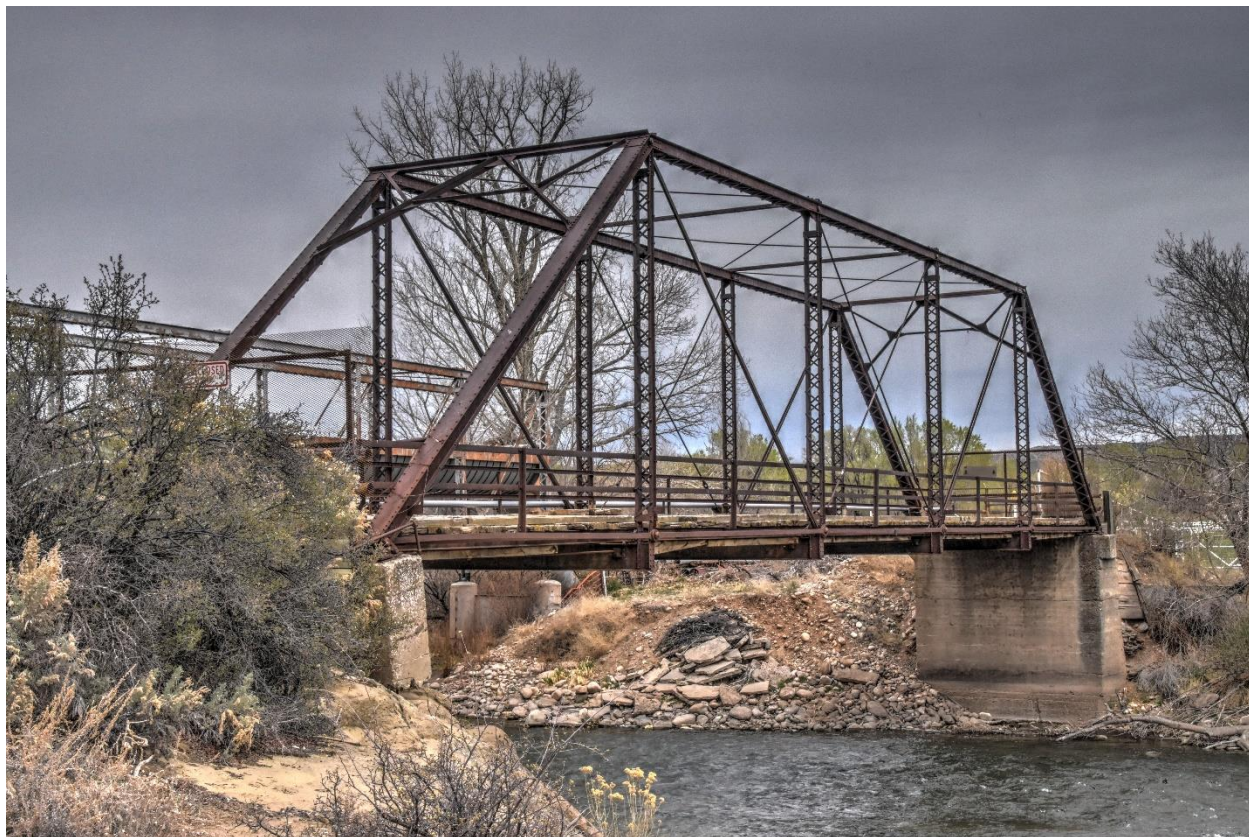
East elevation, view facing northwest.

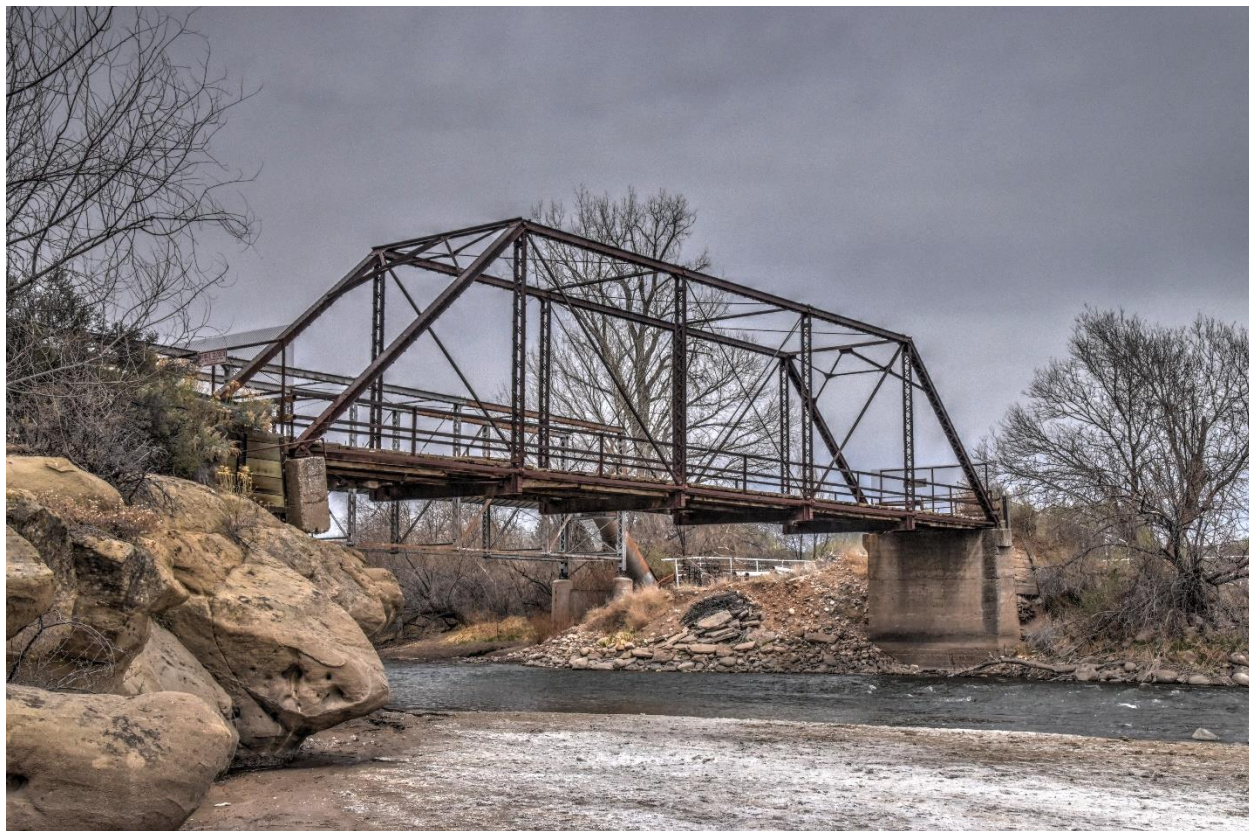
East elevation, view facing northwest.

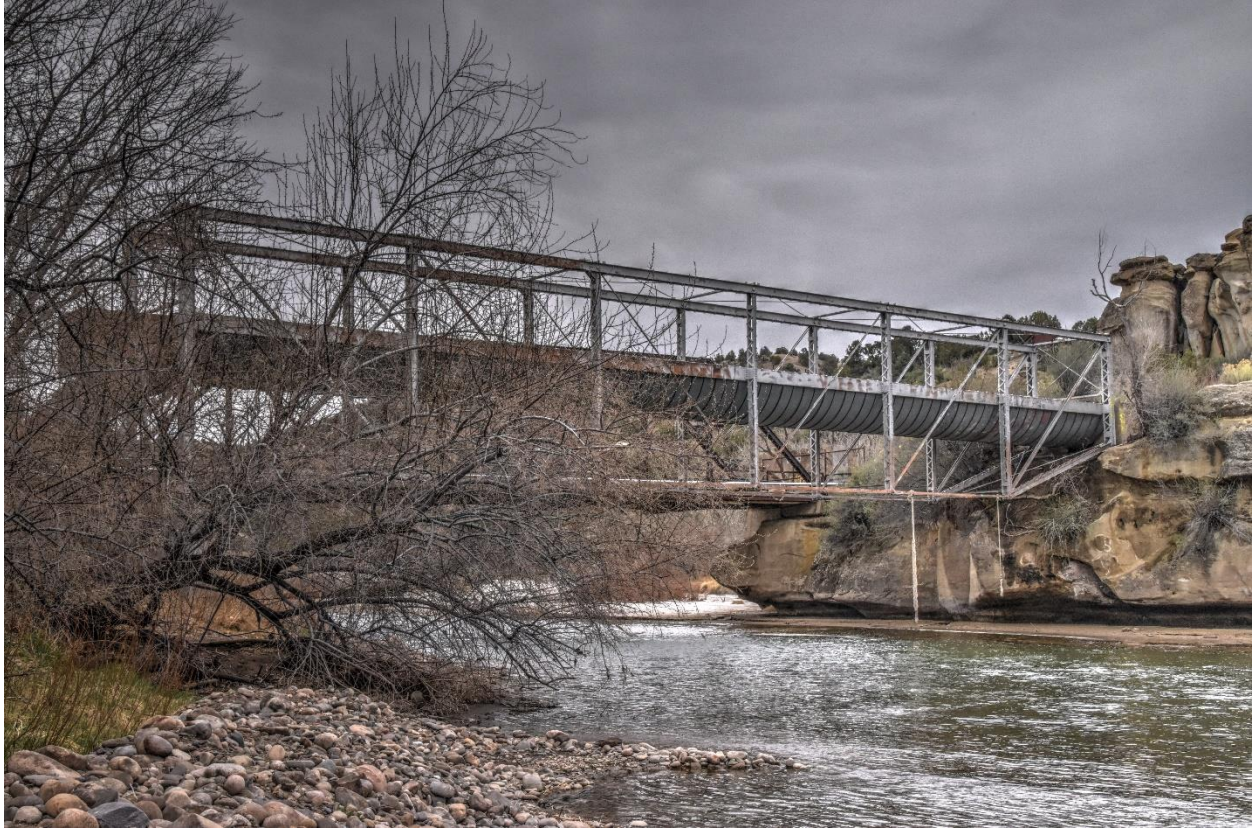
General view, west elevation. Cedar Hill Bridge pictured behind the flume bridge.

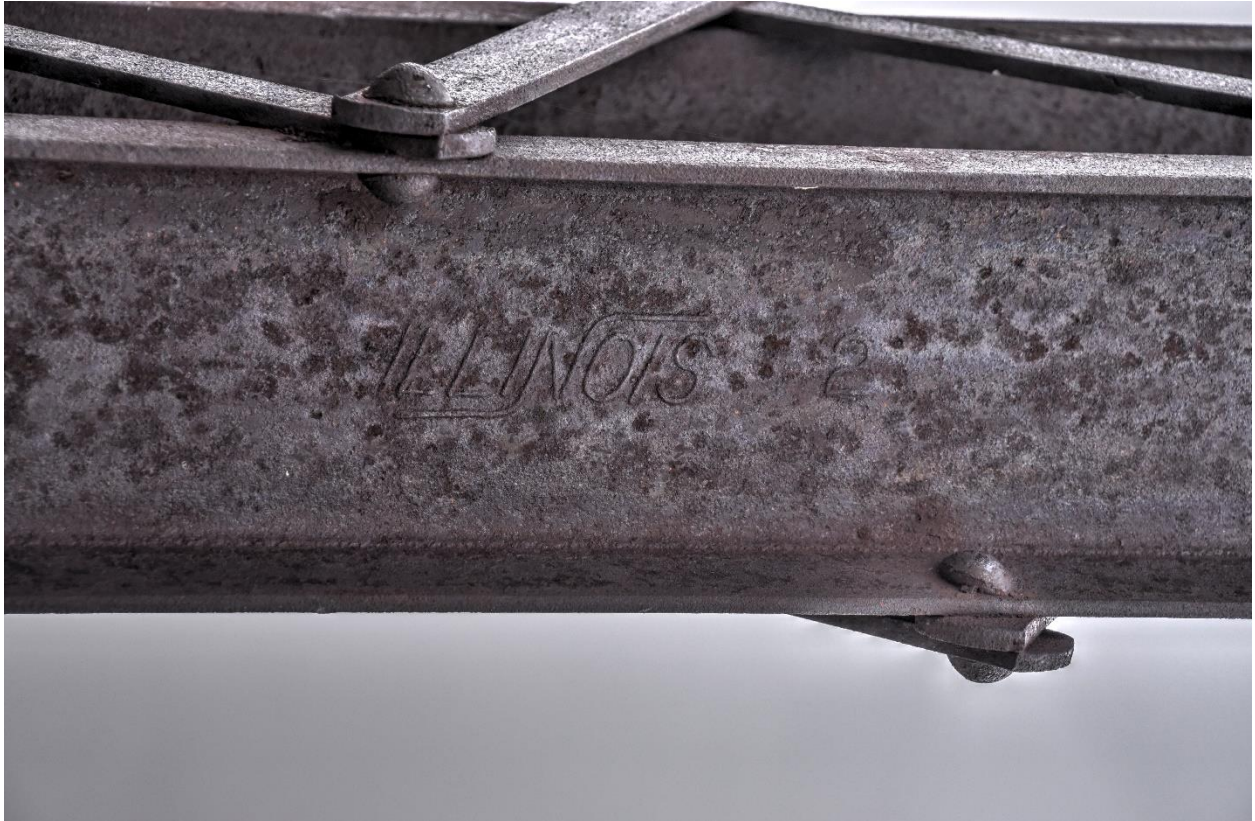
"Illinois 2" rolled into vertical member channel. Typical for vertical member, upper chord, and end post channel.

The builder of the bridge is not known. The bridge was reportedly constructed shortly after floods in 1911 devastated area bridges. The rolled channels display "Illinois 2." The "Illinois" refers to Illinois Steel

which had become part of United States Steel (USS) in 1904. Until the 1950s, USS continued to roll steel bearing the former company name of the particular mill rolling the steel. Most steel with "Illinois" was followed by a "G" or "S" (referring to respectively to the Gary, Indiana Works and the South Chicago Works). Illinois steel with a "2" after the name is extremely rare on bridges, and the meaning of the "2" is unclear, but may refer to a designation for a particular steel mill.

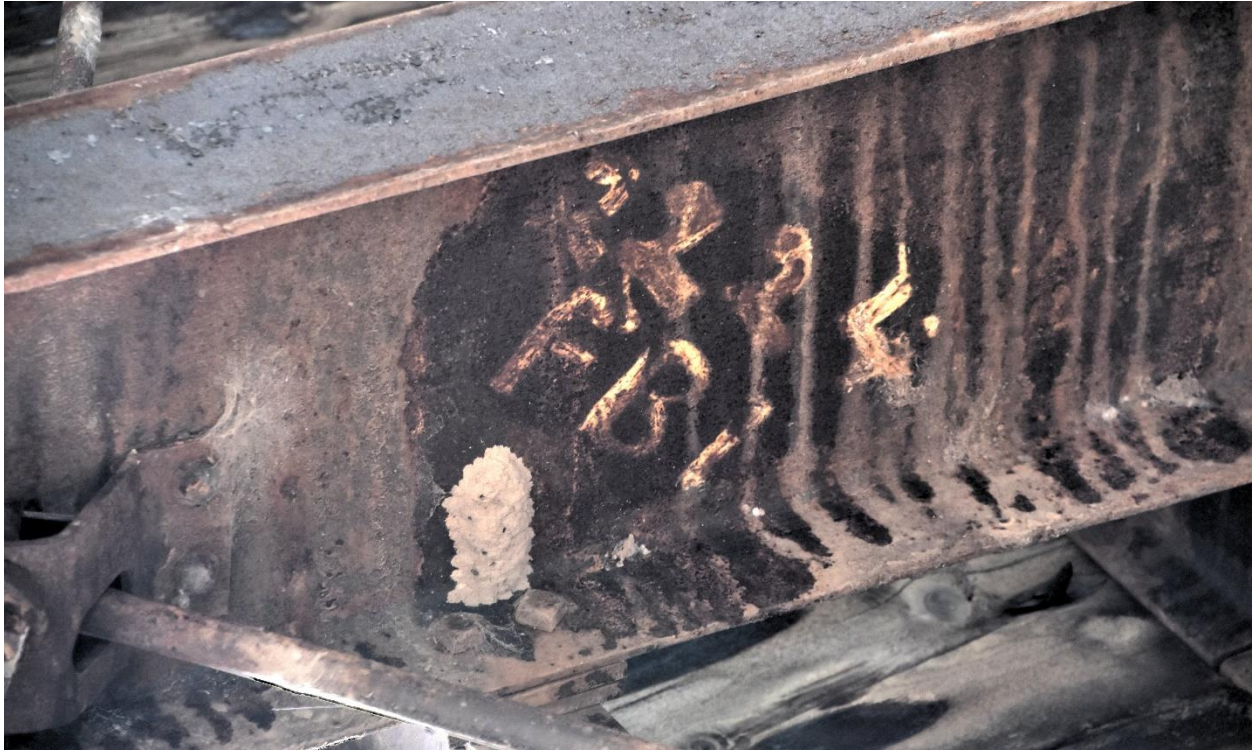
Detail of floorbeam showing what appears to be “2224” and “FB1” which may refer to Job # 2224 and Floorbeam #1 from the original construction of the bridge.

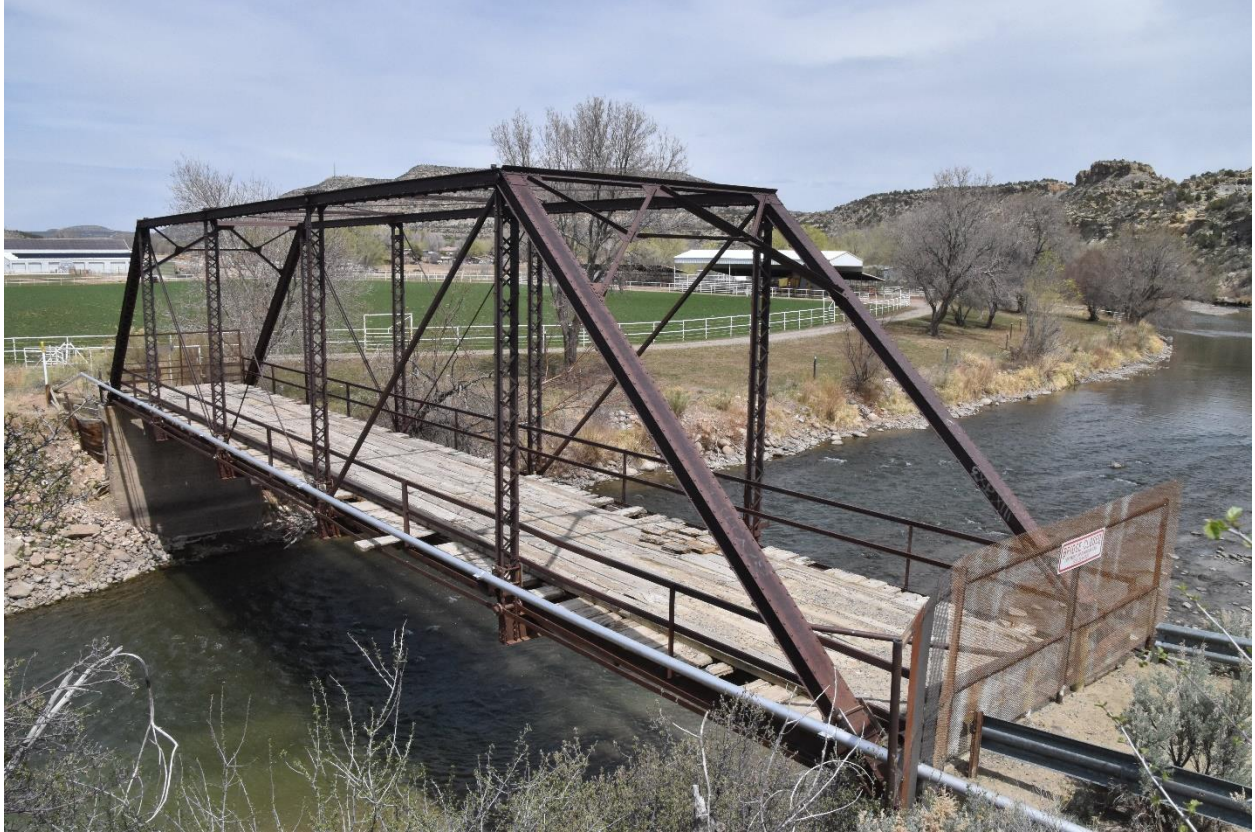
View beside bridge at southwest quadrant facing northeast.

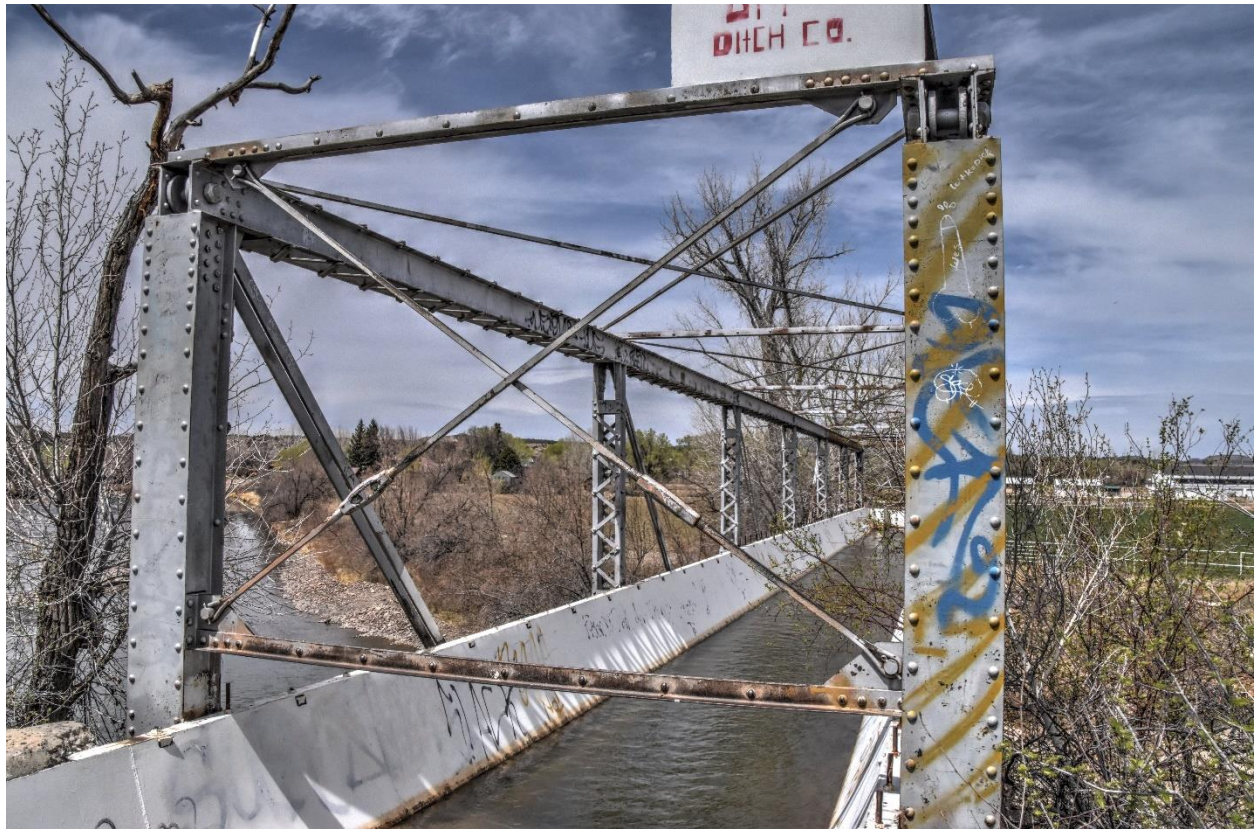
View of the flume bridge showing water flowing on the bridge.
