New Casselman River Bridge, Grantsville, Maryland

Rehabilitation Project Information

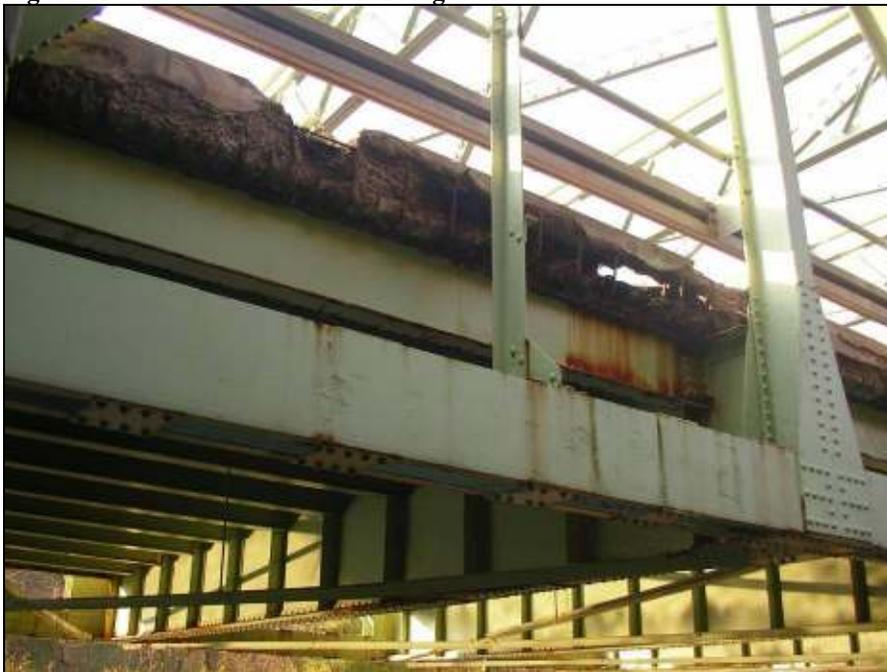
Figure 12. New Casselman River Bridge

The New Casselman River Bridge was constructed in 1932 when the National Road was relocated from its original nineteenth-century location. It is a Pratt truss bridge with riveted connections. The bridge's largest span is about 133 feet, and its total length is about 137 feet. The deck width is 40 feet and the vertical clearance above the deck is just less than 15 feet.
