Historic Bridge Foundation Facebook Archives

Did You Know: Bedstead Truss Bridges

April 2017

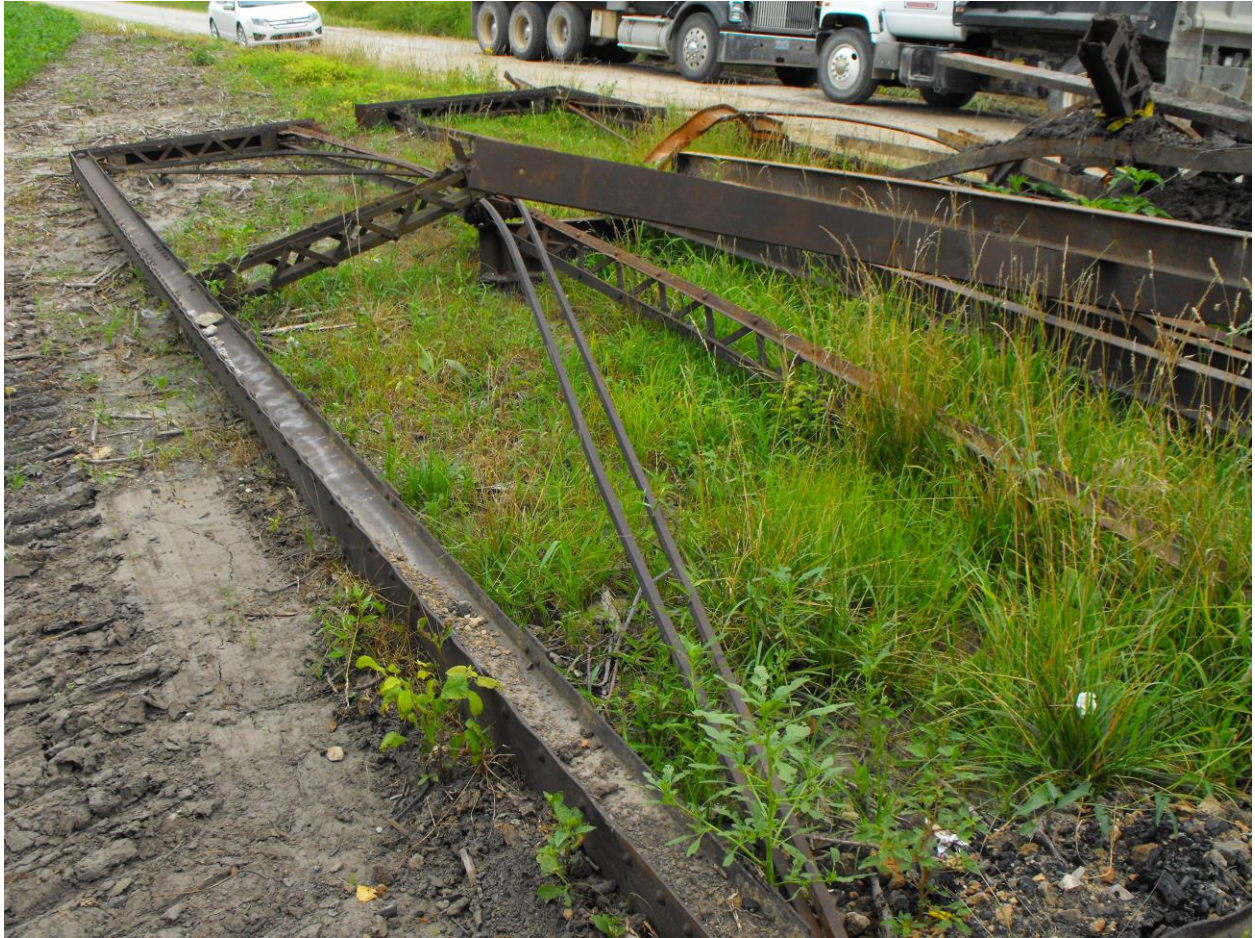
214 – Many surviving bedstead truss bridges face an uncertain future. This bridge on CR-214 in Saline County, Missouri was demolished in 2009.

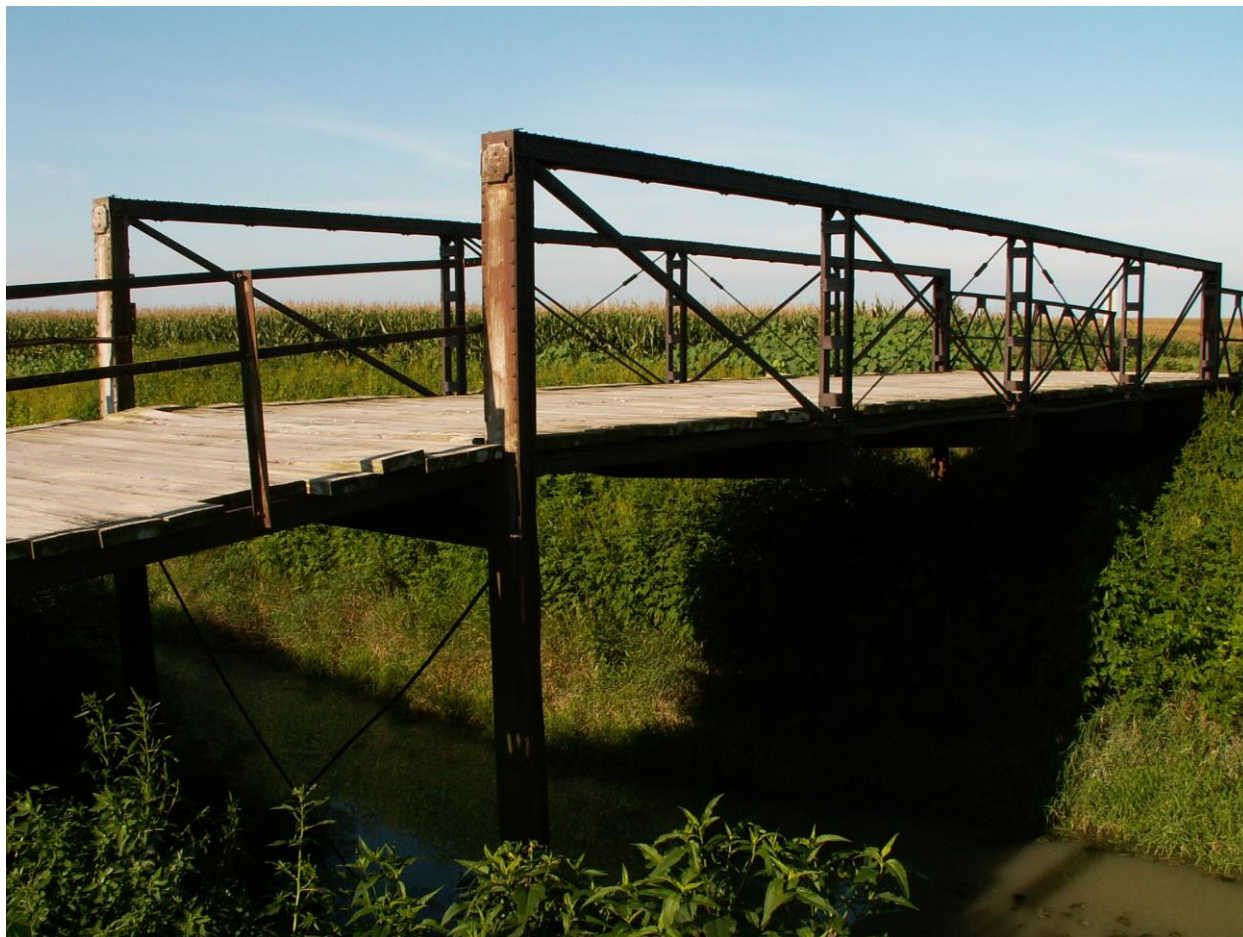
1250 – This old and impressive bedstead truss bridge was built in 1885 by the Smith Bridge Company of Toledo, Ohio. Located in Iroquois County on CR-1250, it has been closed and abandoned.

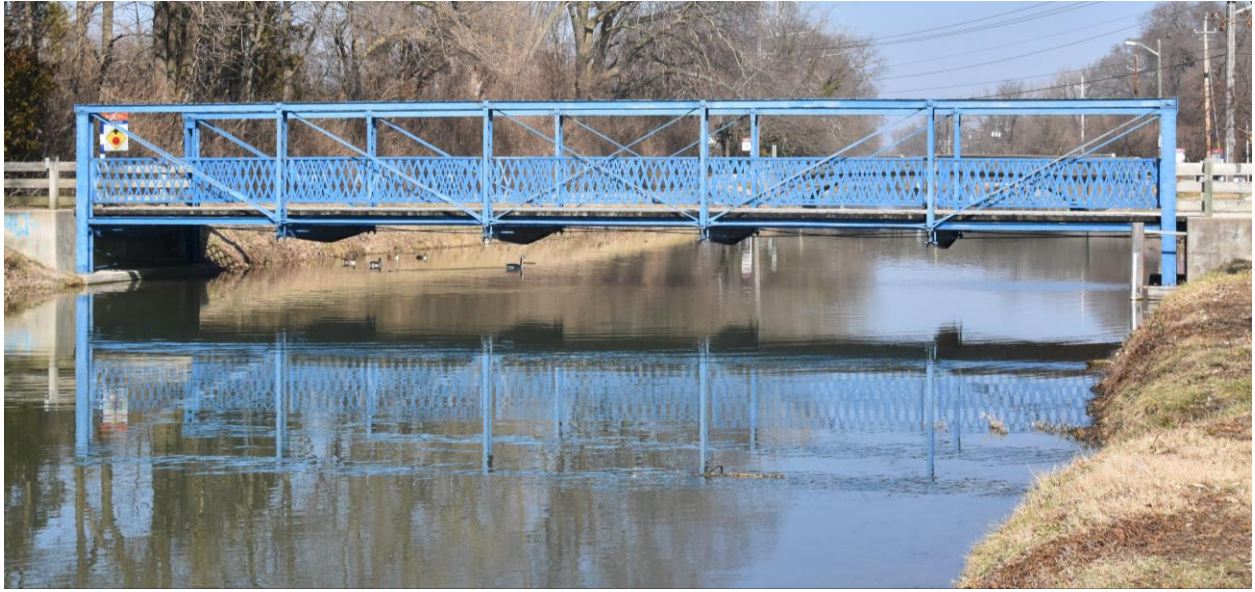
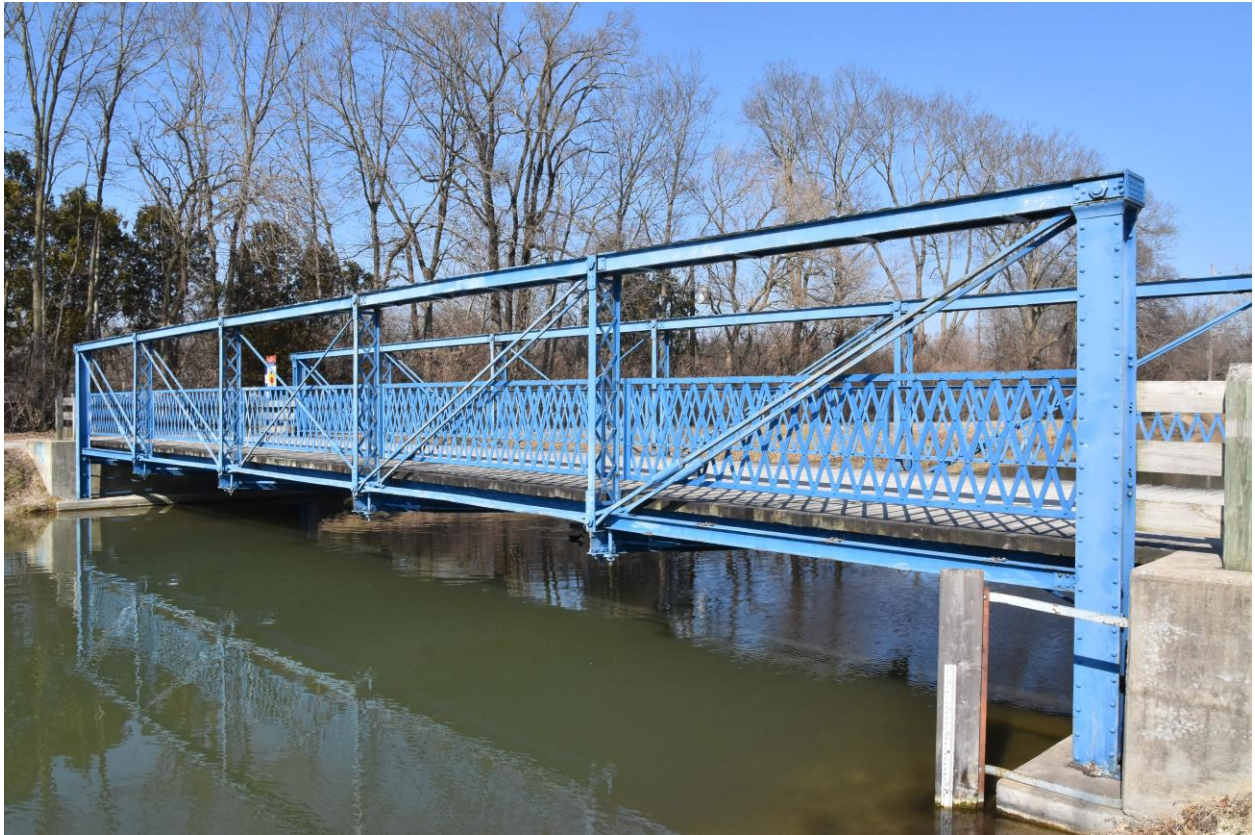
Lycreek 1 and 2 – Built in 1879 by the Wrought Iron Bridge Company of Canton, Ohio, this impressive bedstead truss bridge was relocated and preserved on a trail system in Indianapolis. It is one of the oldest known surviving bedstead truss bridges in the country.

One of the oldest bedstead truss bridges known to survive was built in 1879 and has been relocated and preserved over the Central Canal in Indianapolis. However, many surviving bedstead truss bridges are abandoned, or remain in use in rural agricultural settings where their future may be uncertain. Most bedstead truss bridges date from 1890 to 1910. Older examples do exist, but stand out as particularly rare and significant. Because of the years when most bedstead truss bridges were built, most have pinned connections and follow the Pratt truss configuration, both of which were common in this period.

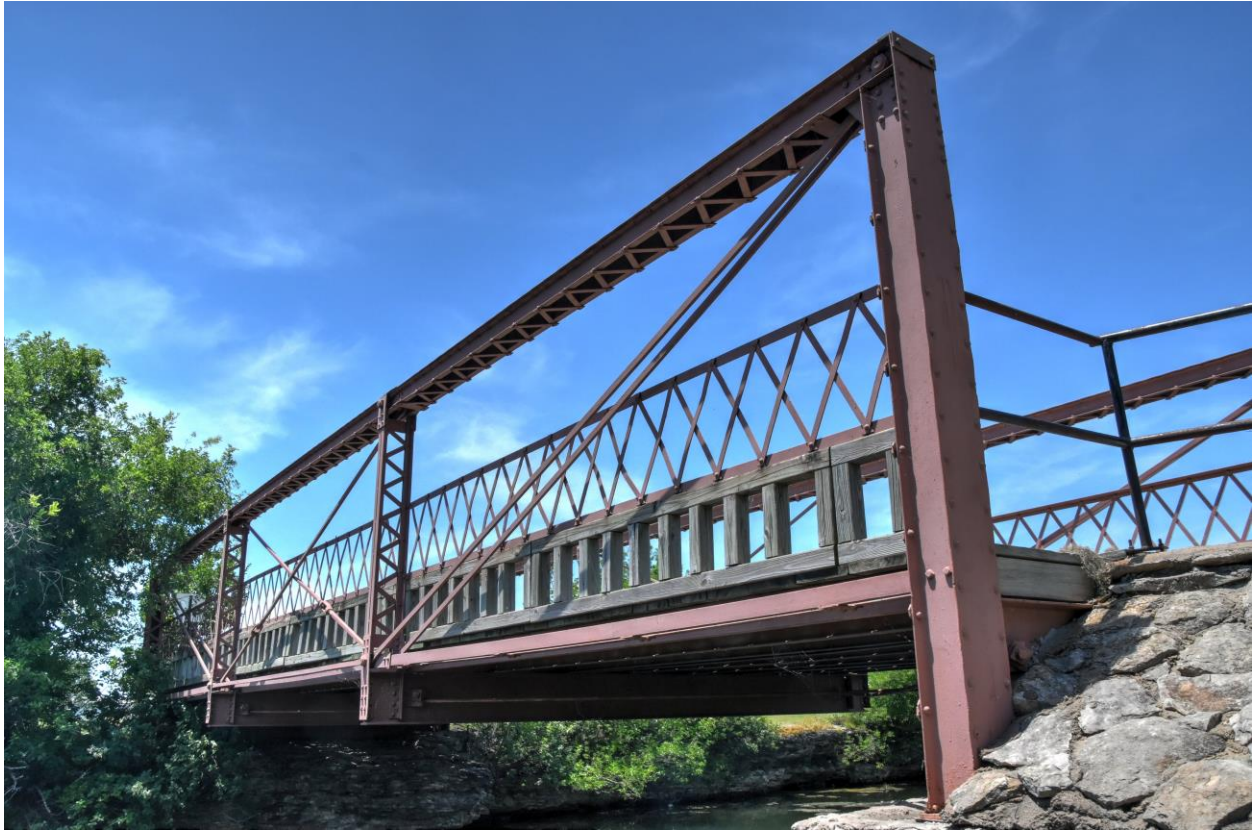
Kellogg – Built in 1915 and relocated and preserved for pedestrian use in 2005, this bedstead truss bridge is on the grounds of the Oklahoma Department of Transportation in Tulsa.

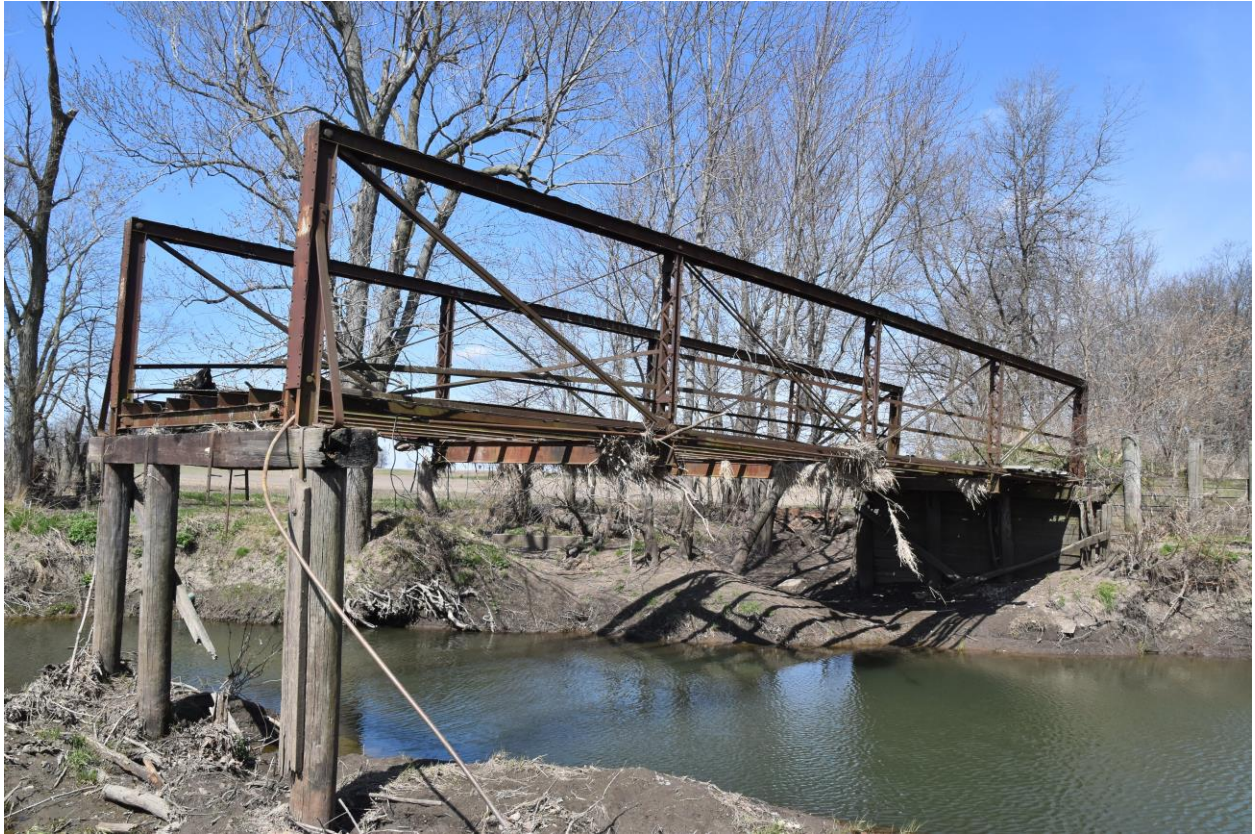
christiantr138_6202 – Located on TR-138 in Christian County, Illinois, this bedstead truss bridge appears to have had its legs cut off and replaced with timber piles. Today abandoned with the approaches missing, even the "new" timber piles are in poor condition. If left in its current condition, this bridge will eventually collapse.

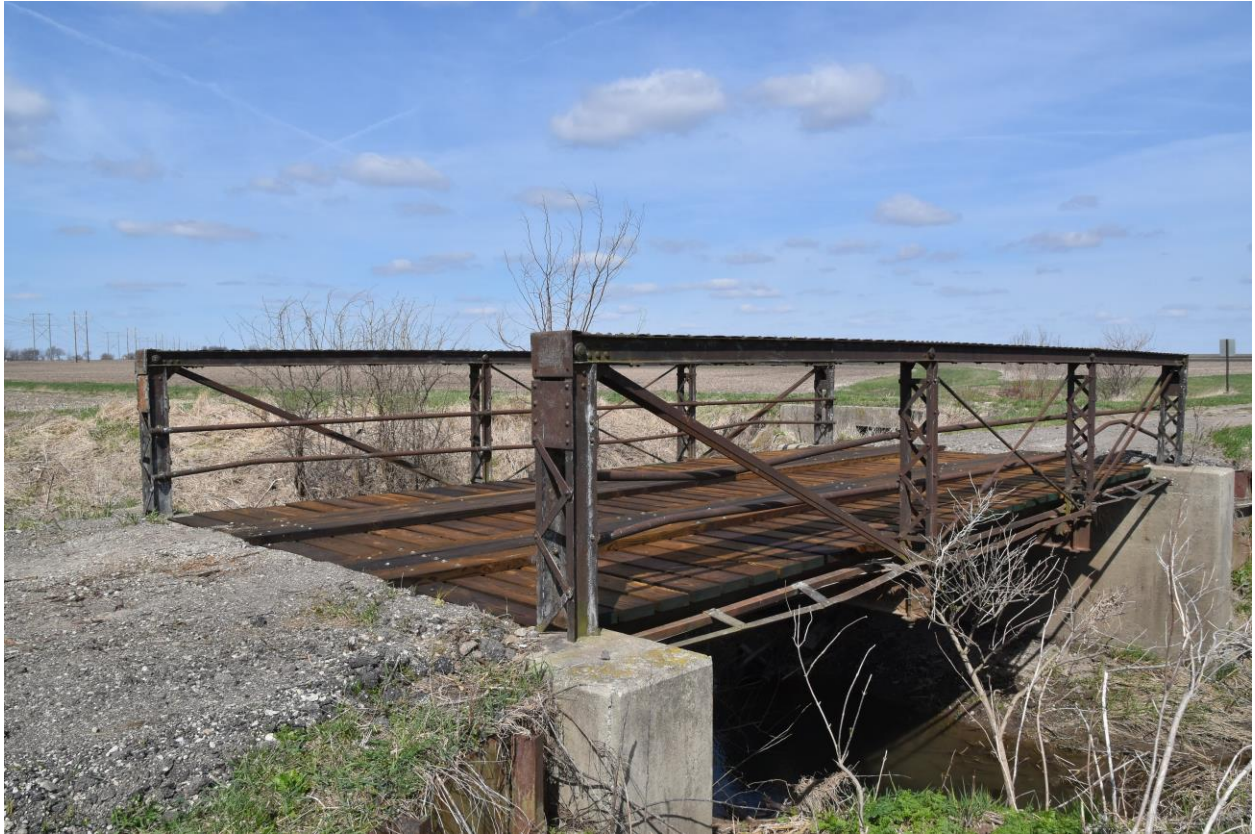
christiantr258_5446 - Located on TR-138 in Christian County, Illinois, this bedstead truss bridge was built in 1898. It received a new timber deck ca. 2016, and remains open to light vehicular traffic. It is a good example of a bedstead truss bridge where the legs have been encased in a newer concrete abutment.

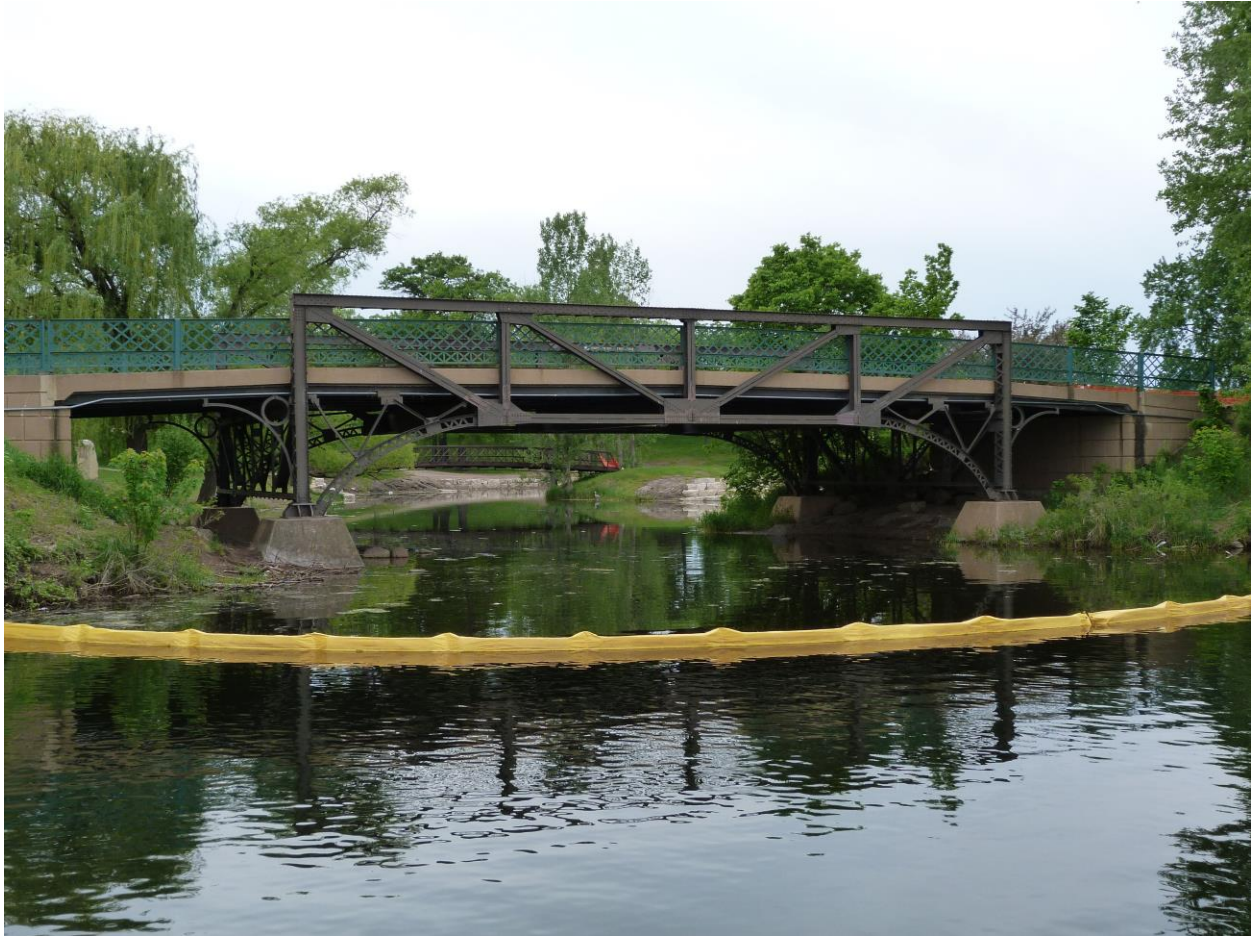
phalenparktruss3976 - Built in 1906 by the St. Paul Foundry Company of St. Paul, Minnesota, this bridge in Phalen Park, St. Paul, MN is an unusually ornamental bedstead truss with a curved lower chord.
