## Historic Bridge Foundation Facebook Archives

### Focus Bridges: Western United States Bridge Fires

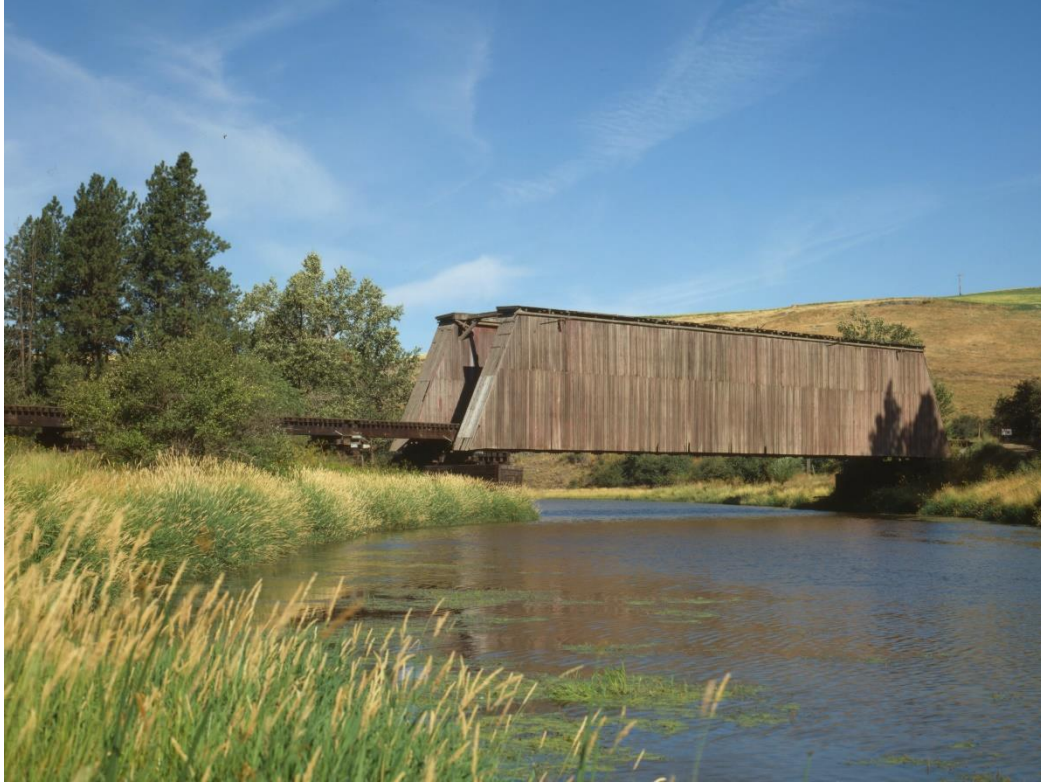
The Goodpasture Covered Bridge is a Howe covered bridge dating to 1938 and listed on the National Register of Historic Places. The National Register listed 1966 Belknap Covered Bridge, also a Howe truss, was reportedly not so lucky as news reports are indicating that this bridge has been destroyed by fires.

Goodpasture Covered Bridge

In Lane County, Oregon, the fires have come very close to claiming two covered bridges. Firefighters worked to save the Goodpasture Covered Bridge from destruction. This video shows fires raging around the firefighters as they hose the bridge down. <https://www.facebook.com/100014798942403/videos/939825003187456>

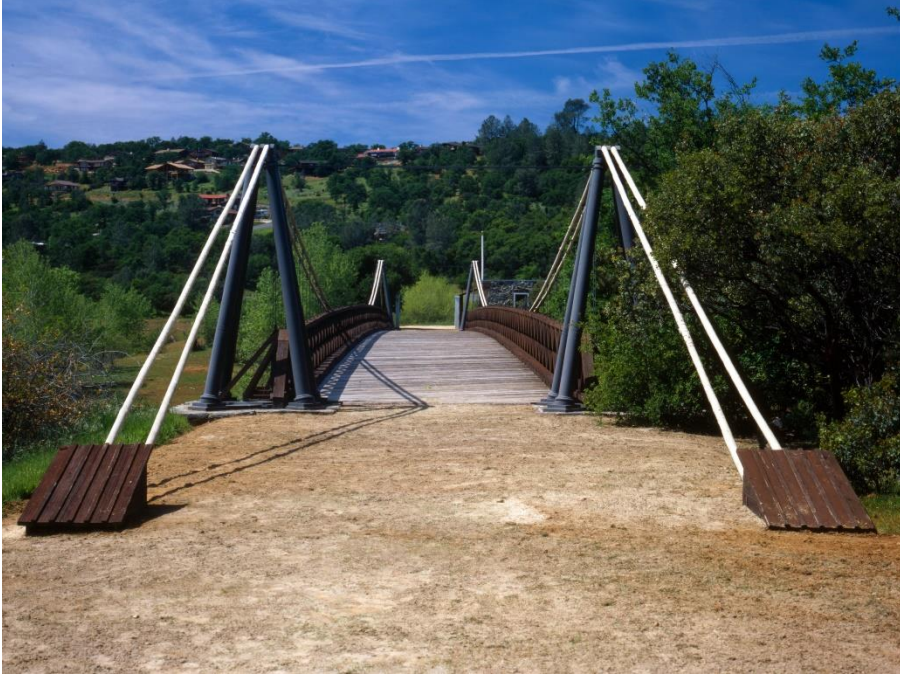
The original Bidwell Bar Suspension bridge, which dates to 1856 and was relocated to a park setting for pedestrian use, has thus far been spared from the fires, although one fire reportedly was nearby. This bridge contains cast iron tripod towers, and its cable support a timber stiffening truss and deck, putting this bridge at a high risk if fires did in fact reach the bridge.

Old Bidwell Bar Suspension bridge

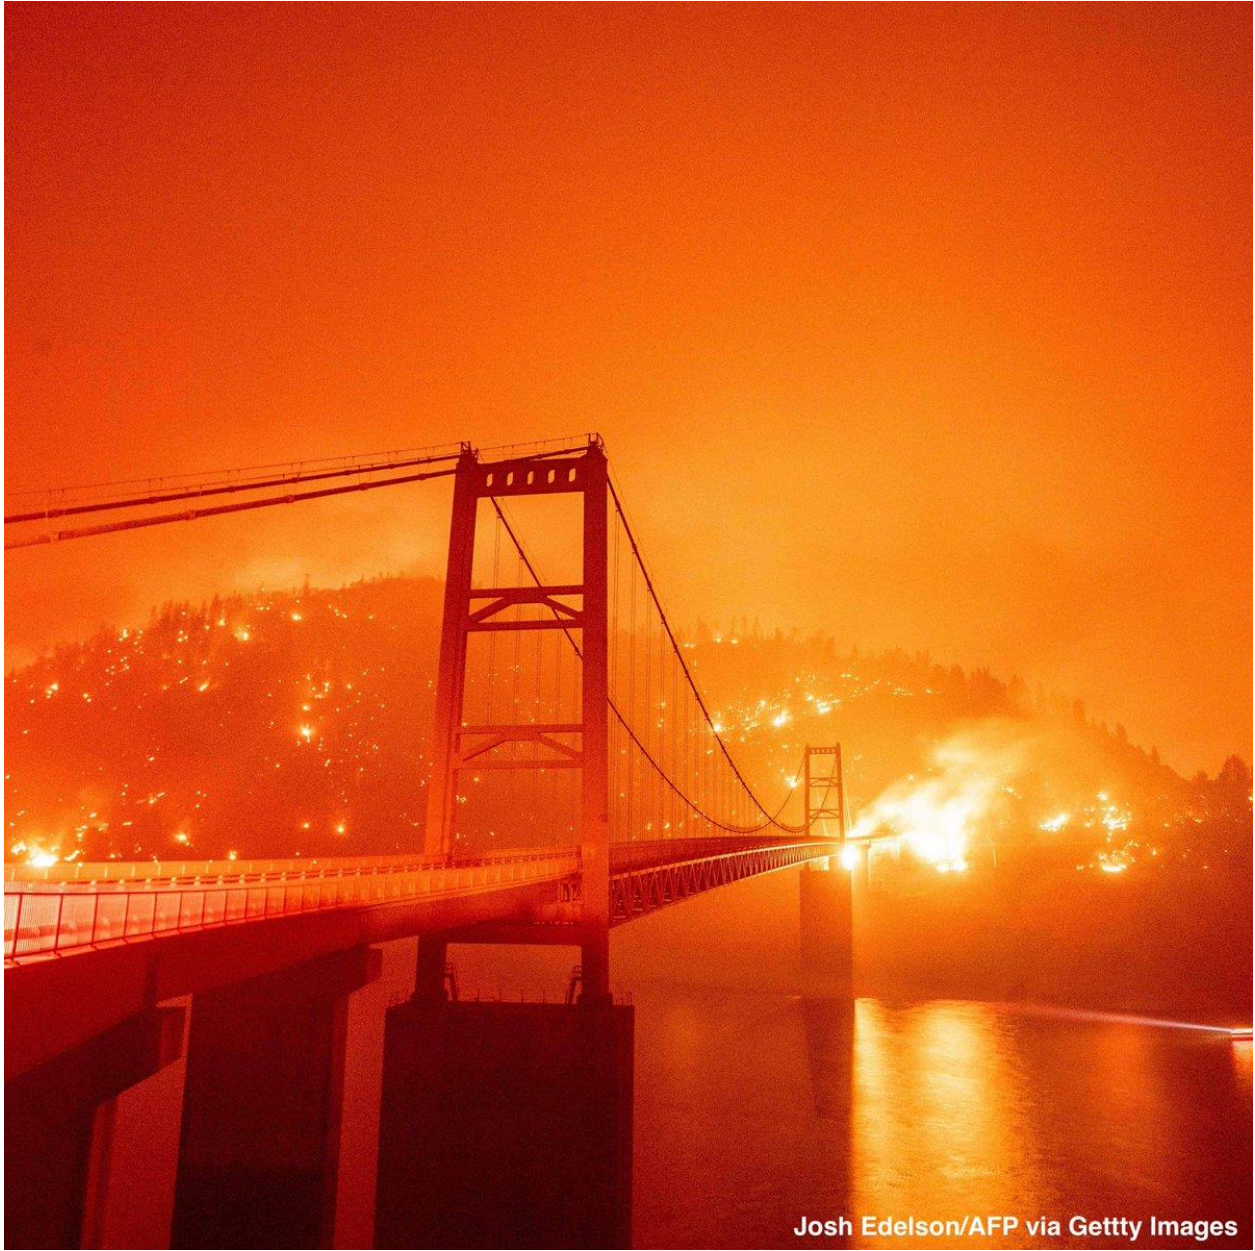
The 1965 Bidwell Bar Suspension Bridge in Butte County, California was the subject of dramatic photos showing the bridge with the nearby mountainside covered in flames. Despite the dramatic photos, the steel and concrete bridge itself appears to be unharmed. This article has a photo showing the Bidwell Bar Bridge: <https://abcnews.go.com/US/oregon-governor-issues-emergency-declaration-wildfires/story?id=72895505>

Bidwell Bar Suspension bridge
